CK-2122

SHOVEL CREEK 0.1km

2017 Inspection

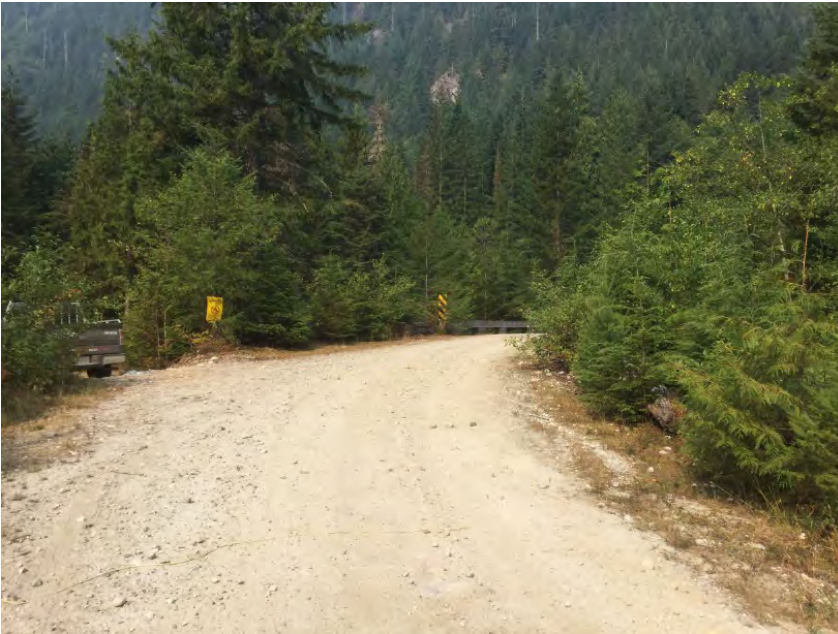
Approach from Left Bank when facing downstream

| 1 | Medium | Brush and grade approaches with activity |

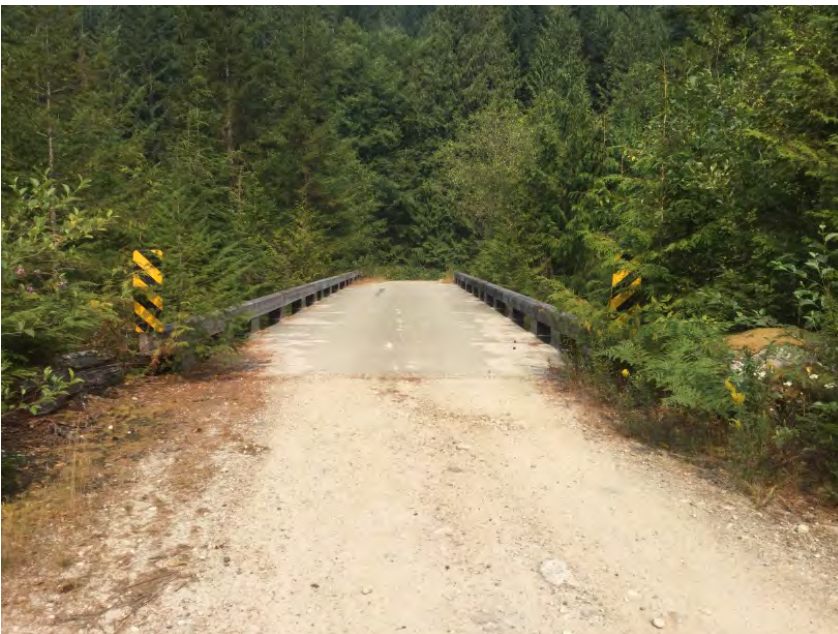
Approach from Left Bank when facing downstream

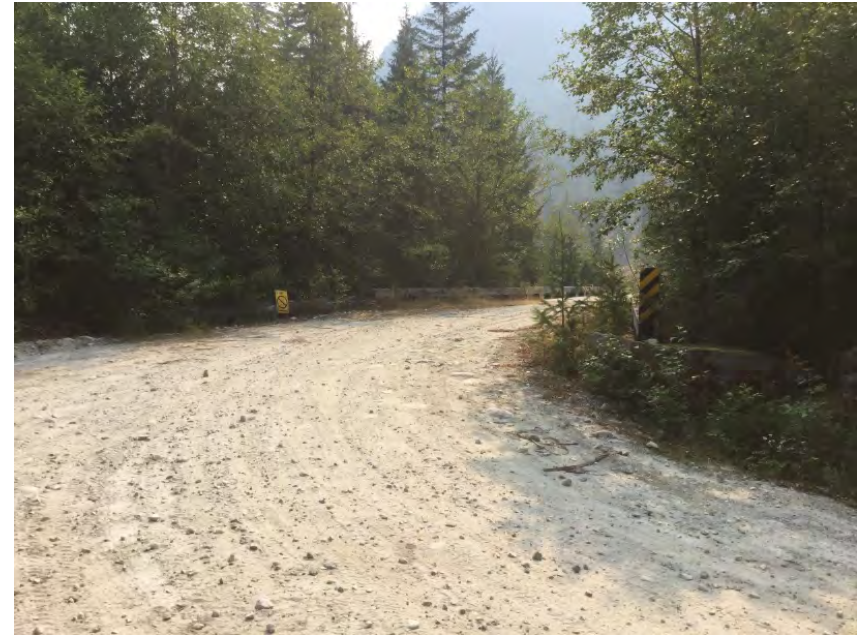
Approach from Right Bank when facing downstream

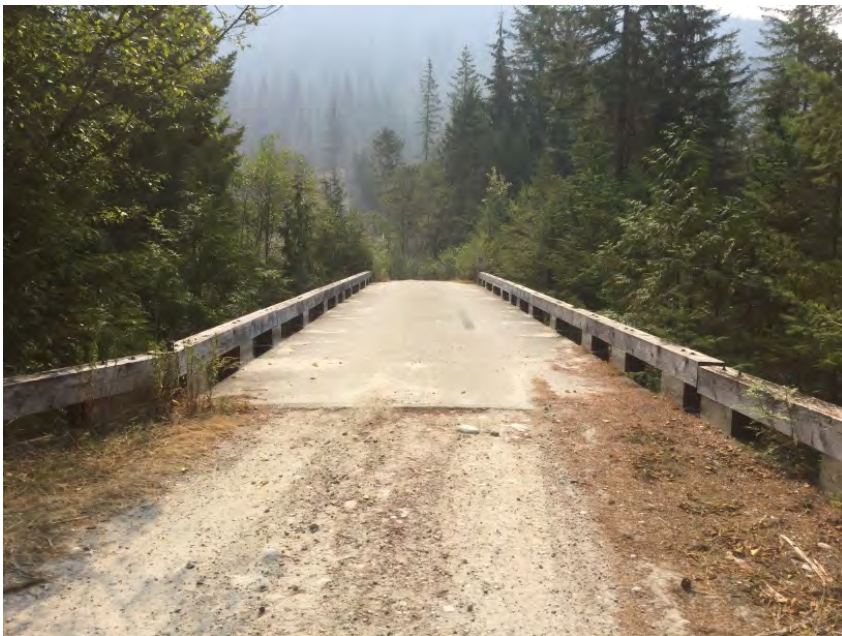
Approach from Right Bank when facing downstream

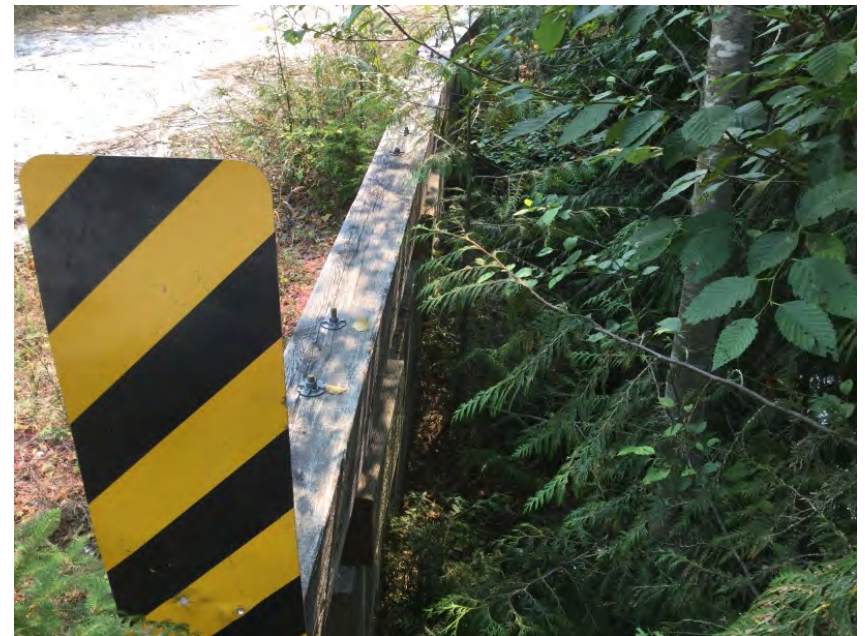
Downstream right bank wingwall - 3 piece precast concrete

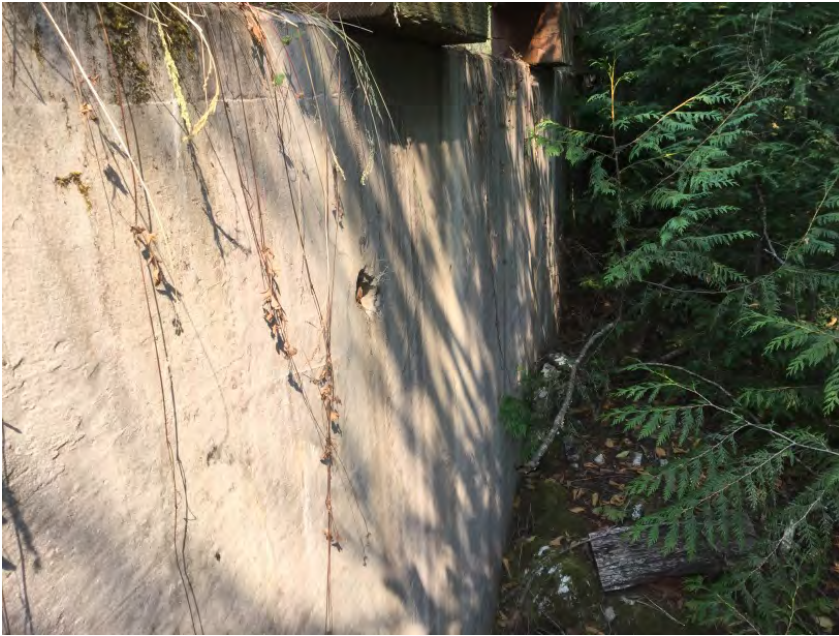
Upstream right bank wingwall - 1 piece precast concrete

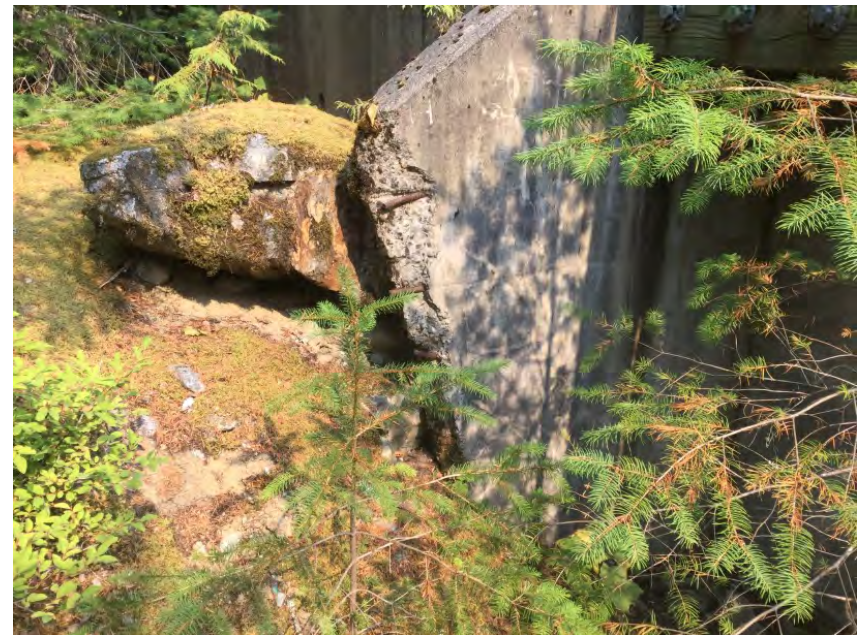
Minor damage at road surface, and downstream right abutment section removed due to terrain

Downstream right bank portion of ballast wall removed due to terrain feature

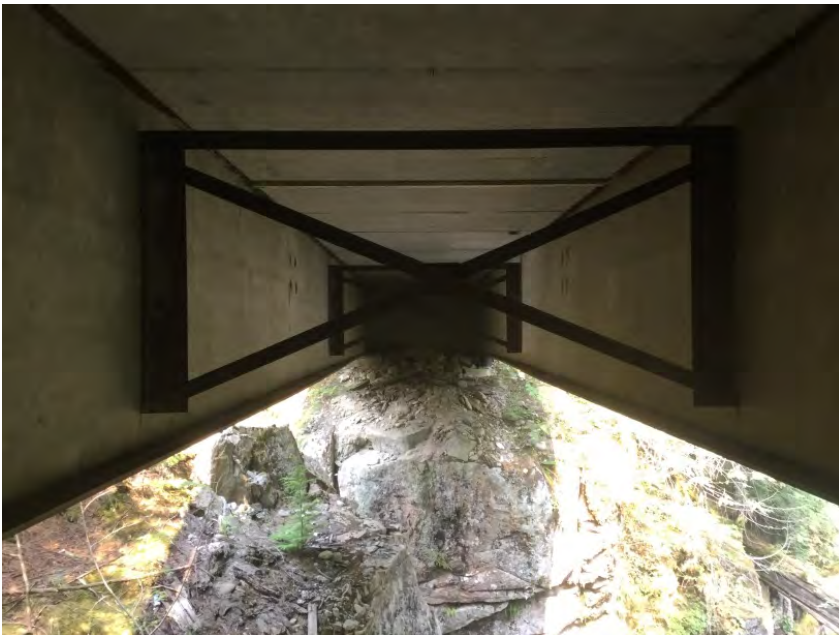
Composite girders - hairline cracks noted

Superstructure
