CK-2123

SHOVEL CREEK 7.6km

2017 Inspection

| Crossing Name | Pick Creek |

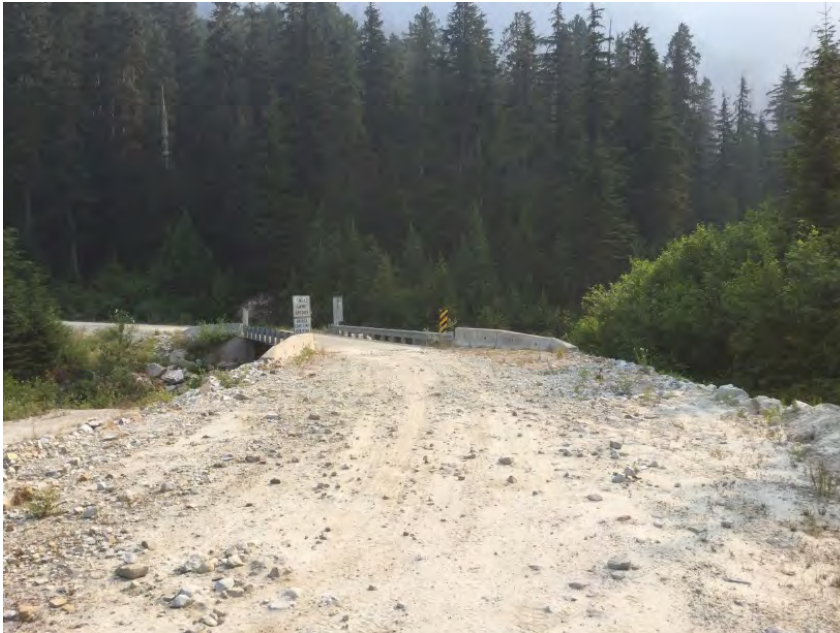
Approach from Left Bank when facing downstream

HC both approaches

| Item | Priority | Repair Description |
|---|---|---|
| 1 | Low | Grade and brush road if/when used for industrial purposes |

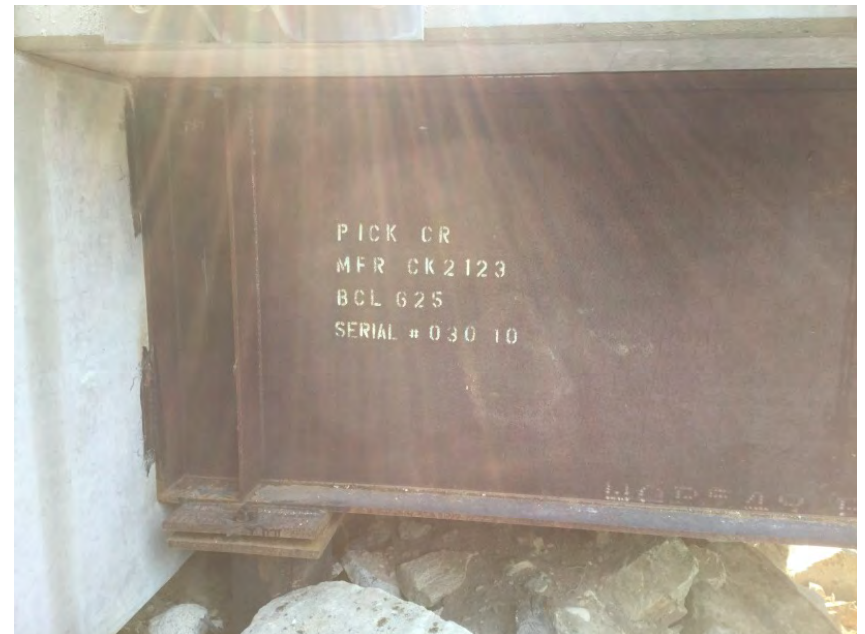
Serial/ID Plate See photo

Structure ID

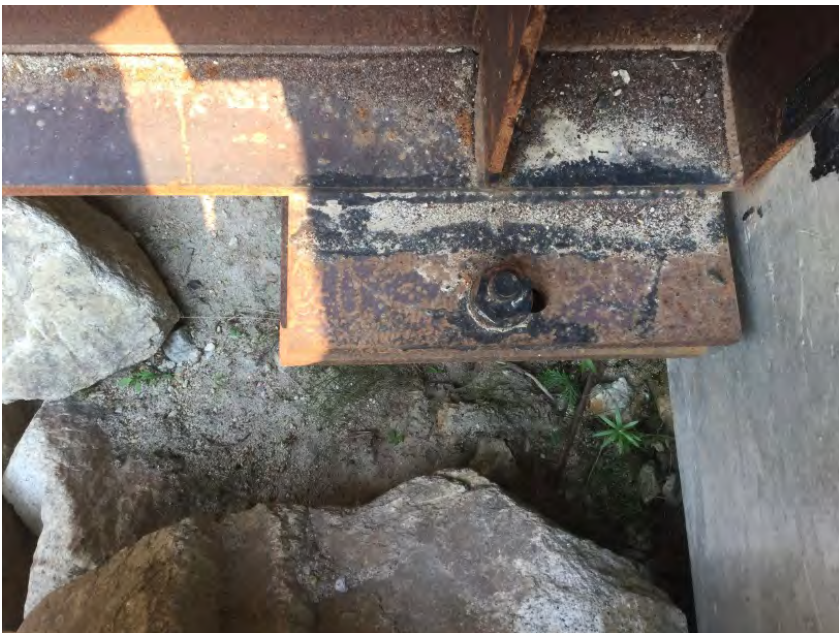
Bearing plates at right abutment at extent of slot causing pad to bulge

Bolts at extent of slots at right abutment

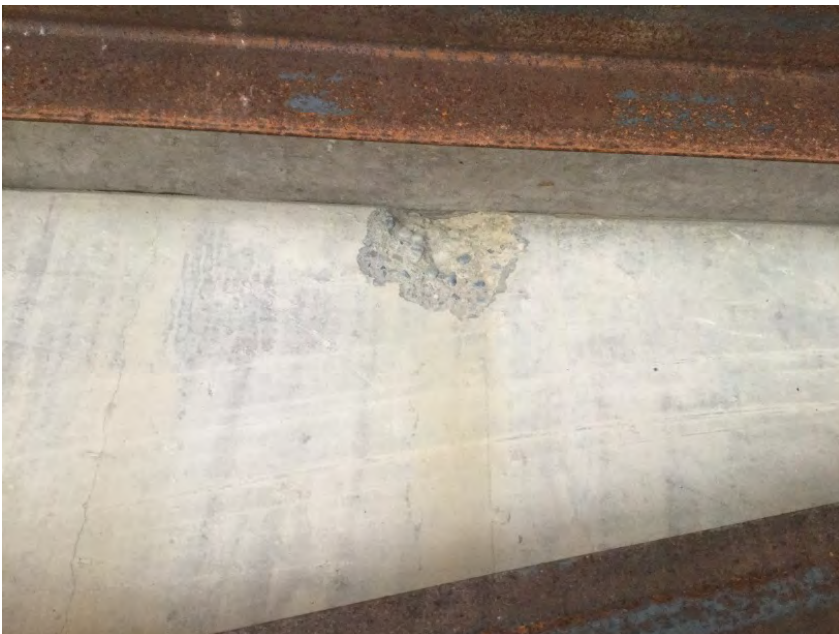
Small spall at left bank ballast wall
