CK-2124

SHOVEL CREEK 2.9km

2017 Inspection

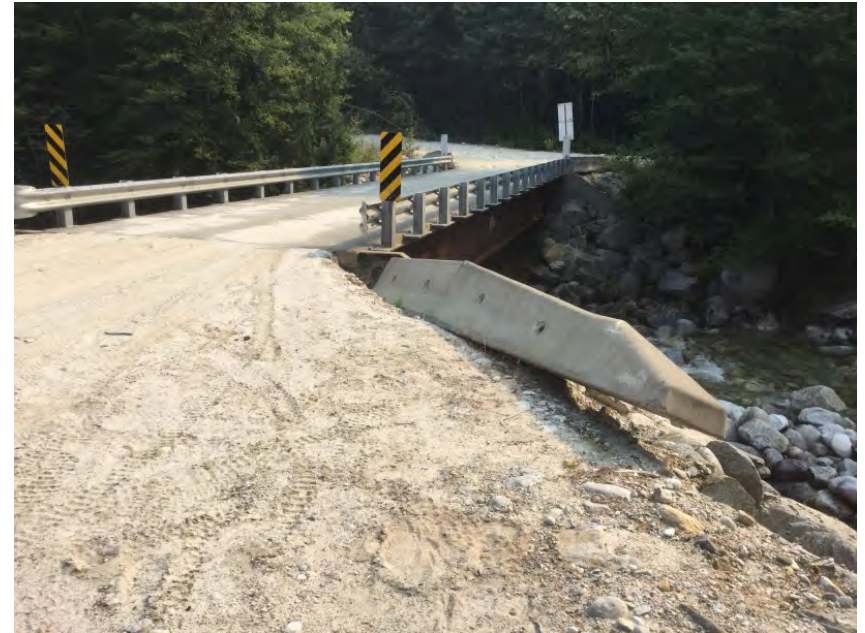
Due to failing fill no posts on left upstream have failed off surface

Failing at both approaches, but especially left upstream

Failing left upstream no post barriers

At left upstream approach, replace missing fill and add riprap to protect against future fill failure. Adjust concrete fender at same location as guardrail post is currently exposed. Monitor fill at both approaches. Current load rating of BCL 625 or 64 tonnes to continue.

| Item | Priority | Repair Description |
|---|---|---|
| 1 | Medium | Replace missing fill and rearrange concrete no post barriers at left upstream approach |

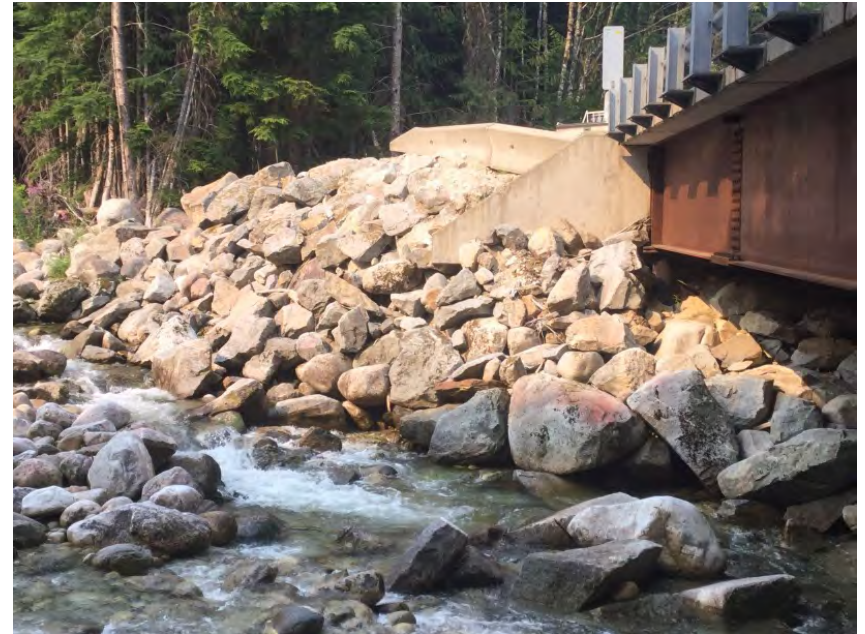
Steep at left upstream

Steep riprap at left upstream

| Item | Priority | Repair Description |
|---|---|---|
| 2 | Medium | Additional riprap to be added to left upstream bank to help protect future failing fill |

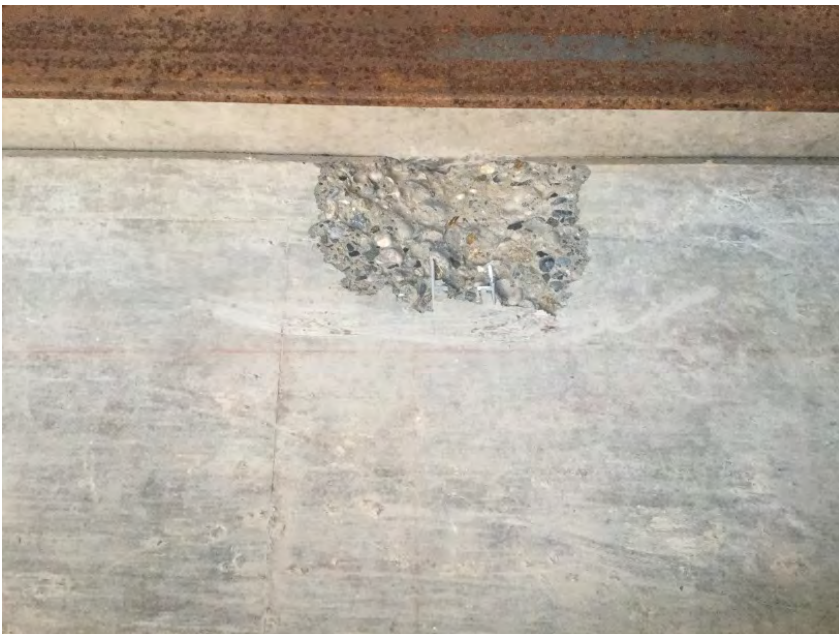
Small spall at left ballast wall
