CK-2129

STS'AILES 12.5km

2017 Inspection

| Crossing Name | Cartmell Creek |

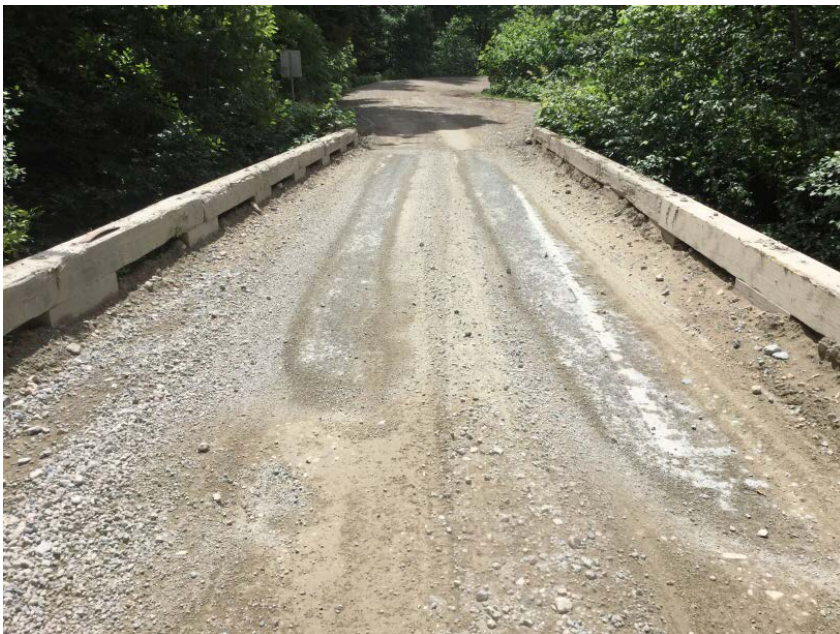
| Running Surface | Poor | sediment on deck |

| Concrete Deck | Fair | Wear noted |

| Item | Priority | Repair Description |
|---|---|---|
| 3 | Medium | Clean sediment from deck |

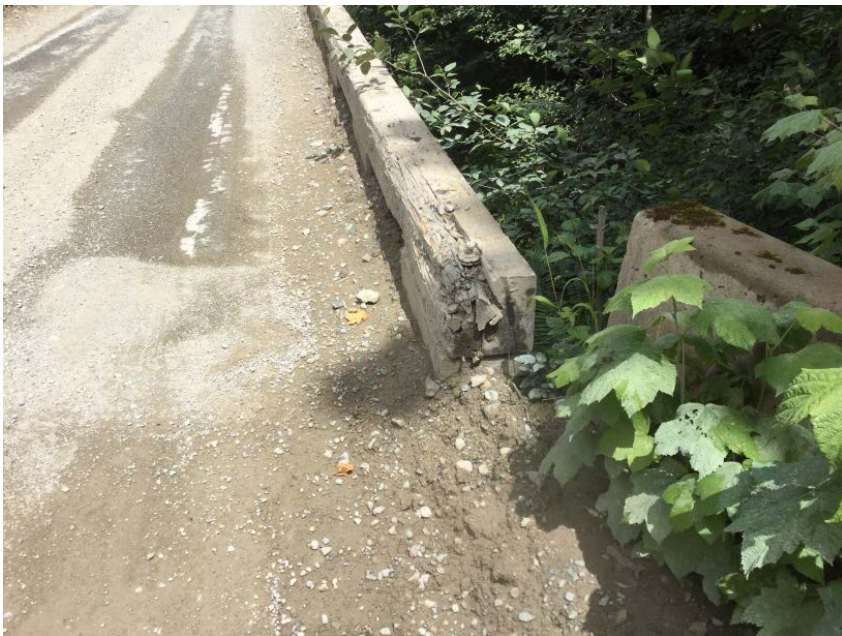
| Curb Rail/Blocks/Posts | Fair | Some damage noted at both approaches |

Damage noted to right approach rails

| Item | Priority | Repair Description |
|---|---|---|
| 1 | Medium | Replace damaged sections of rail and brush both approaches |
