CK-2134

STS'AILES 23.5km

2017 Inspection

| Crossing Name | Hale Creek |

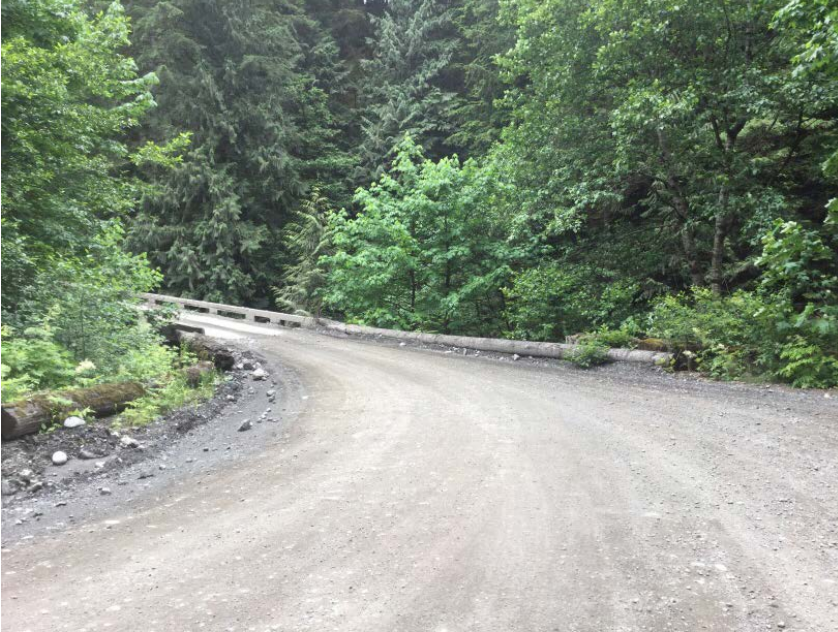
HC both approaches limits visibility

Approach from Left Bank when facing downstream

| Repair Item | Priority | Repair Description |
|---|---|---|
| 3 | Medium | Replace missing delineators and brush approaches |

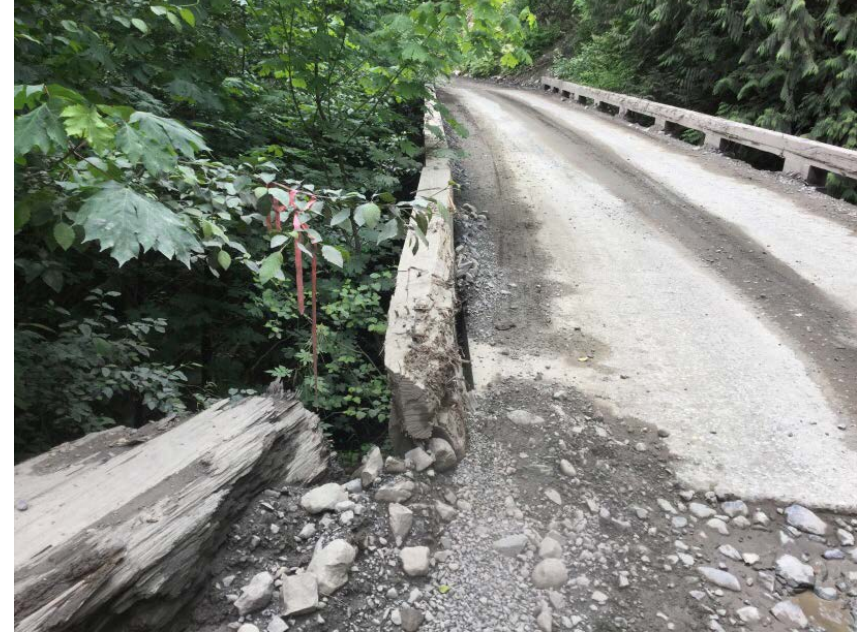
Curb Rail/Blocks/Posts      Fair      Damage noted to both downstream rails

Damage to left downstream guardrail

Replace damaged sections of guardrail. Replace the upstream right approach fender log. Replace missing delineator and brush approaches. Present load rating of L75 or 68 tonnes to continue.

| Repair Item | Priority | Repair Description |
|---|---|---|
| 1 | Medium | Repair damaged sections of rail |

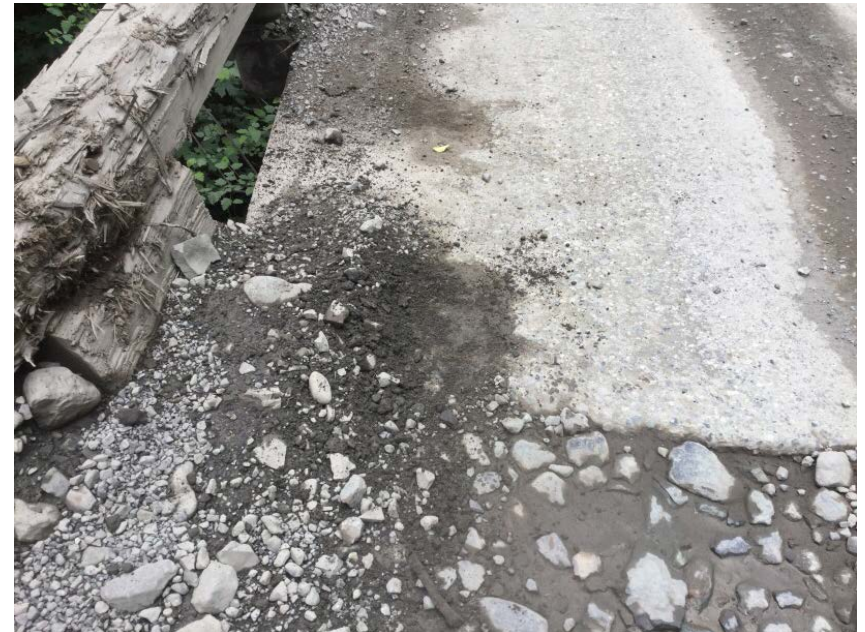
Grout Pockets      Fair      Some pockets up to 20mm wear depth

Grout pockets are wearing up to 20 mm in some locations

| Item | Monitor Description | Frequency |
|---|---|---|
| 2 | Grout pocket wear | Routine Inspection |

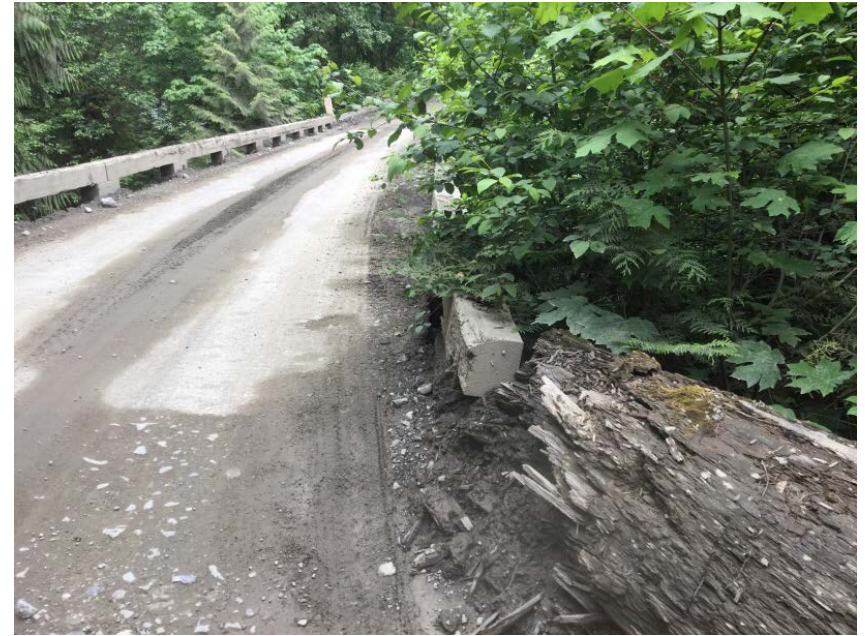
Right downstream guardrail damage

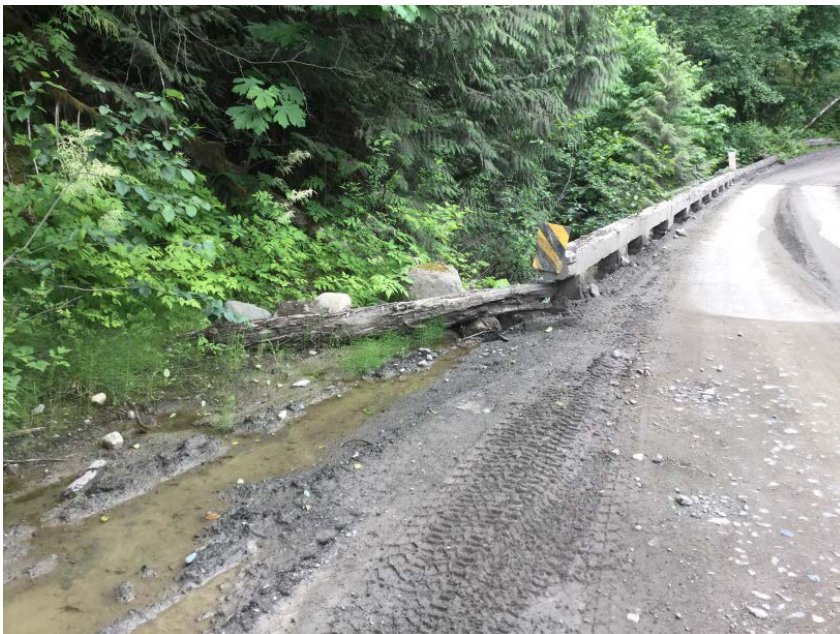
Logs, upstream right approach is small

Right upstream fender - very small

| Repair Item | Priority | Repair Description |
|---|---|---|
| 2 | Medium | Replace upstream right fender log |

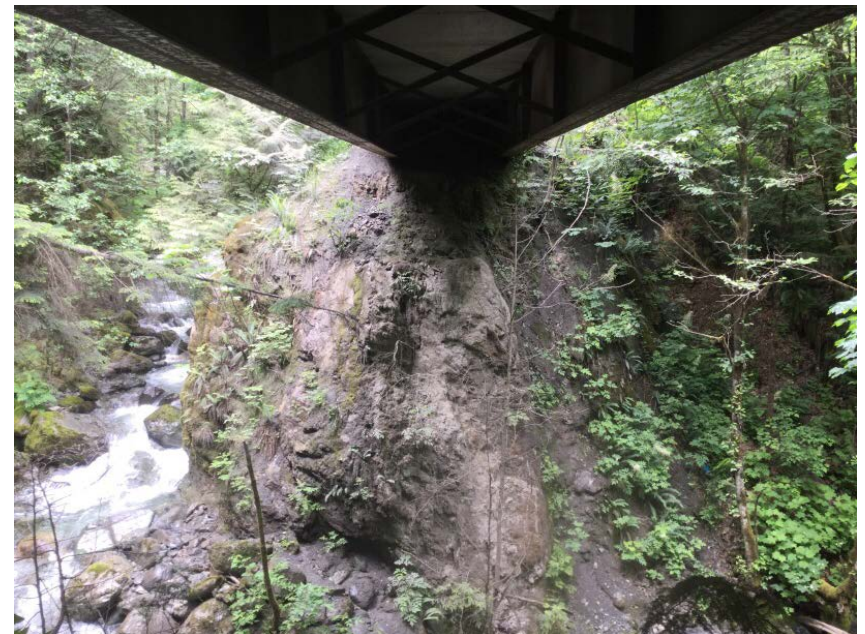
covered in sediment on left abutment

Left Bank Abutment when facing downstream

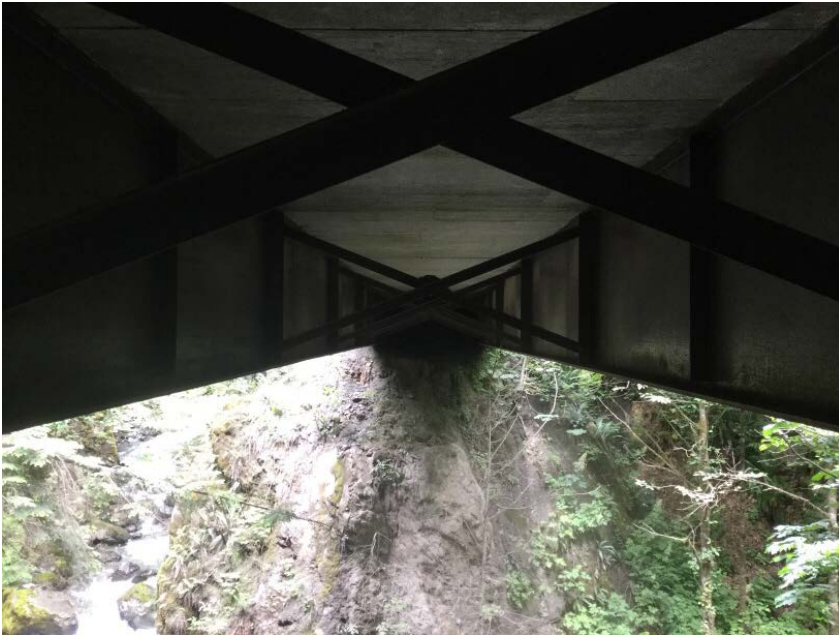
Corrosion noted at both ends

Superstructure

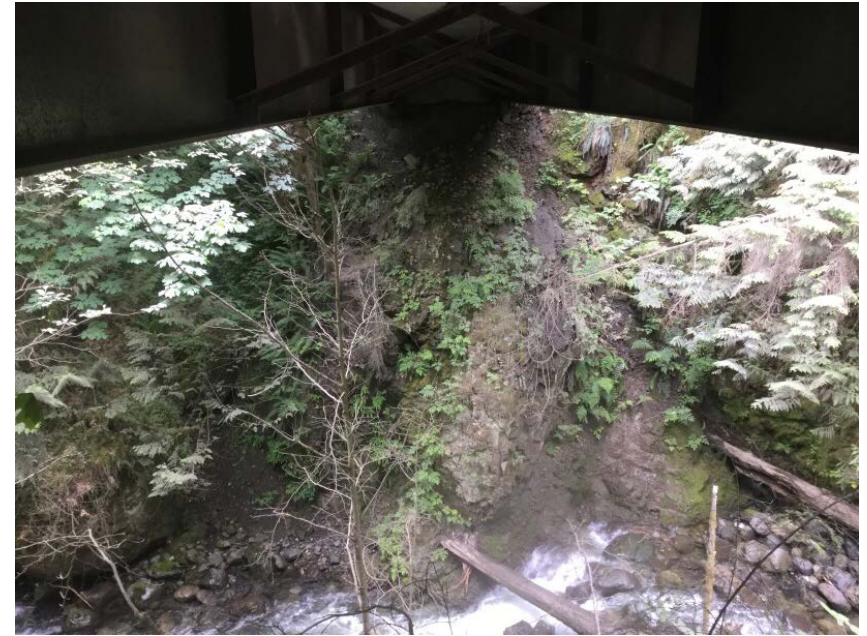
Only noted at right bank, minor corrosion

Right Bank Abutment when facing downstream

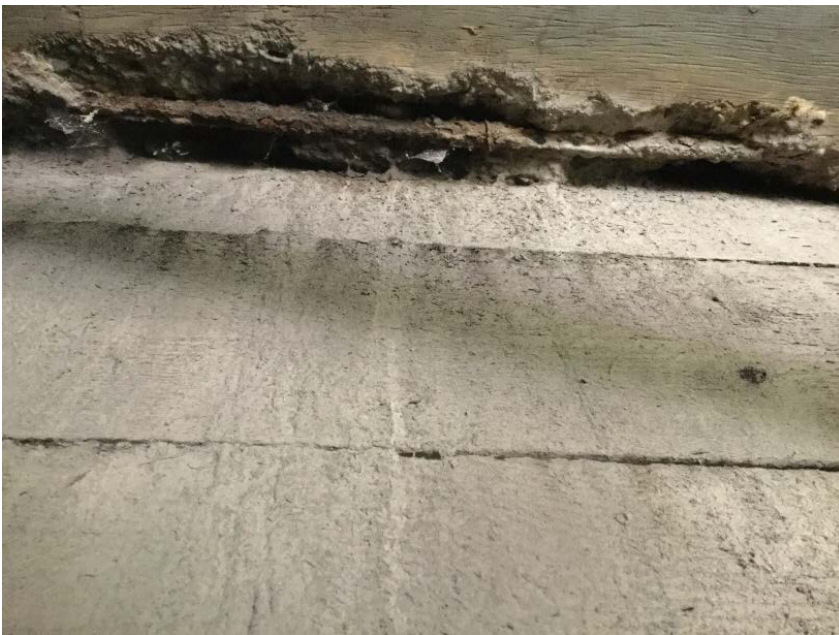
Damage under first panel on right approach

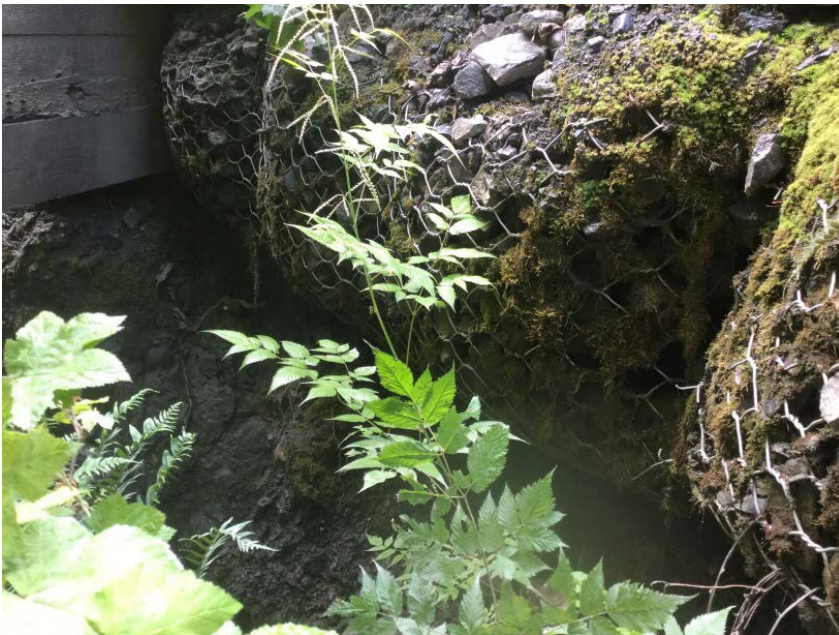
only on left approach, fill eroding under downstream gabions

eroding under downstream left gabions

Left downstream gabion wall - up to 500mm erosion under gabions

| Item | Monitor Description | Frequency |
|---|---|---|
| 1 | Gabion walls and eroding fill at downstream left approach | Routine Inspection |
