CK-2138

STS'AILES 34.5km

2017 Inspection

| Crossing Name | 20 Mile Creek |

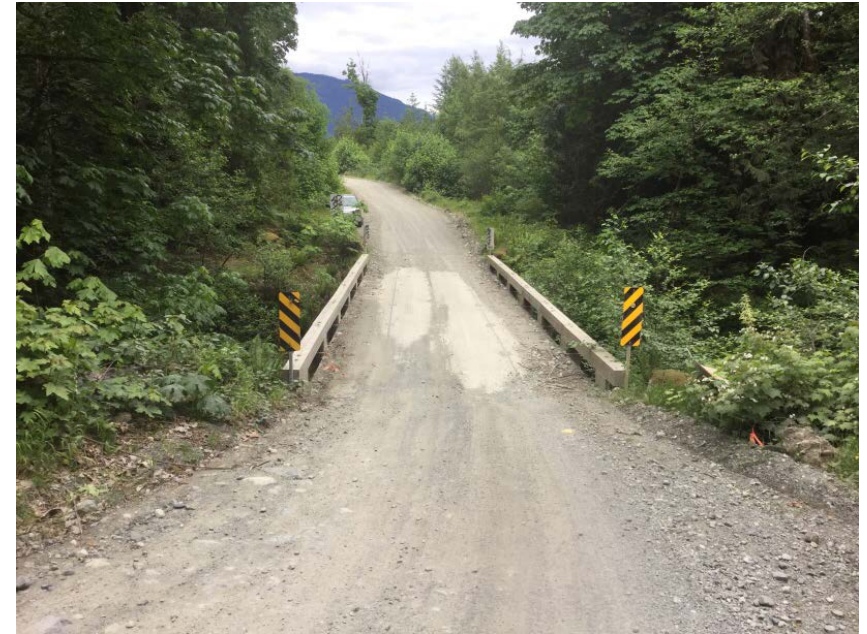
Approach from Right Bank when facing downstream

Abrupt VC right approach

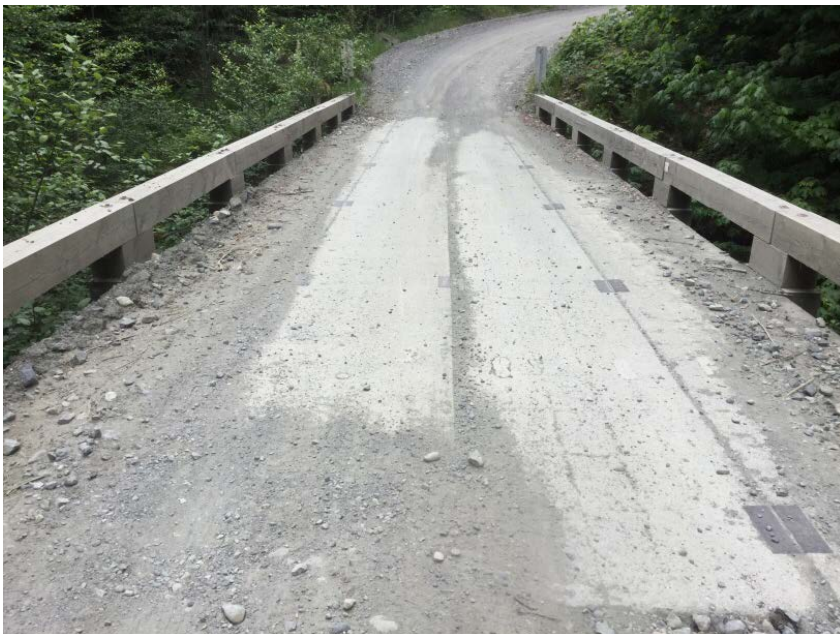
Deck

Grout Pockets Fair Where the slabs tie into cap

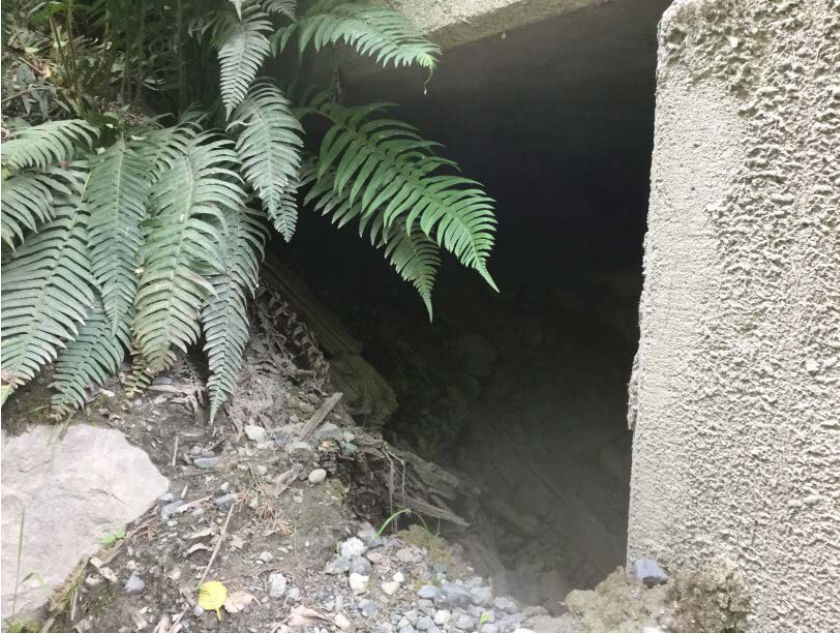
Loosing fill behind RB cap
