CK-2141

STS'AILES 49.1km

2017 Inspection

| Crossing Name | Trio Creek |

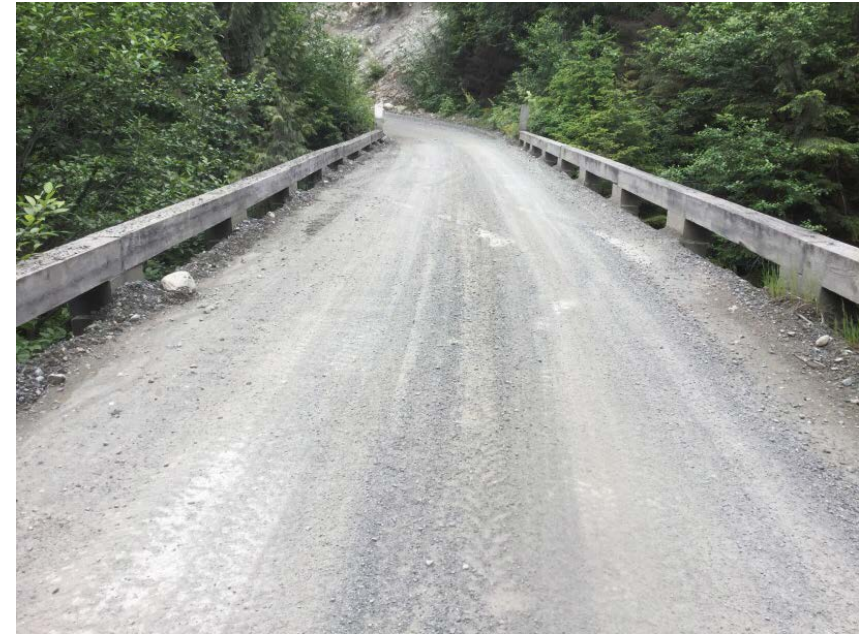
Deck

Running Surface      Fair

| 2 | Medium | Clean sediment off deck |

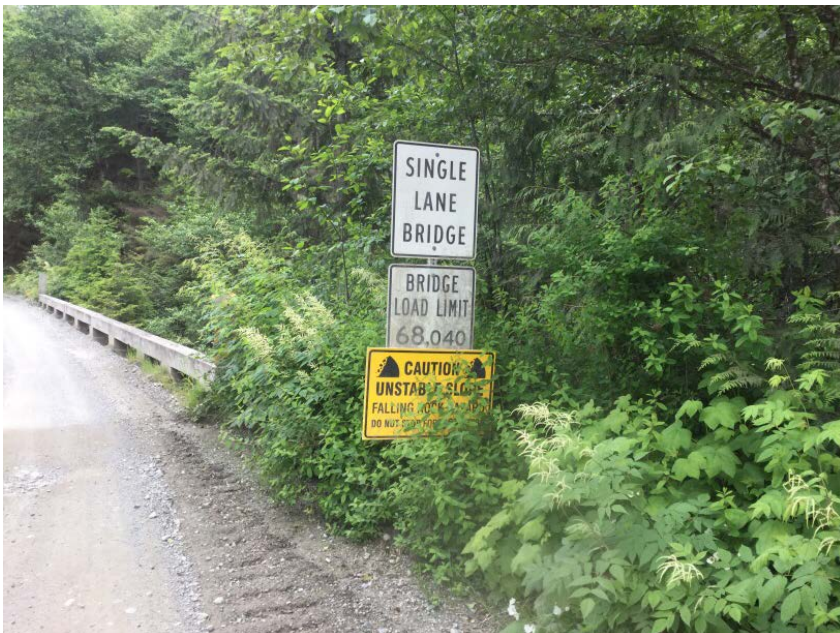
Load Rating Sign

Posted Load Rating 68040

| 3 | Low | Update load rating sign |

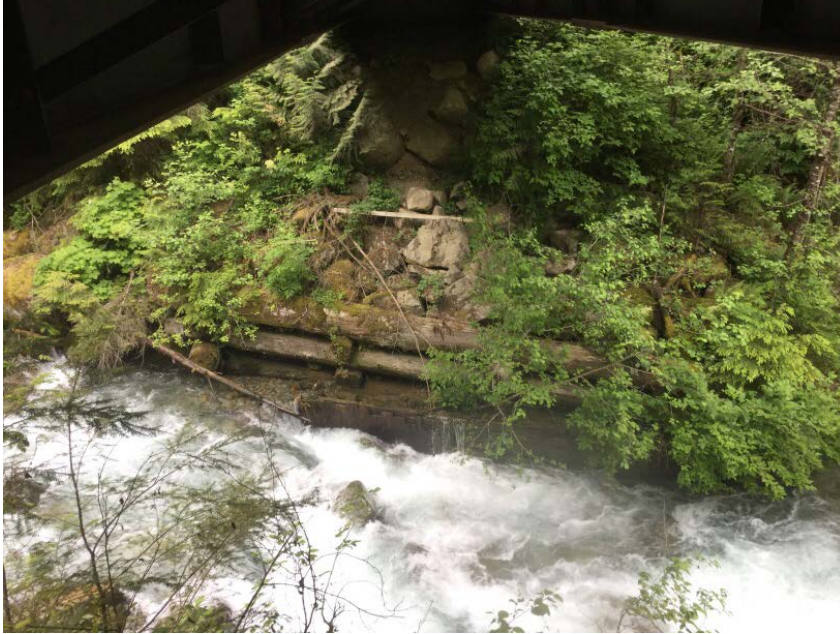
Left Bank Abutment when facing downstream

Piles or Posts Good LB

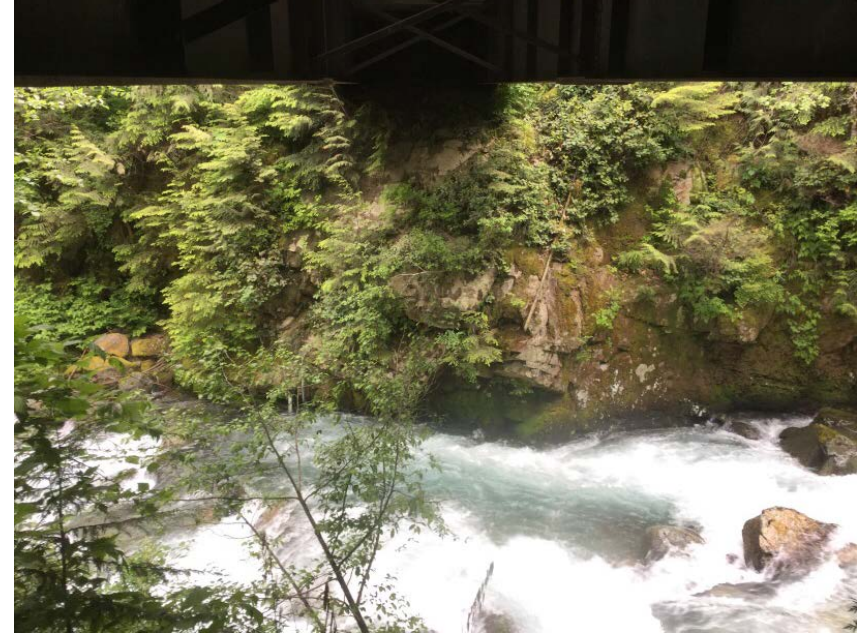
Right Bank Abutment when facing downstream

Concrete Good RB

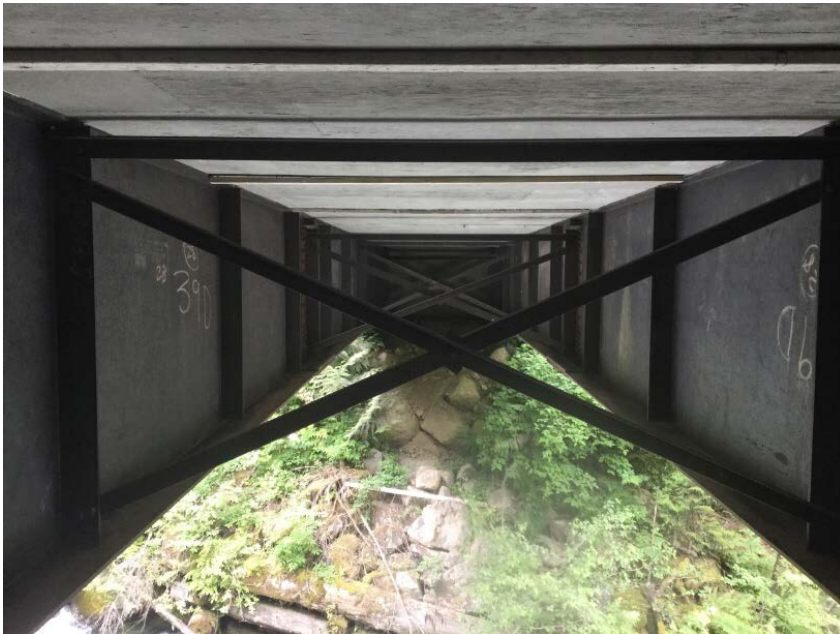
Superstructure

Girders Good
