CK-2143

STS'AILES 55.4km

2017 Inspection

| Crossing Name | Doctors Creek | | |

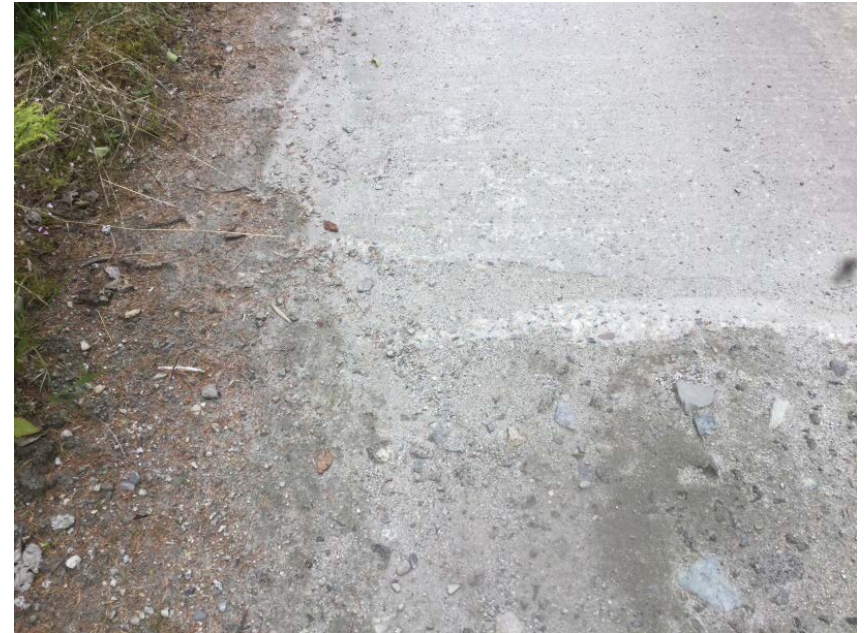
Ballast Wall Fair

Concrete Deck      Fair      Minor damage at approaches

Deck and ballast wall damage on left bank

Repair damage noted to ballast walls and deck panels. Replace guardrail, risers and blocks. Update load rating sign. Present load rating of CL-625 or 63 tonnes to continue.

| Repair Item | Priority | Repair Description |
|---|---|---|
| 1 | Low | Repair ballast wall and deck were damaged |

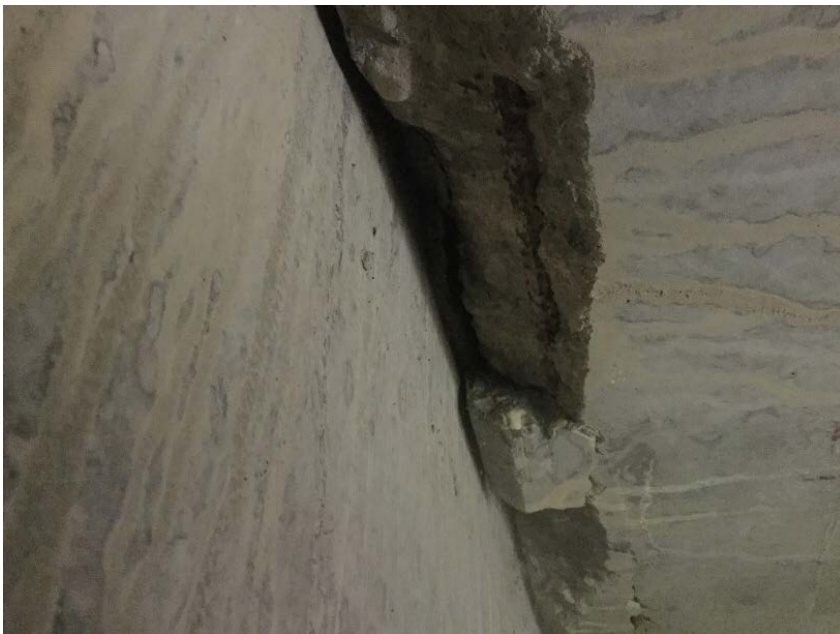
Damage to panel 1 on RB, limited to underside

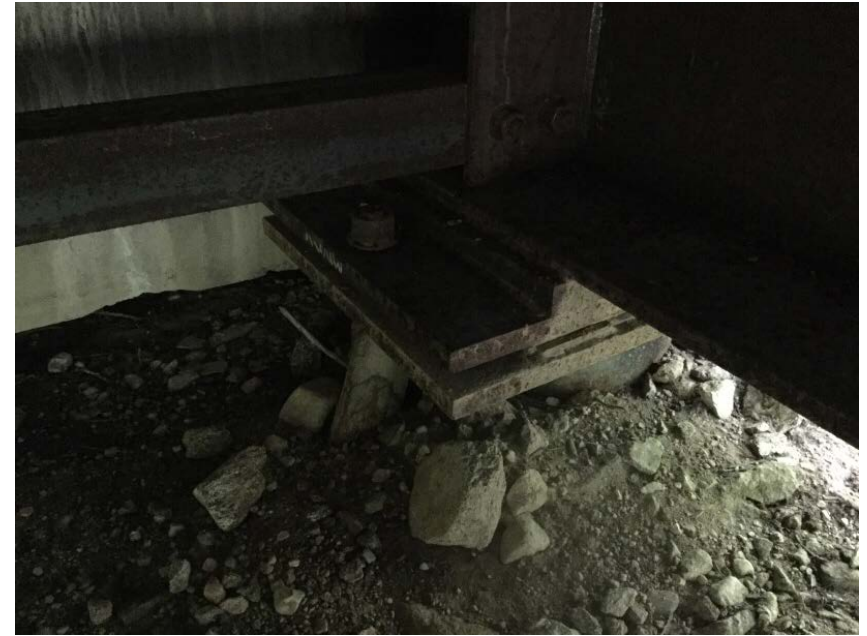
Shim plates for bridge grade, typical
