CK-2146

STS'AILES 64.4km

2017 Inspection

| Crossing Name | Coon Creek |

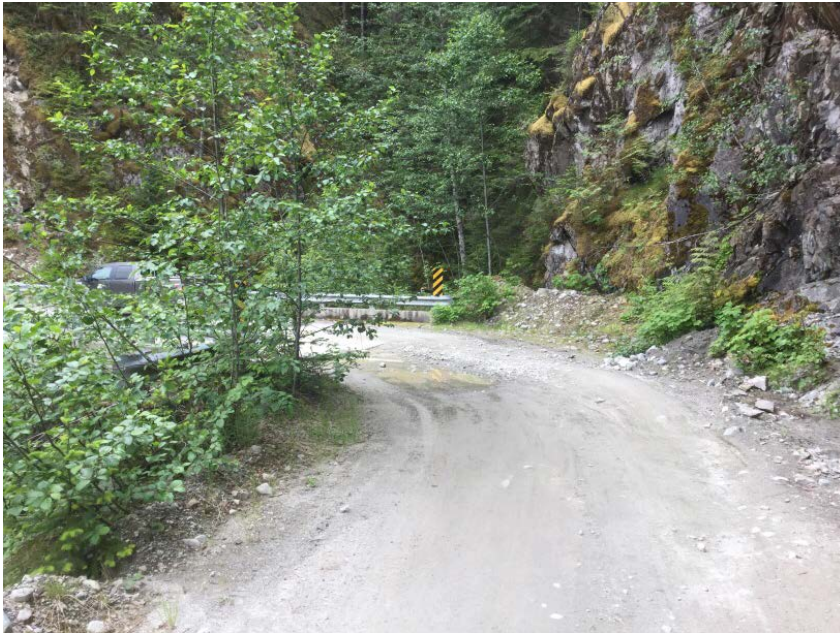
Approach from Left Bank when facing downstream

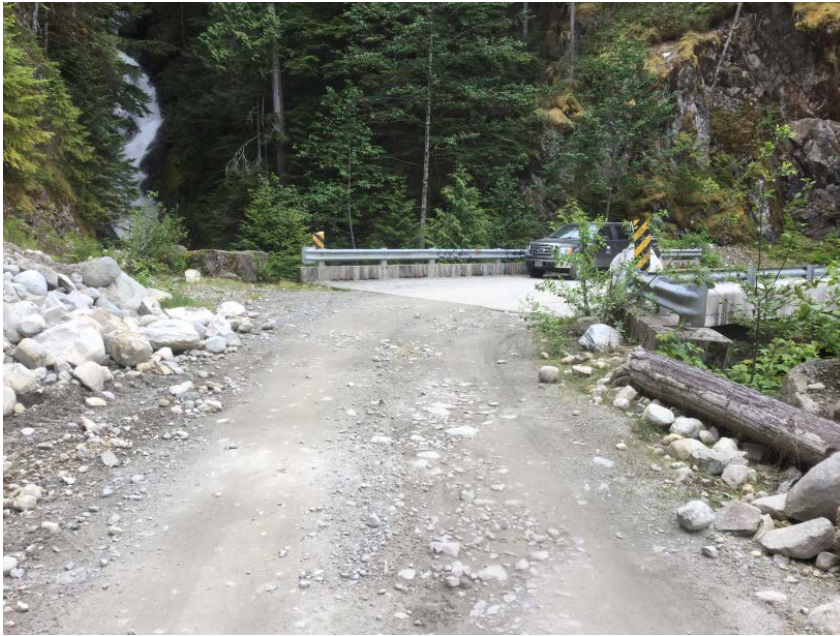
Approach from Right Bank when facing downstream

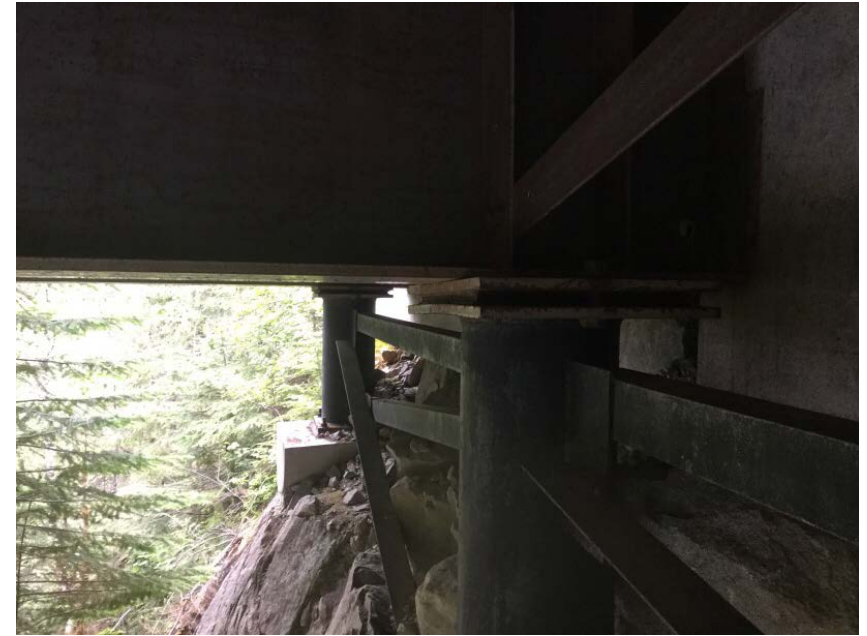
RB has slight deformation on plates

Centre right bank bearing is slightly deformed, typical for 2 other right bank bearings

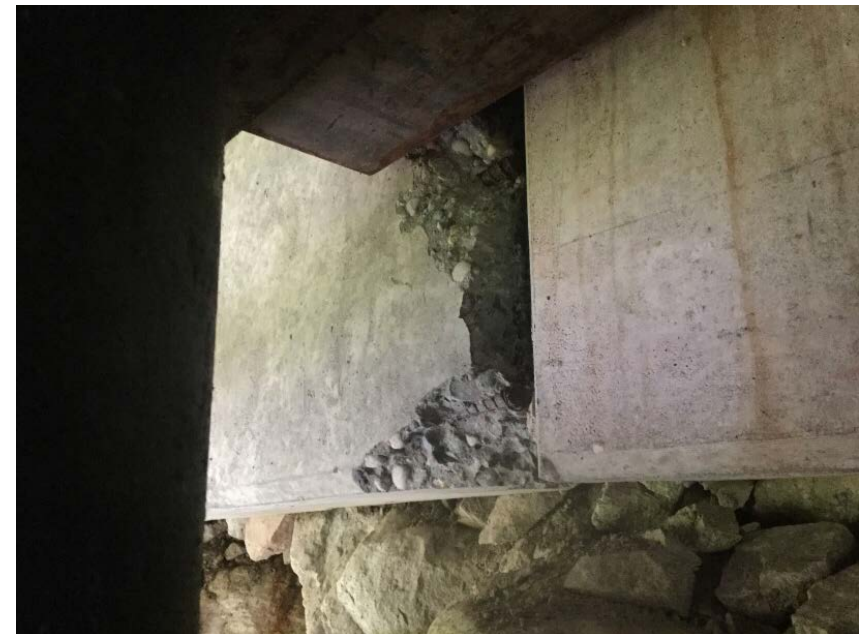
Minor damage noted on right bank

DS ballast wall damage

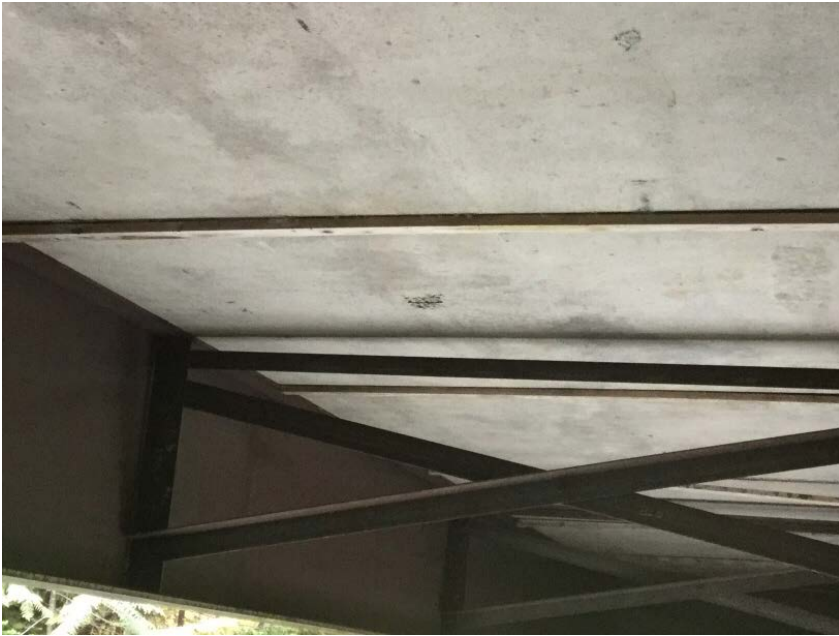
Spall look caged approx centre of span US

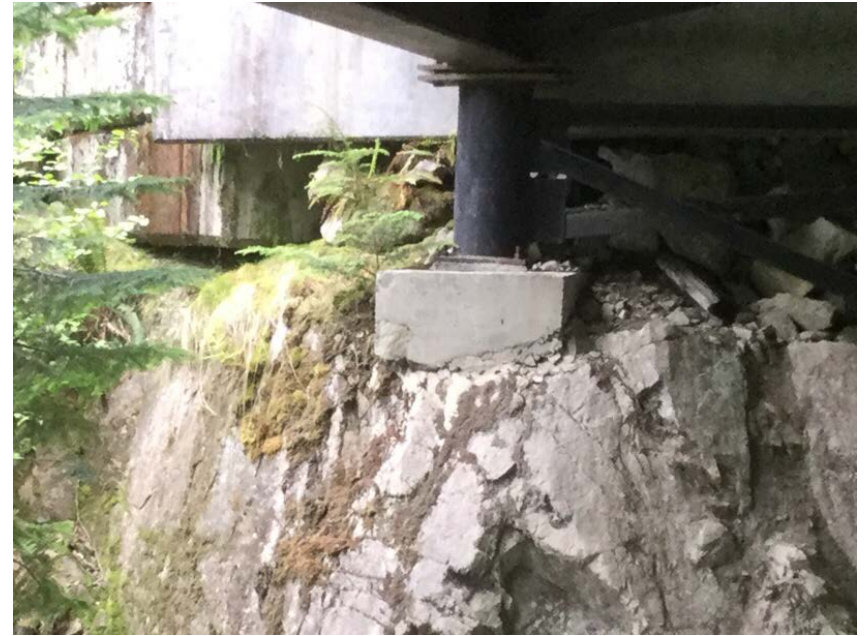
DS right bank footing appears to have spalled and patched in the past

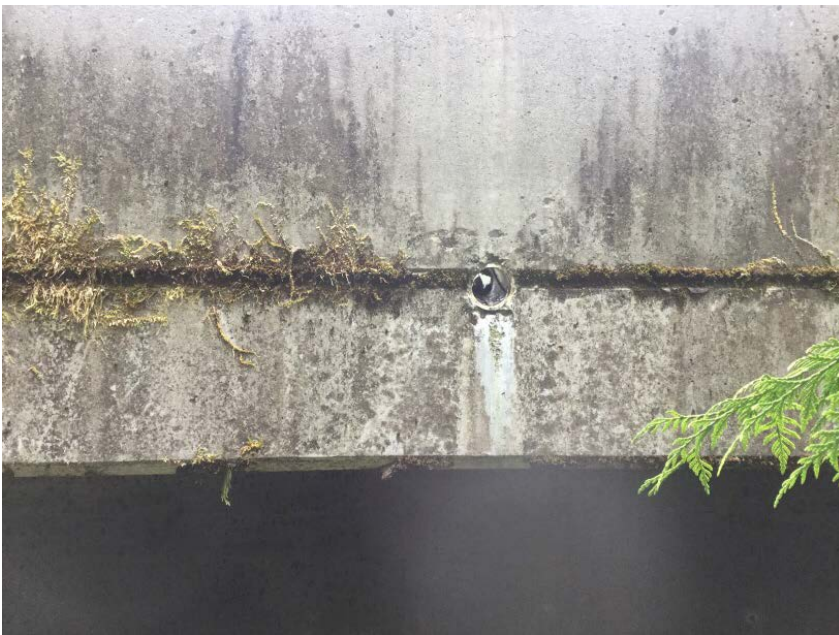
Deck drainage

2 Medium Clean sediment off deck and open up deck drainage holes

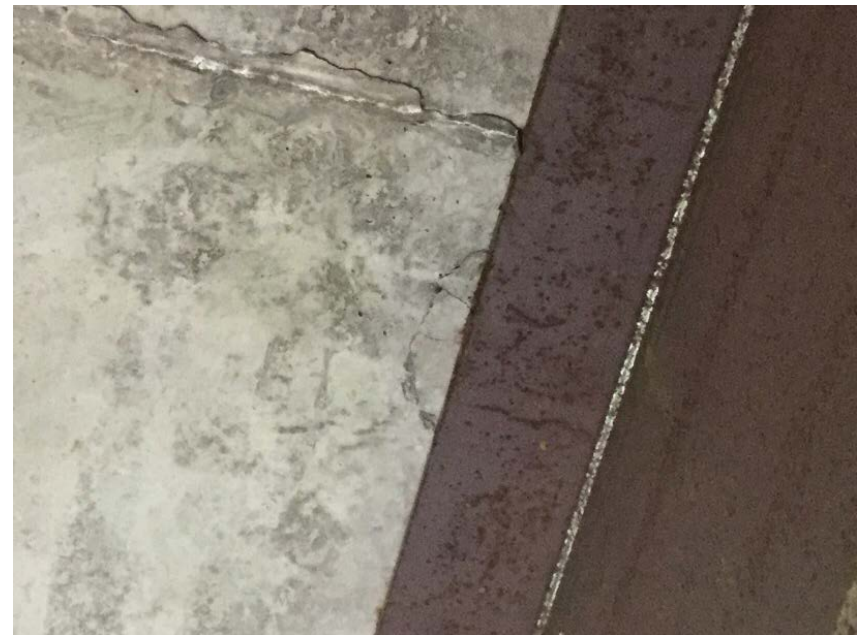
Underside of deck, over centre girade 3rd panel from left bank.

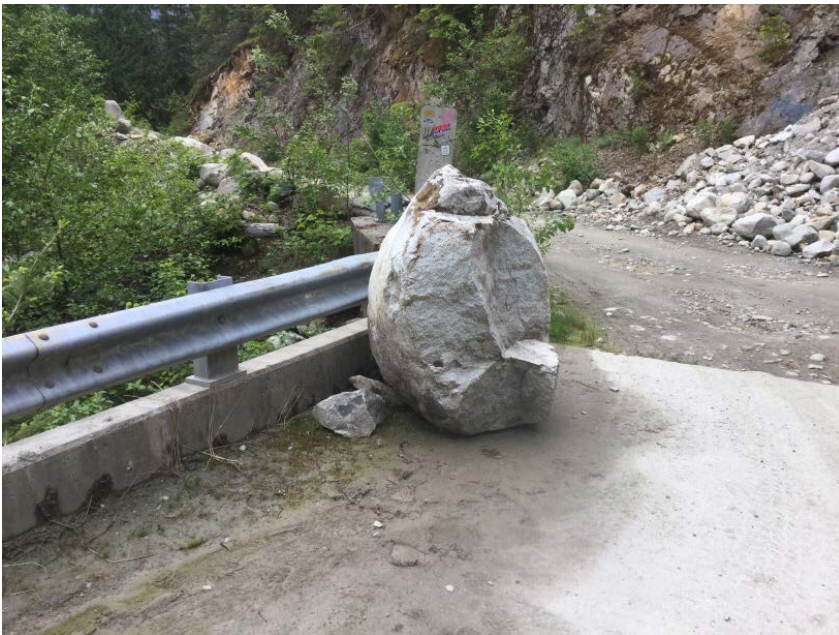
Debris on deck

Remove boulder and clean sediment from deck. Present load rating of L100 or 91 tonnes to continue.

| Item | Priority | Repair Description |
|---|---|---|
| 1 | High | Remove boulder from bridge deck |
