CK-2154

JONES-WEST 0.8km

2017 Inspection

| Crossing Name | Wahleach Creek |

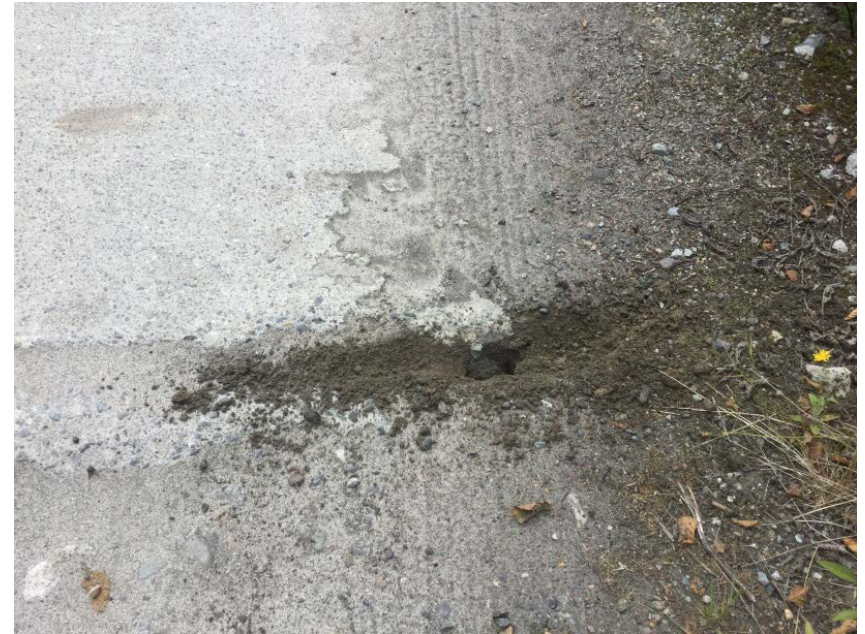
Concrete Deck      Fair      Damage noted on right bank panel 1, underneath

Deck damage at right approach

| Item | Priority | Repair Description |
|---|---|---|
| 1 | Medium | Repair damage to ballast walls and deck Panels at both approaches and grade approaches |

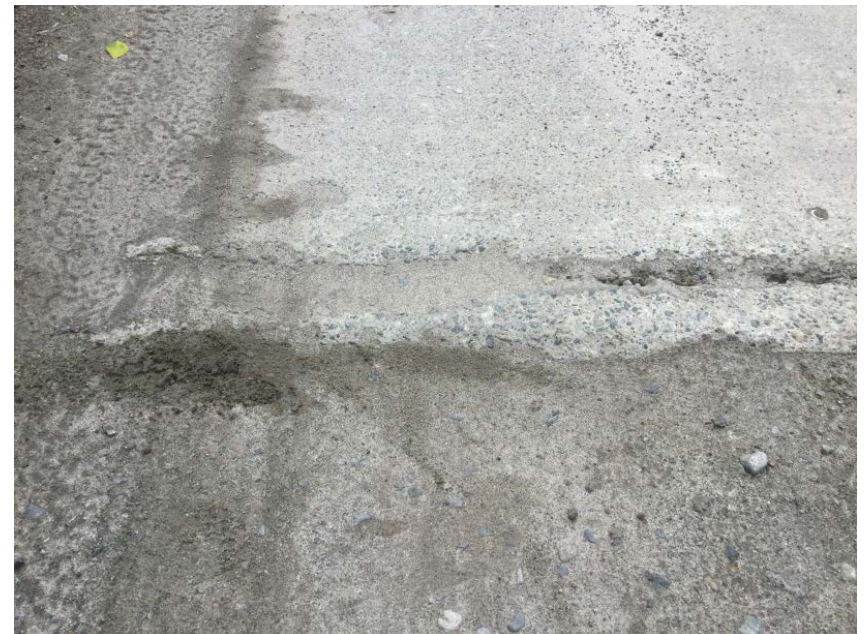
Ballast Wall Fair Damage noted to both walls, at the surface

Ballast wall damage at right approach

Repair damage to both ballast walls and to the underneath portion of panel 1 on right bank.  
 Replace guardrail, risers and blocks. Brush and grade approaches, and post bridge ahead signs.  
 Present load rating of L75 or 68 tonnes to continue.

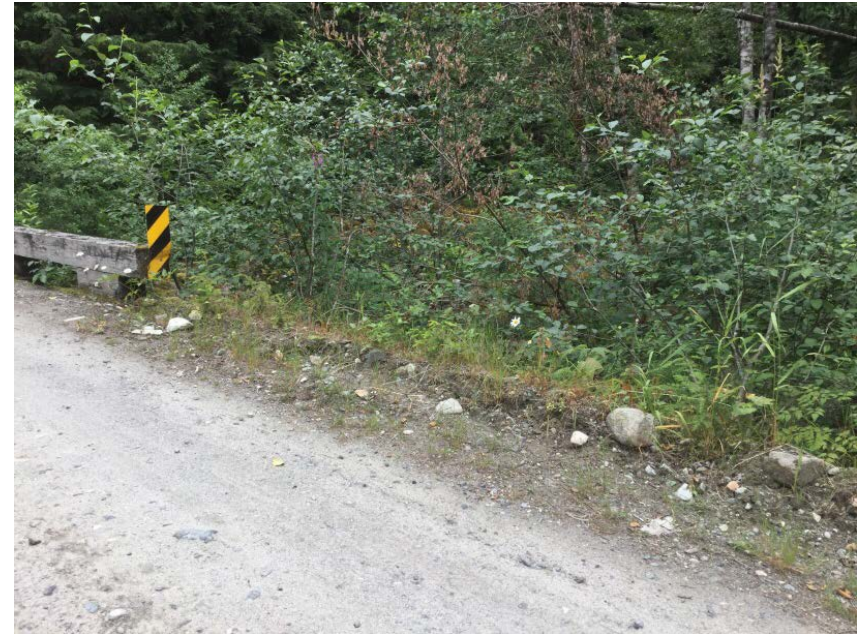
Missing upstream left approach fender - rolled off road

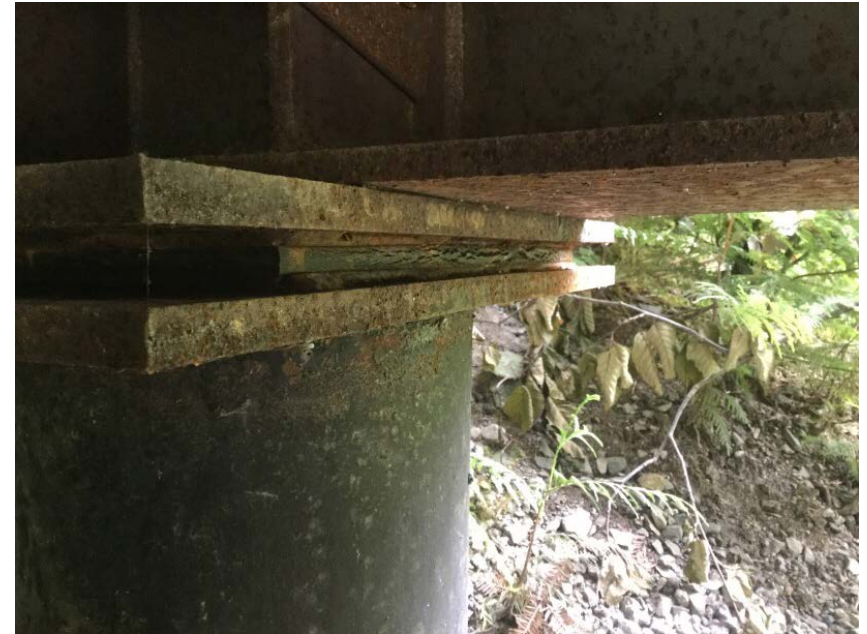
Left bank, downstream bearing pad weathering

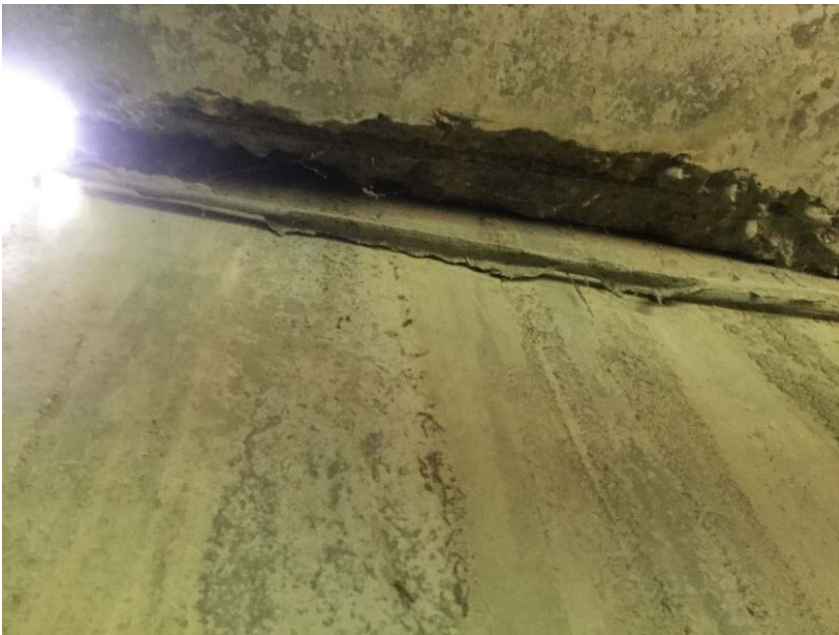
Right bank, panel 1 from underneath
