CK-2161

HUNTER 4700 5.8km

2017 Inspection

| Crossing Name | Side Creek |

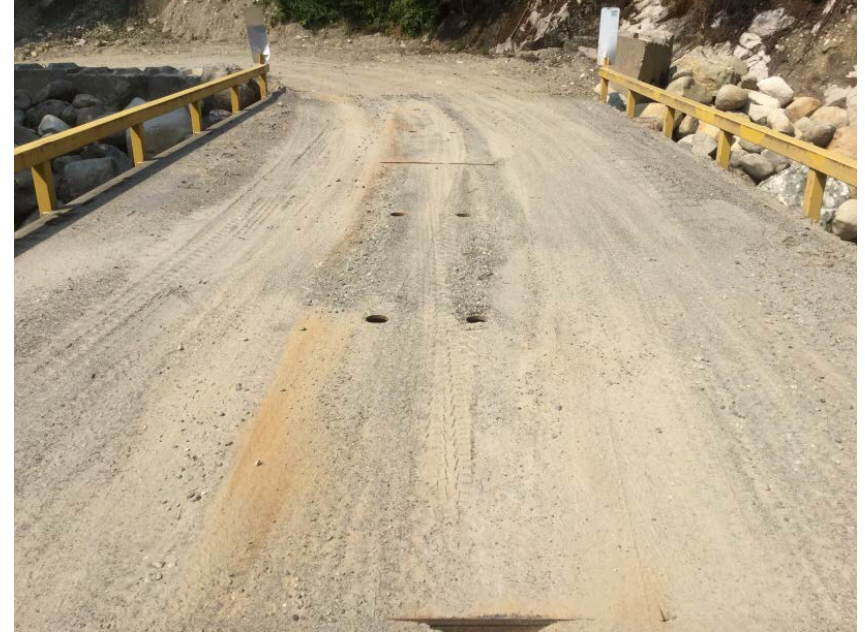
Steel Deck Plate Fair Covered with sediment but appears fair in localized locations

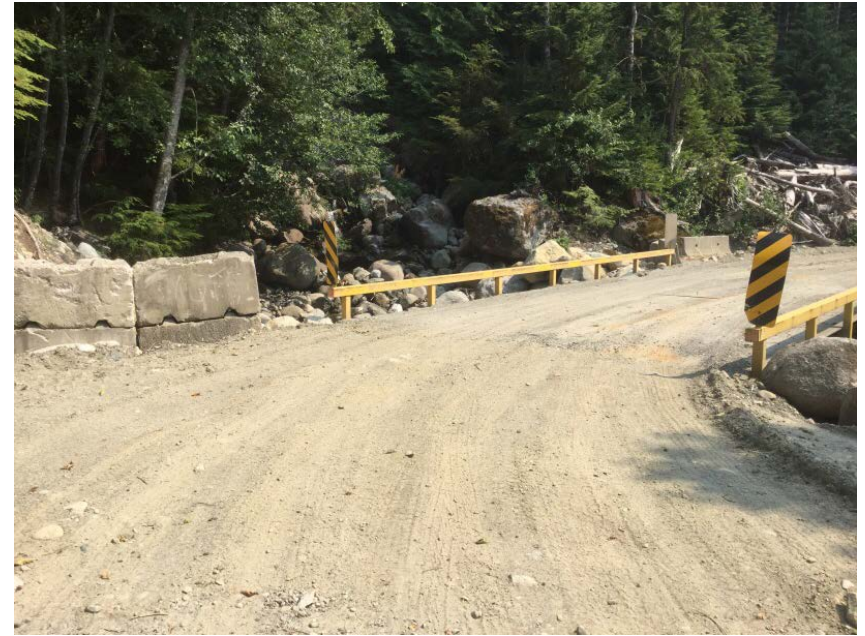
Approach from Right Bank when facing downstream

Very heavy HC right approach
