CK-2196

NAHATLATCH 4.8km

2017 Inspection

| Crossing Name | Nahatlatch River |

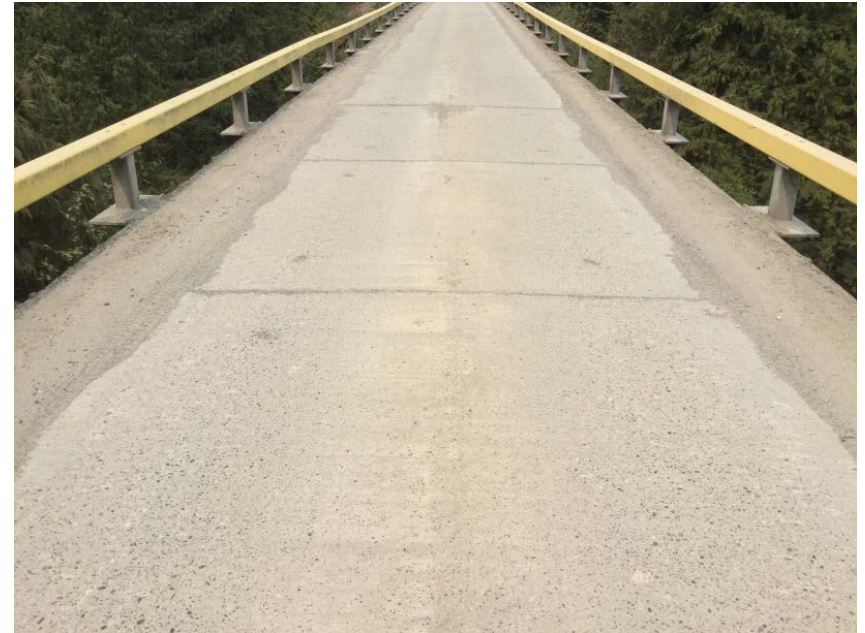
Concrete Deck      **Fair**      approx 50% of the grout worn off lifting hook pockets

Deck Joints      **Fair**      Hairline cracks noted on main span

Main span deck

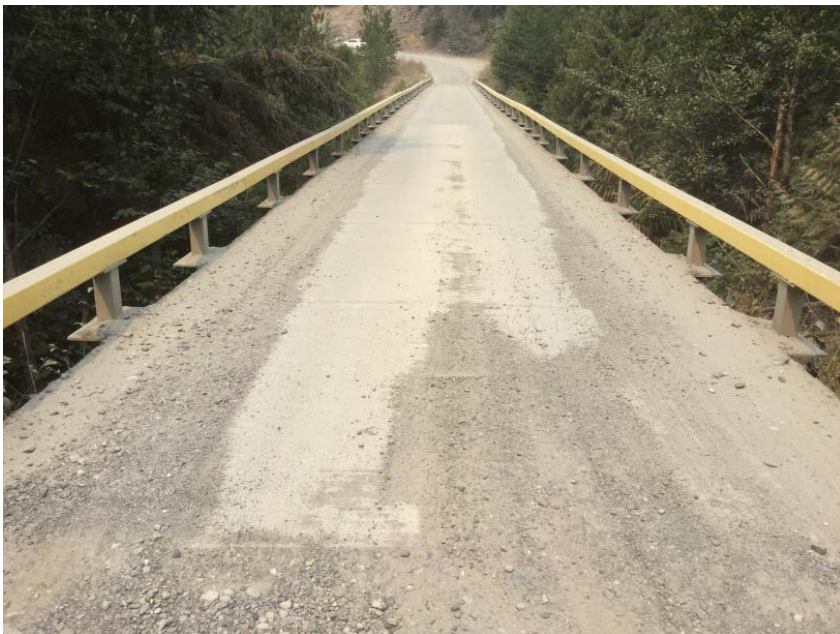
Right bank jump span new and in good condition

Right bank jump span deck

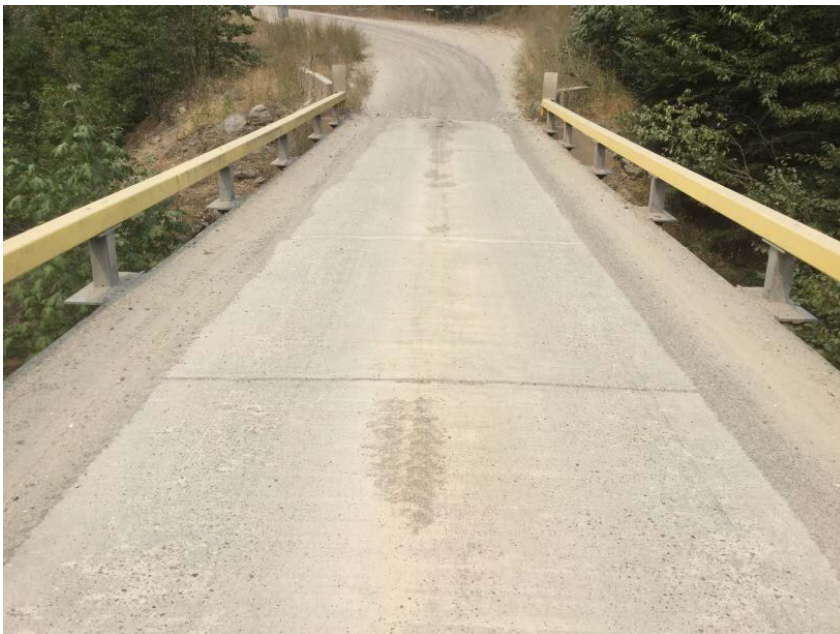
Grout Pockets      **Good**      approx 50% of the grout has worn off lifting hook pockets

Deck Joints      **Fair**      Hairline cracks noted

Left bank jump span deck

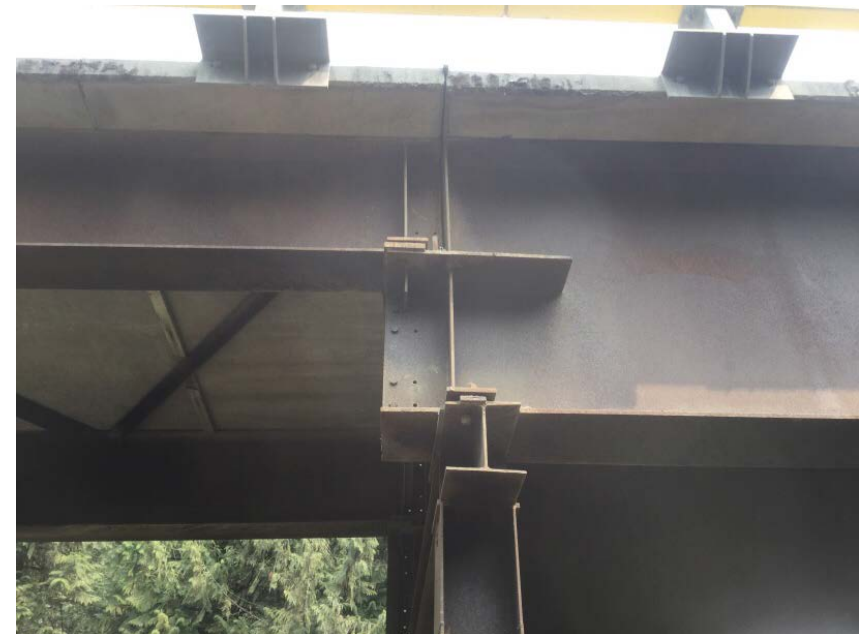
Left bank jump span to main span connection

Monitor the left bank pier condition and the deck joints on the main span and left bank jump span. Present load rating of BCL-625 or 63 tonnes to continue.

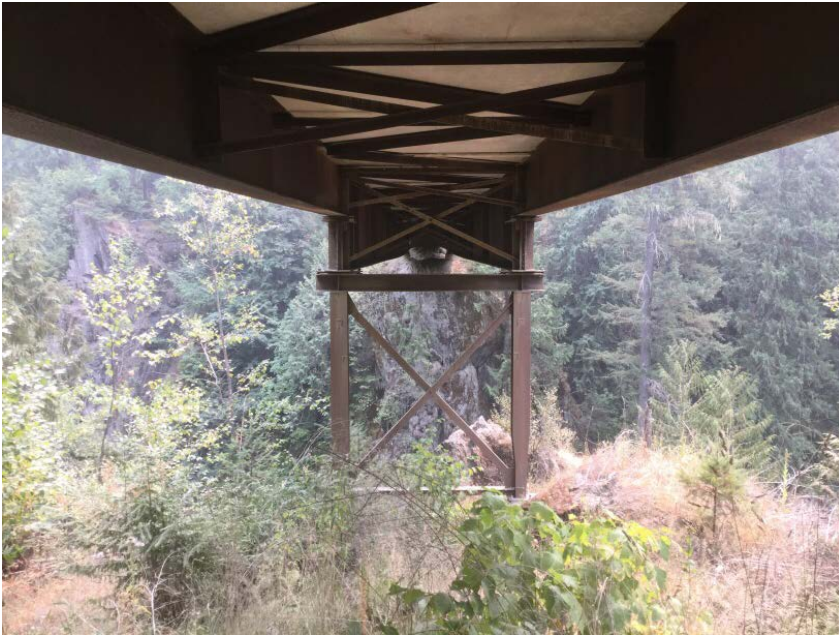
Left span sit on notched out portion of main span girders, which sit on steel H cap. The top plate of bearings is slightly deformed with grease leaking out, bearing anchor bolts have sheared off both bearings and welded restrainers have been placed

Girders Fair Light to moderate surface corrosion

Left bank jump span superstructure and left bank bent

| 1 | Left pier bearing condition | Annual |

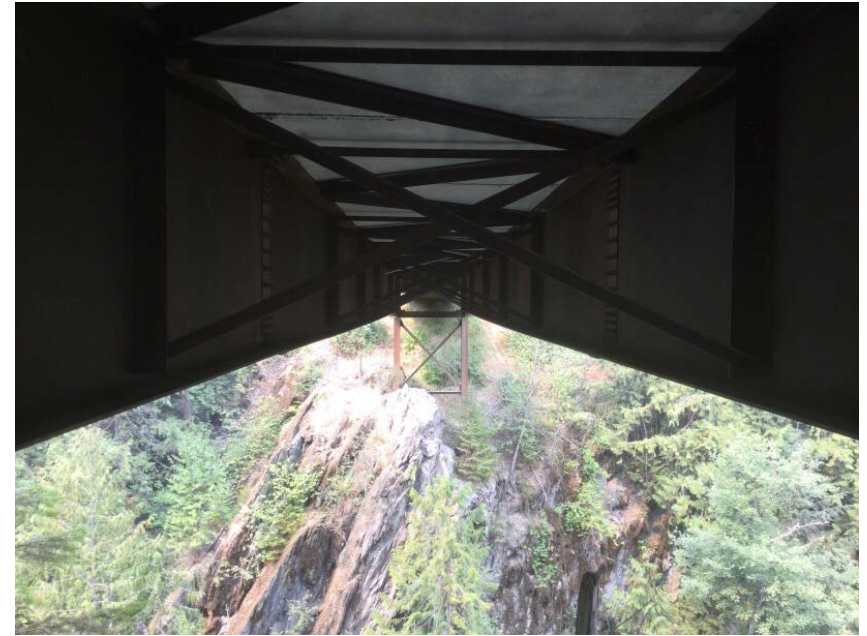
Light to moderate surface corrosion, noticeable sag up to 20mm

Light to moderate surface corrosion

splice plate bolts have all been replaced

Main span superstructure

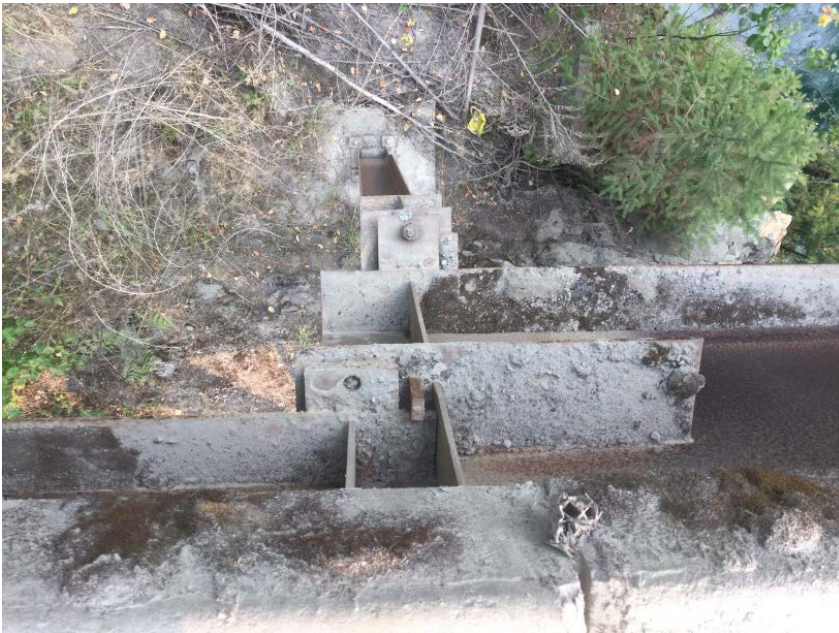
Welded restrainers for left bank jump span

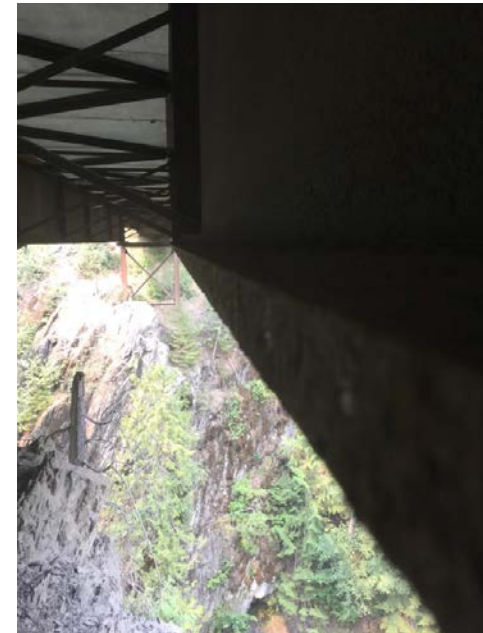
Noticeable sag in main span girders, up to 20mm

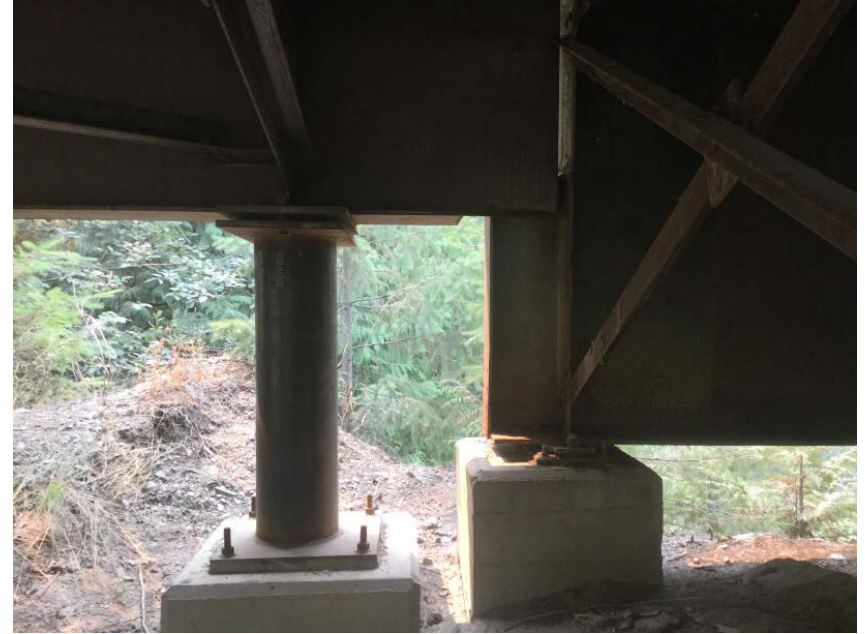
2 separate CIP footings, 1 set for main span and 1 set for right jump span and right span has steel pipe towers

Right bank piers, separate for each span

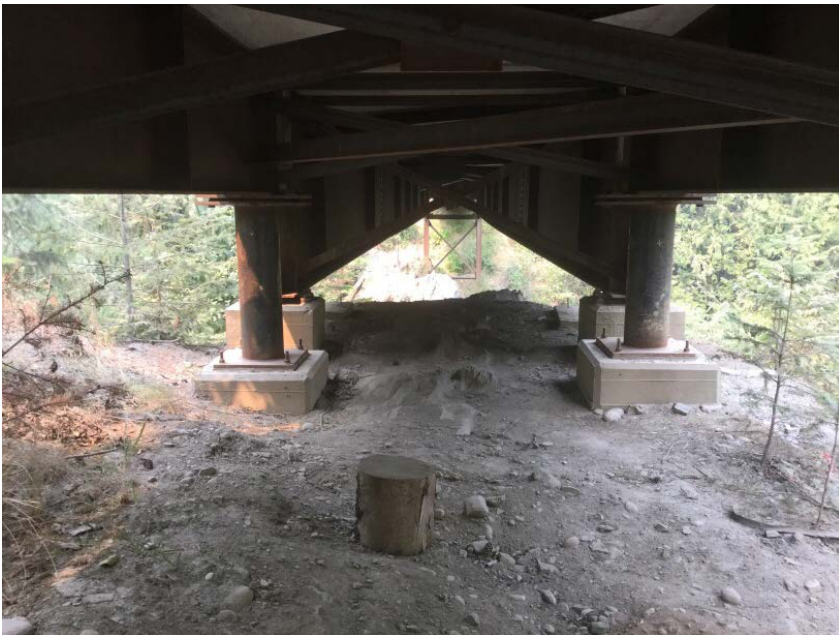
Good for right span pier, fair for main span pier

Right bank jump span pier, with main span pier behind
