CK-2199

NAHATLATCH 34.2km

2017 Inspection

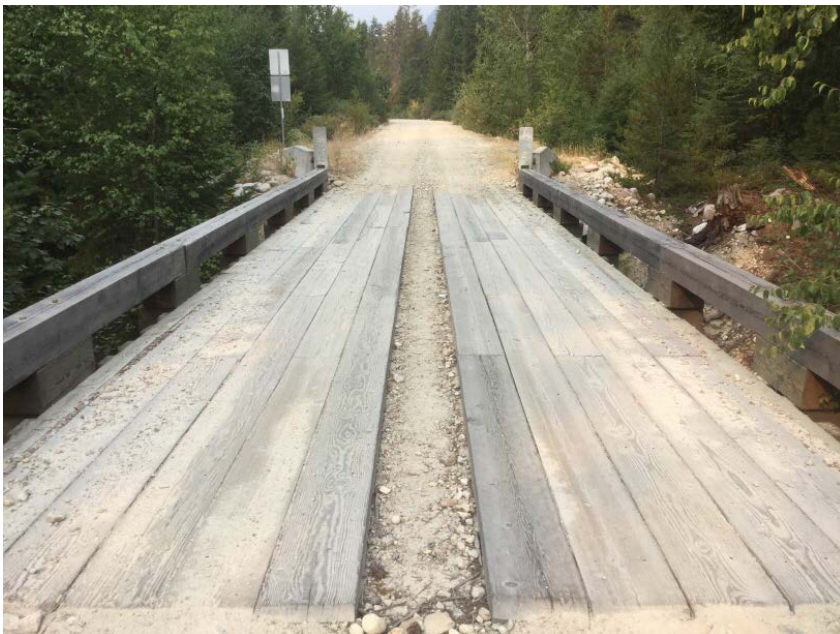
Deck

Hardware      Fair      Some rail bolts loose

| Item | Priority | Repair Description |
|---|---|---|
| 1 | Medium | Tighten guardrail bolts |

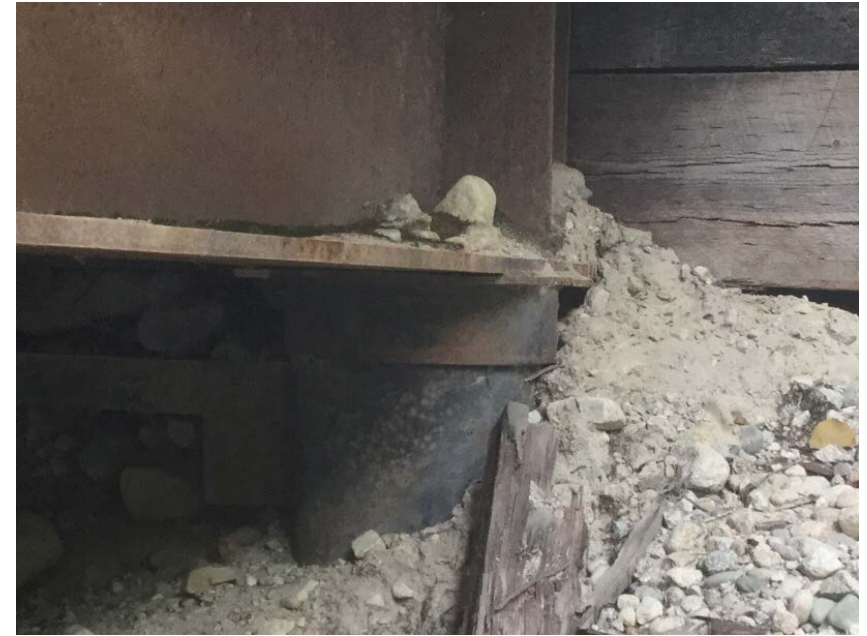
Bearings Fair

Upstream right bank bearing, typical all 4 corners

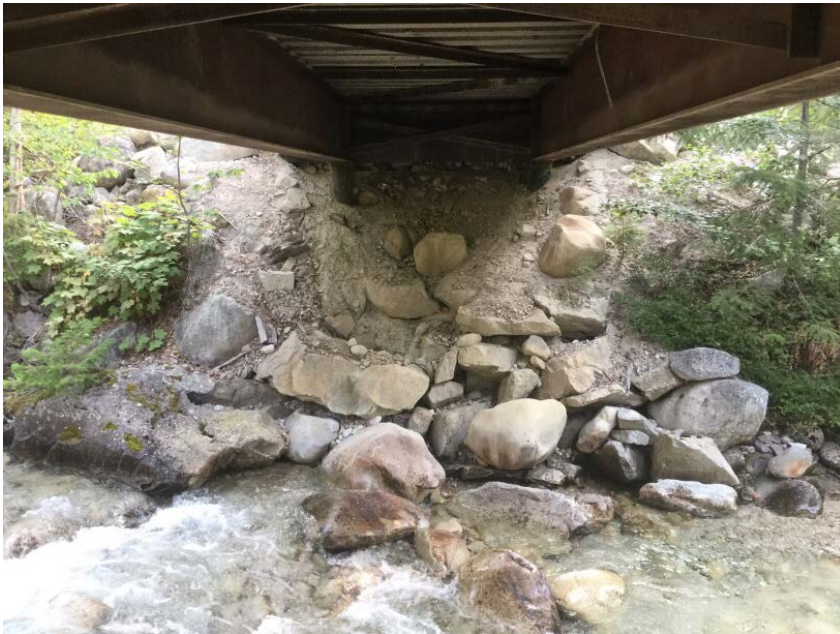
Left Bank Abutment when facing downstream

Riprap Fair Over steepened and round

| Item | Monitor Description | Frequency |
|---|---|---|
| 1 | Riprap condition and fill condition | Routine Inspection |

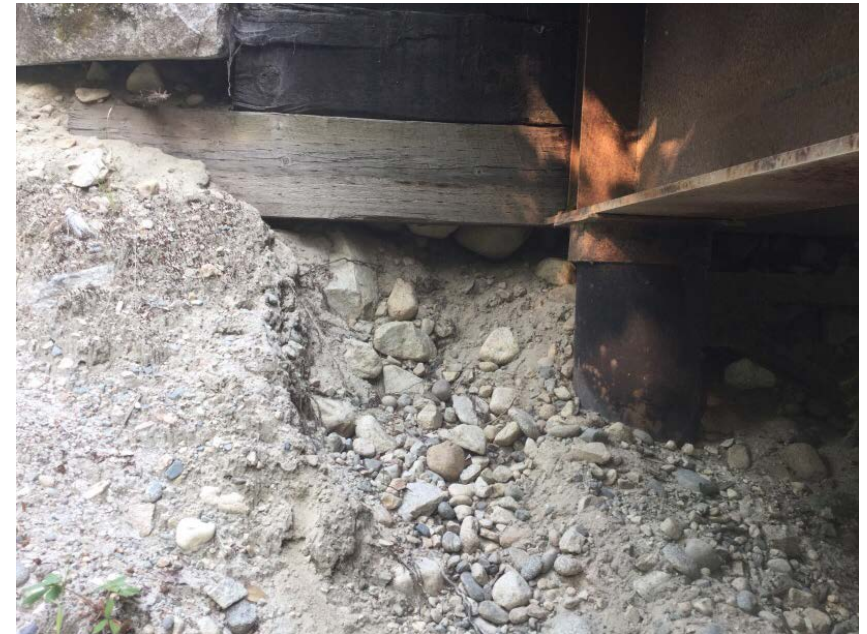
Fill Fair Failing behind both ballast walls

Erosion under ballast wall, both banks

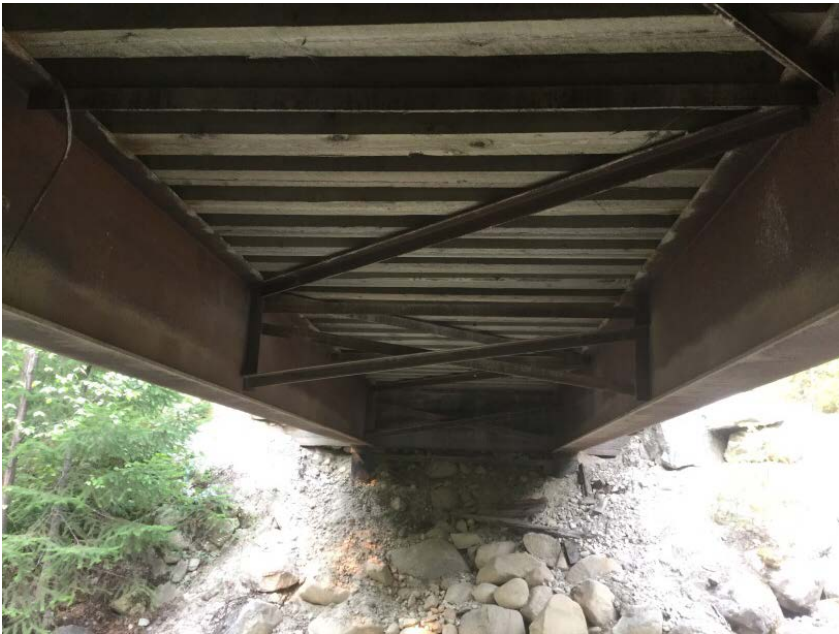
Superstructure

Minimal corrosion
