CK-2200

KOOKIPI CREEK 0.1km

2017 Inspection

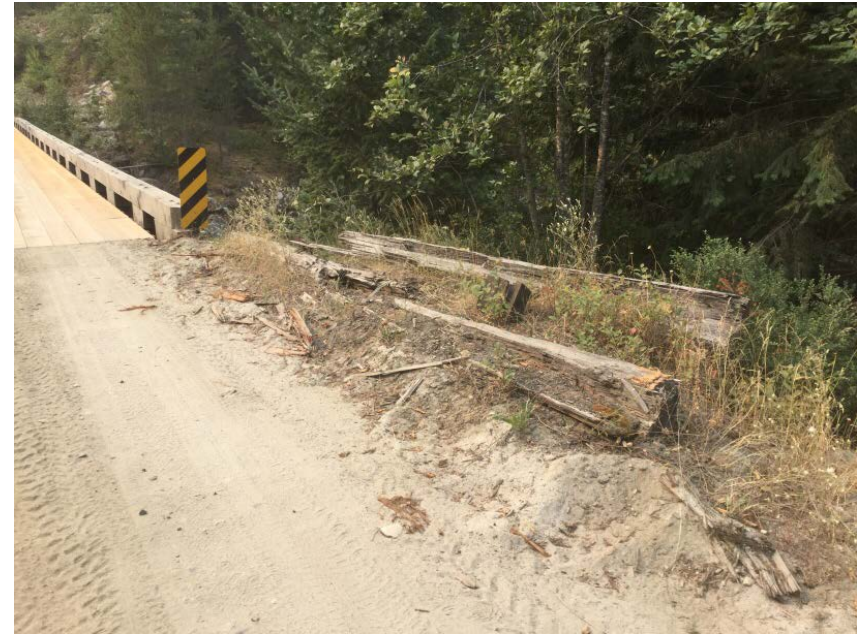
Fender Condition Poor

Rotten and undersized

Upstream left approach fender

| Repair Item | Priority | Repair Description |
|---|---|---|
| 1 | Medium | Replace fenders at all corners |

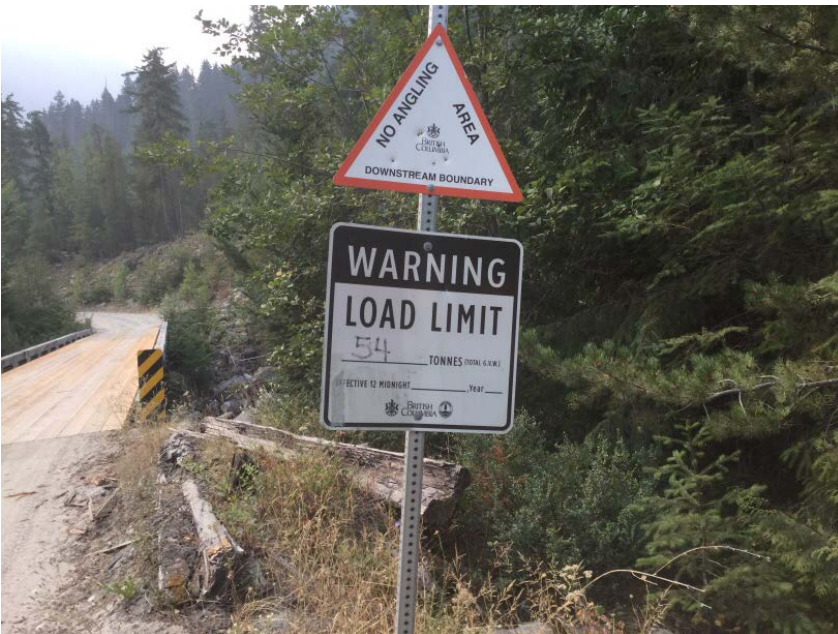
54 tonnes

Load Rating Sign

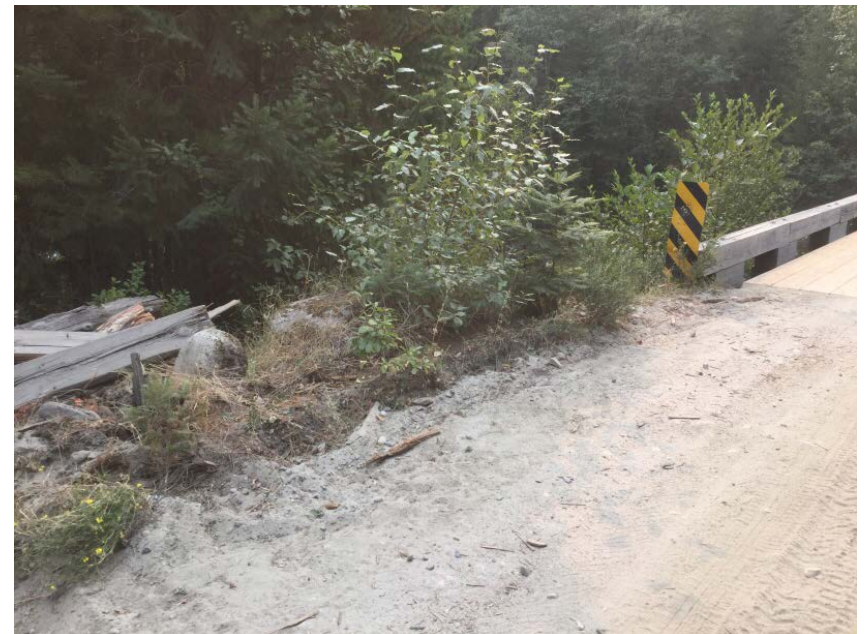
Downstream left approach fender

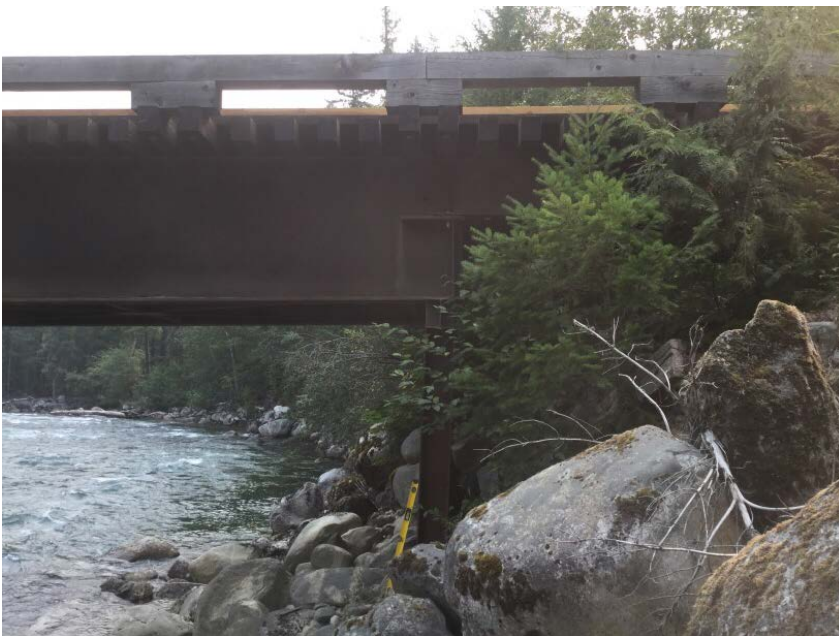
The pier is in fair condition however is bent towards the right abutment 50:1 (V:H)

Jump span seat and support not vertical

| Item | Monitor Description | Frequency |
|---|---|---|
| 1 | Monitor pier displacement | Routine Inspection |

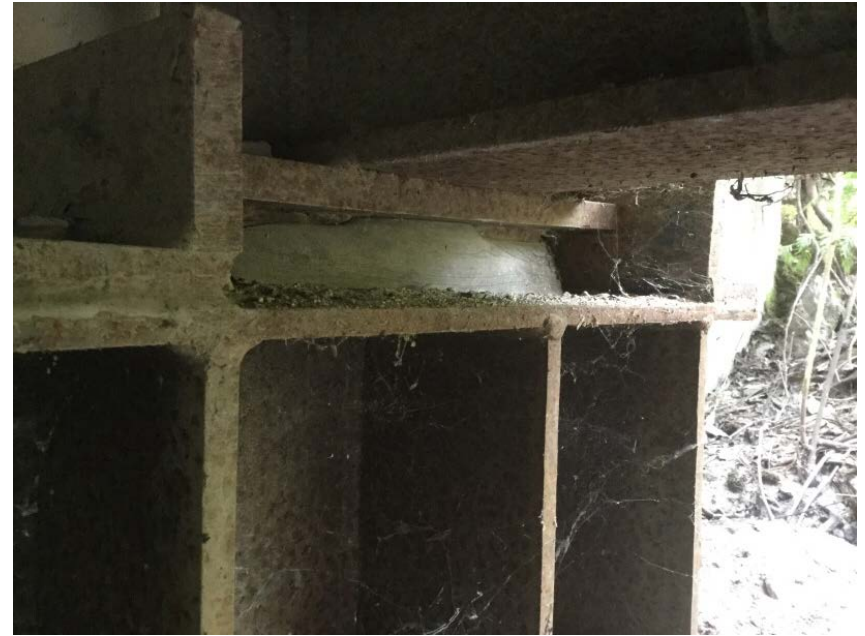
Fair to poor - right bank pads have been displaced towards right approach; and cracking

Upstream right bank bearing, 60mm from stream side cap face

| Item | Monitor Description | Frequency |
|---|---|---|
| 2 | Monitor bearing pads at right bank | Routine Inspection |

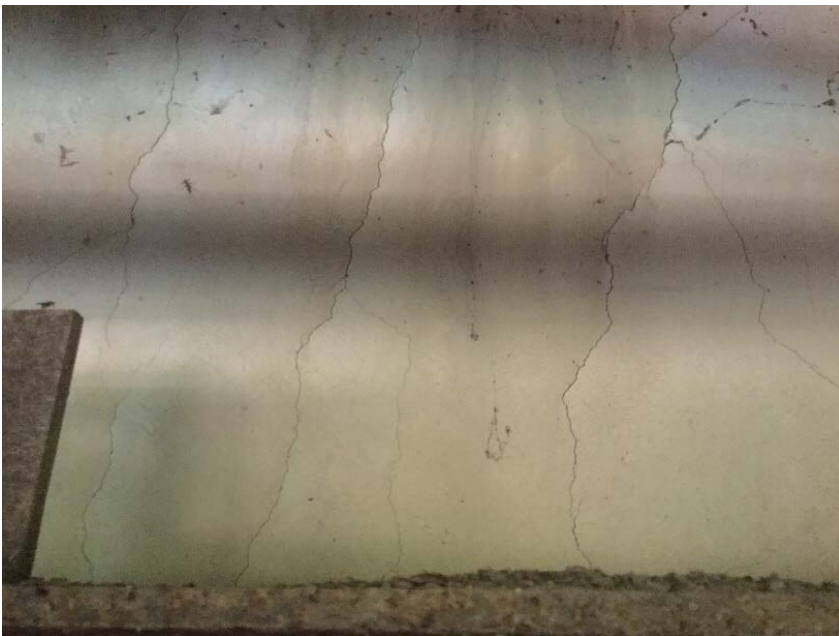
Hairline cracks on both walls, more noted on left bank

Right bank ballast wall cracks

| Item | Monitor Description | Frequency |
|---|---|---|
| 3 | Monitor ballast wall condition | Routine inspection |

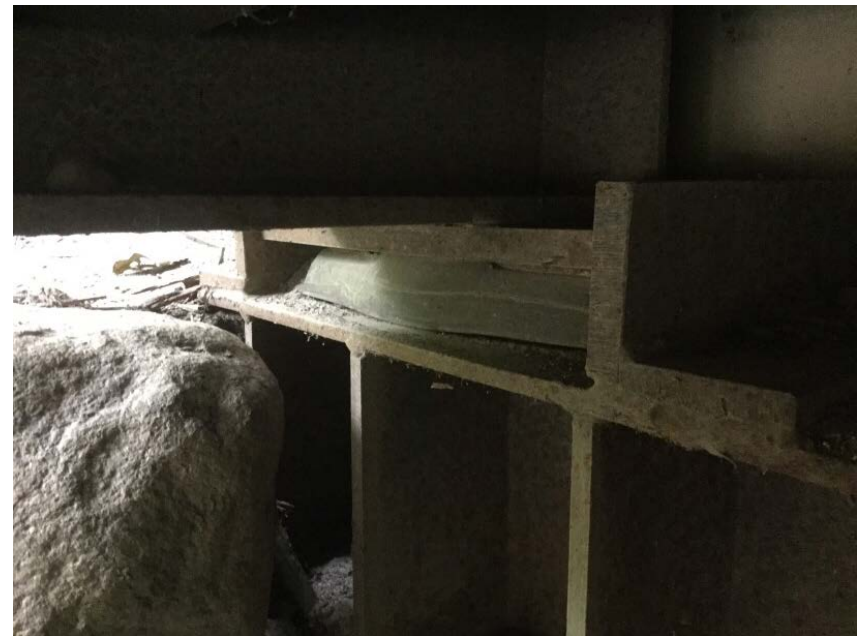
Downstream right bank bearing 30mm from stream side cap face

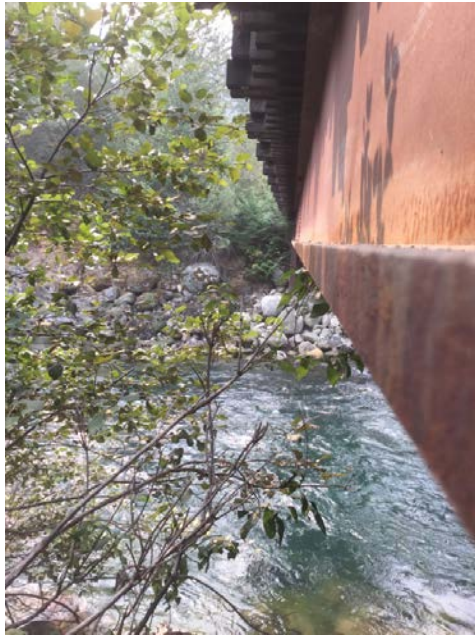
Slight girder sag, estimated at 15-20mm
