CK-2205

NORTH AINSLIE CREEK 17.4km

2017 Inspection

| Structure Class | Major Culvert |

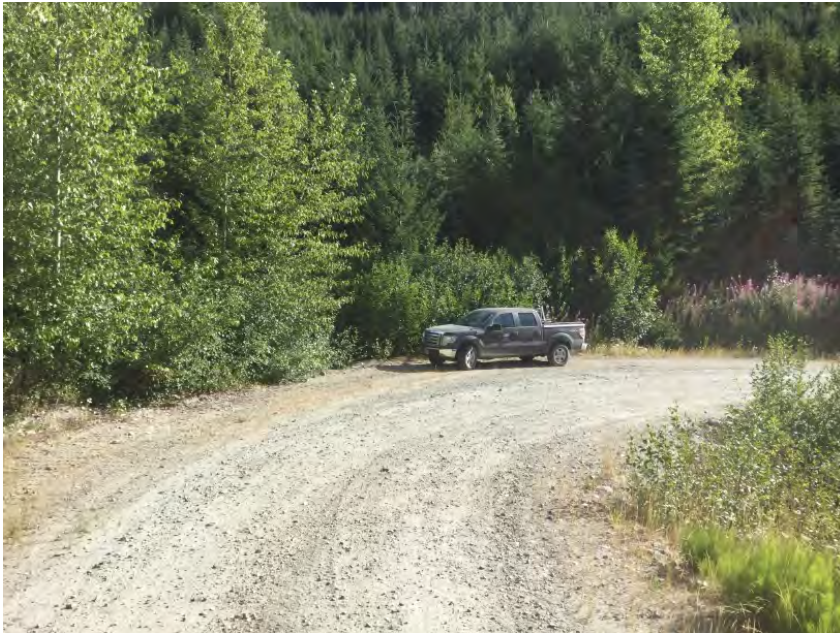
Approach from Right Bank when facing downstream

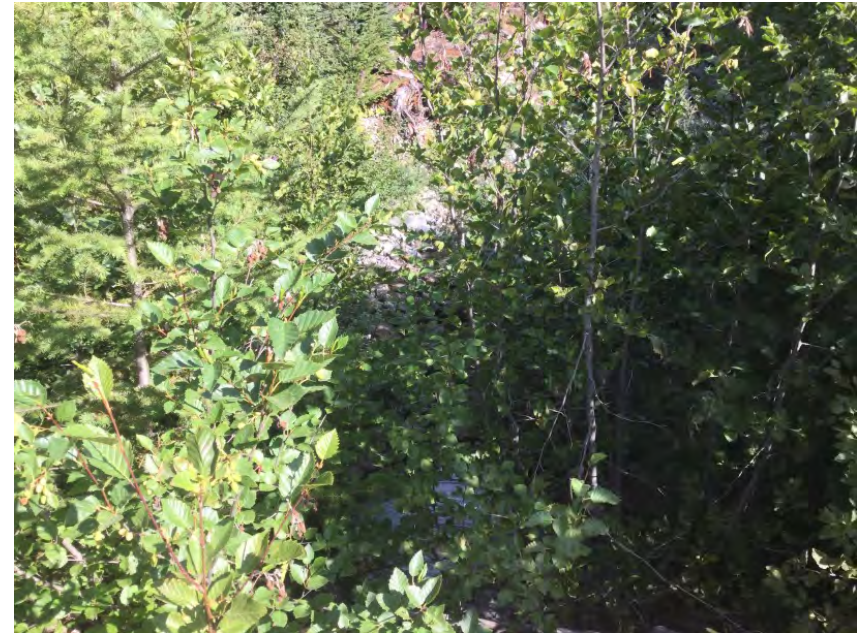
Looking upstream from road

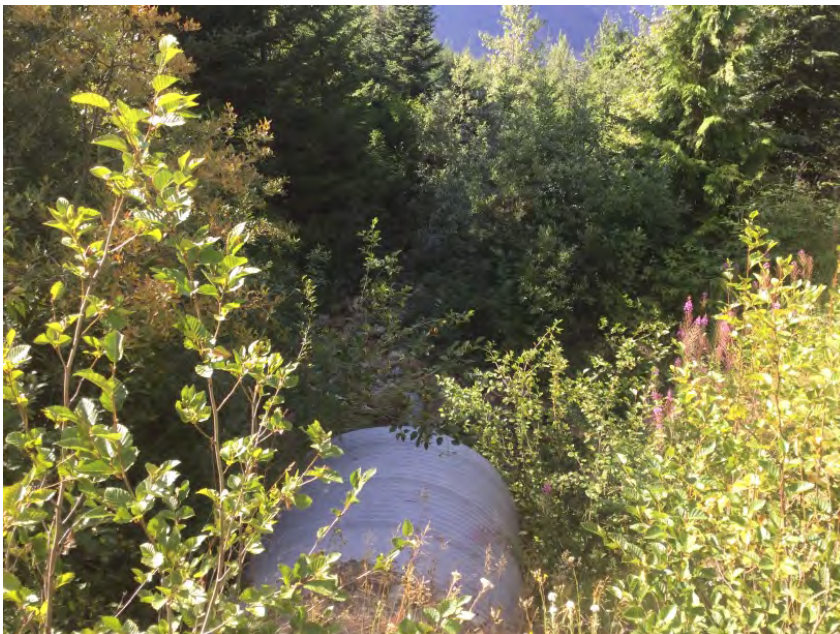
Looking downstream from road

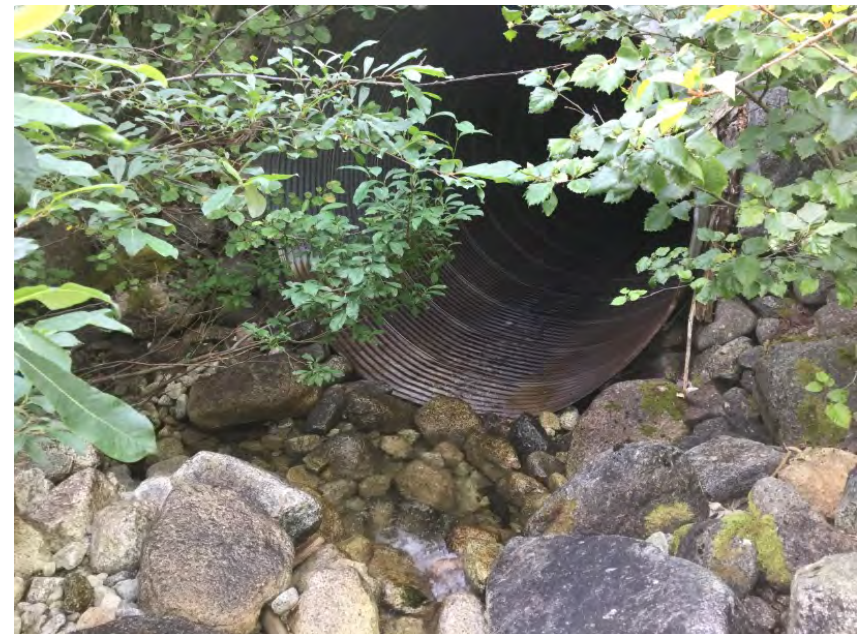
Inlet      Good

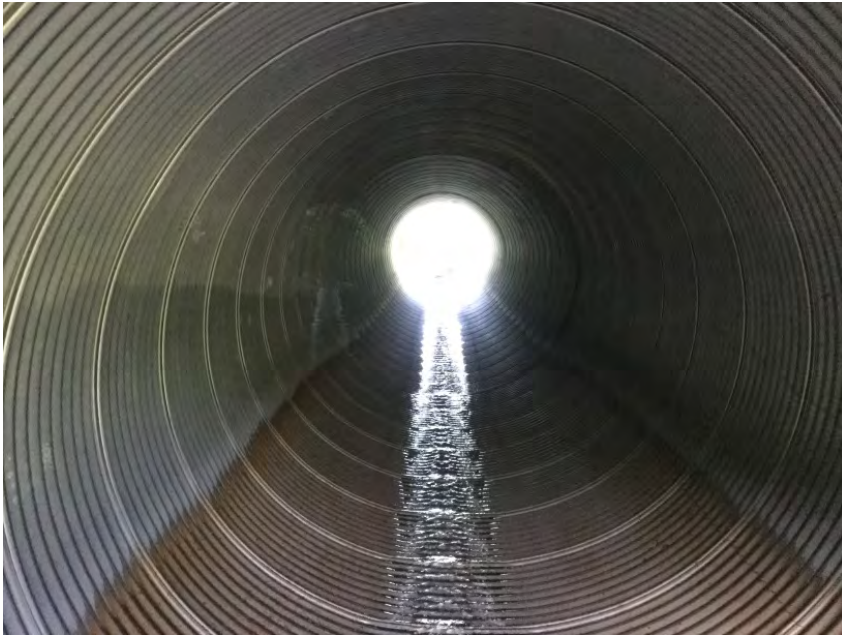
Looking through culvert from inlet

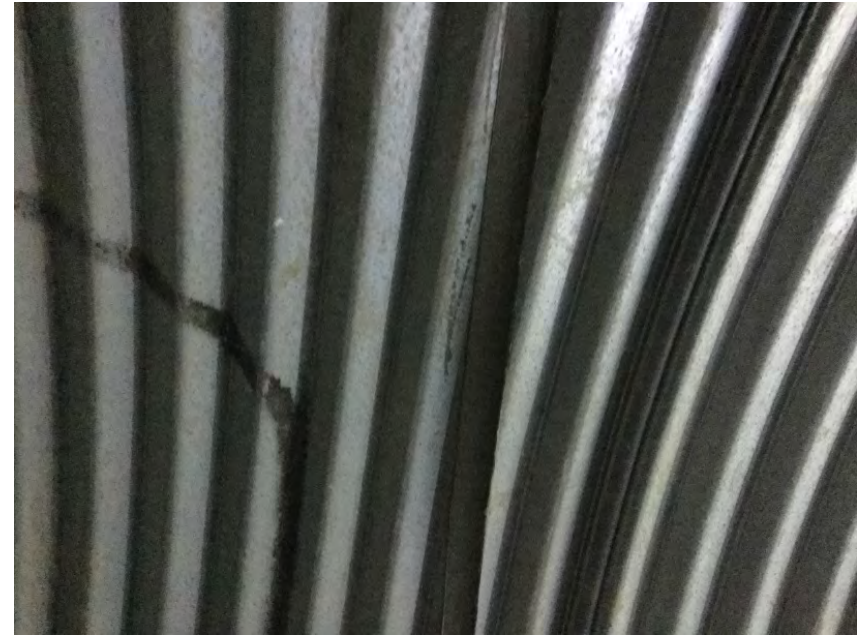
Coupled connection 2

Coupled Connections      Good

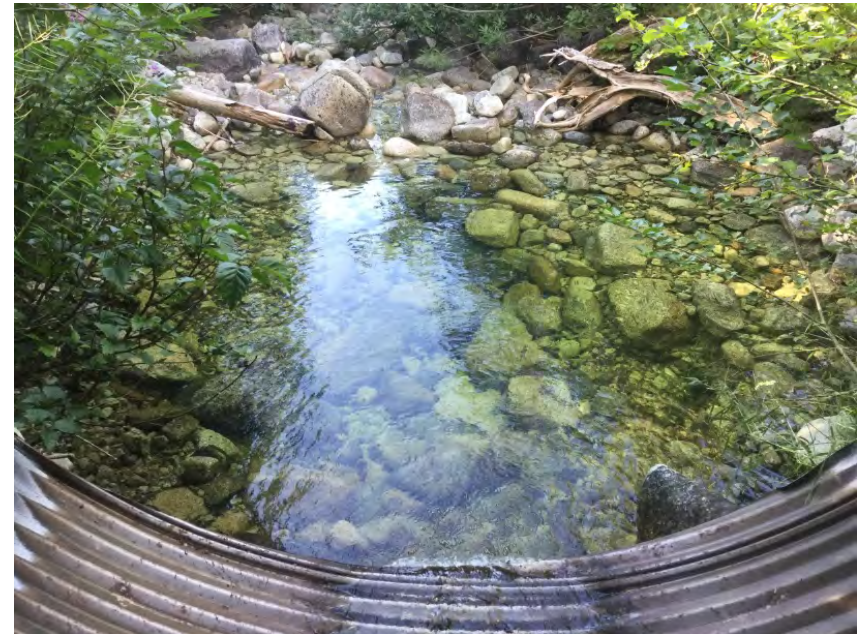
Outlet      Good      1m plunge pool
