CK-2207

MOWHOKAM 15.7km

2017 Inspection

| Crossing Name | Mowhokam Creek |

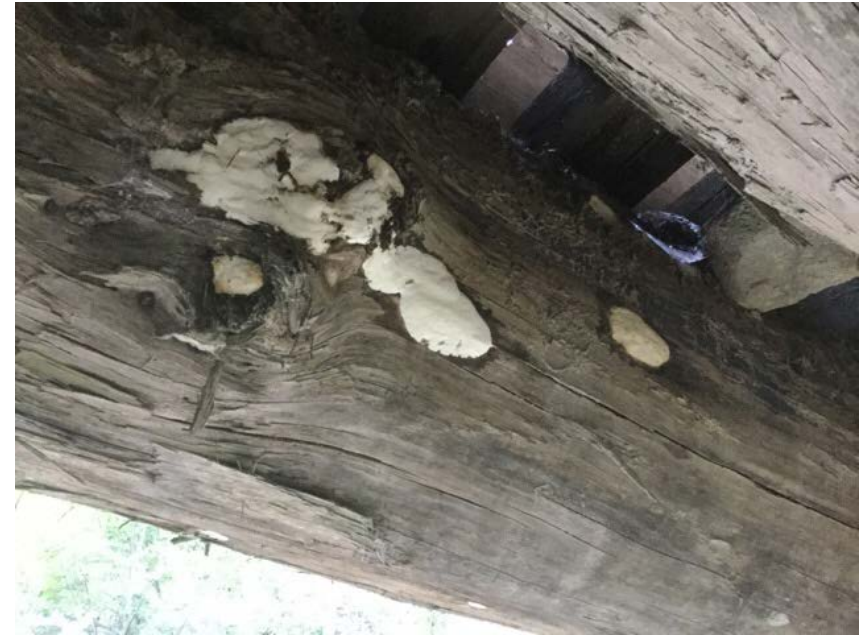
The log stringers and old crib continue to deteriorate; if/when a stringer(s) fail it will put the entire structure at risk. Recommend full removal.

Log stringer bridge may be affected by high flows and affect the stability of the steel girder structure

Log stringers under steel girder in poor condition

Bridge condemned, 0 tonnes load rating. Block access until the entire structure can be removed. Replace with a permanent structure if access is required.

| Item | Priority | Repair Description |
|---|---|---|
| 1 | High | Remove structures and replace or block access |

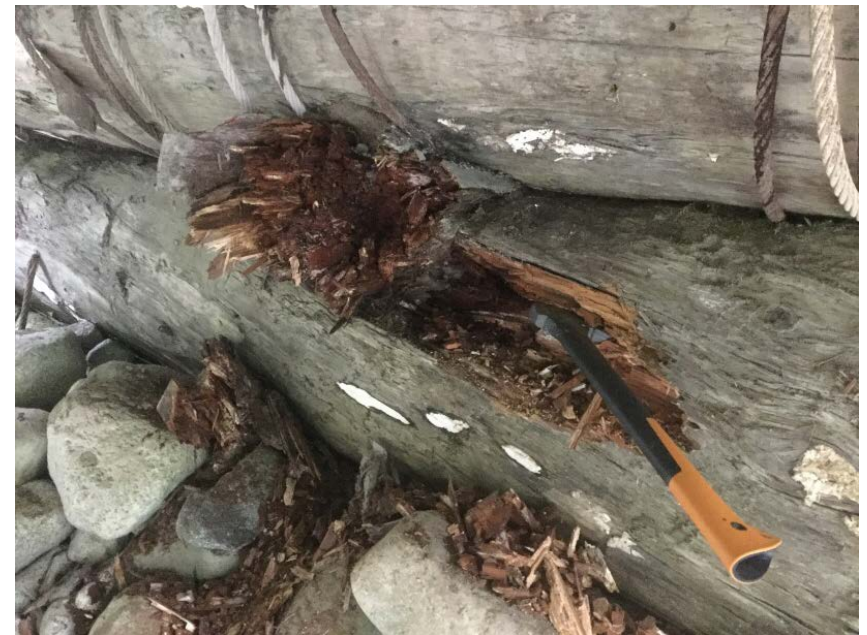
Log crib supports log stringer structure plus log sills that supports the steel girder structure, 200mm sap rot in bottom crib log, 50mm sap rot in top crib log

Log crib supporting stringers in poor condition

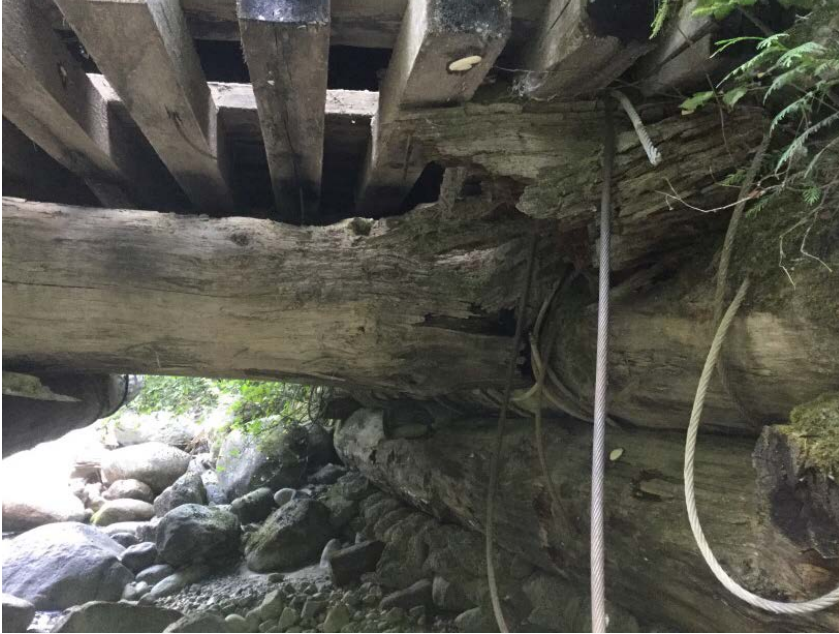
Stringer condition at left bank

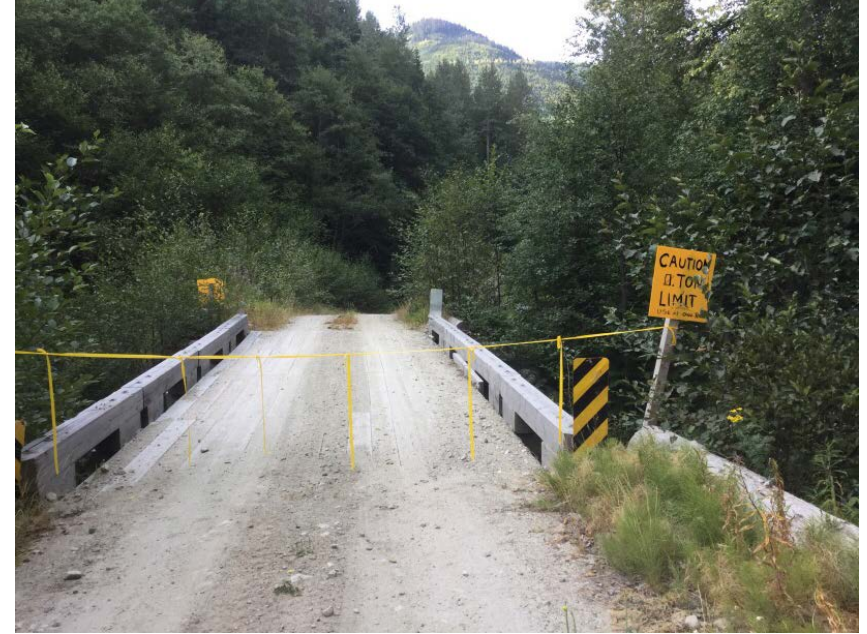
Updated load rating sign and notification at right approach

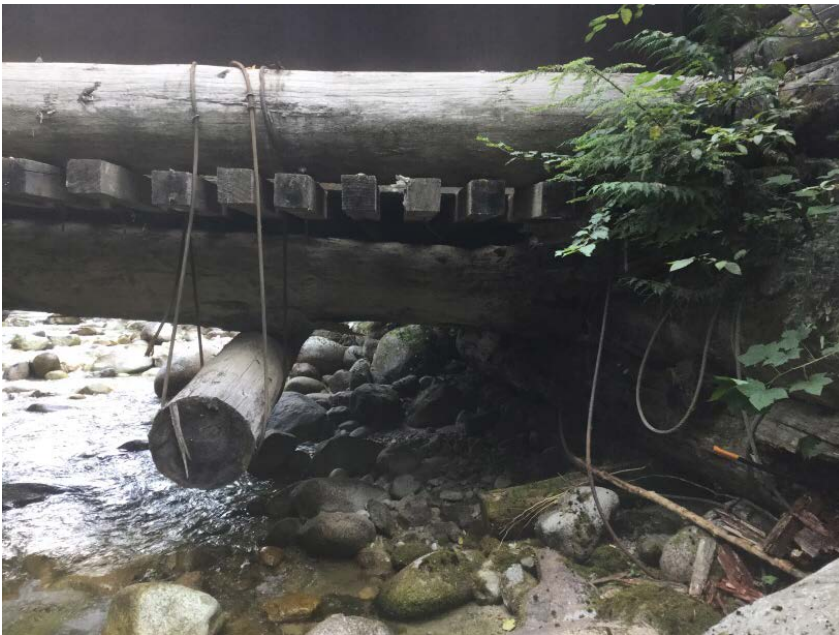
The needle beam is holding the stringer up

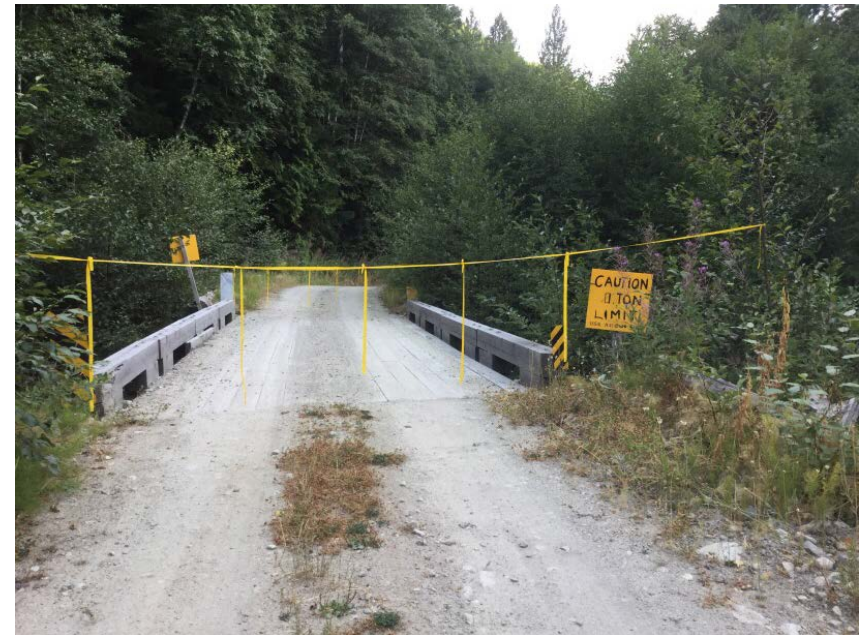
Updated load rating sign and notification at left approach
