CK-2220

PITT RIVER 12.1km

2017 Inspection

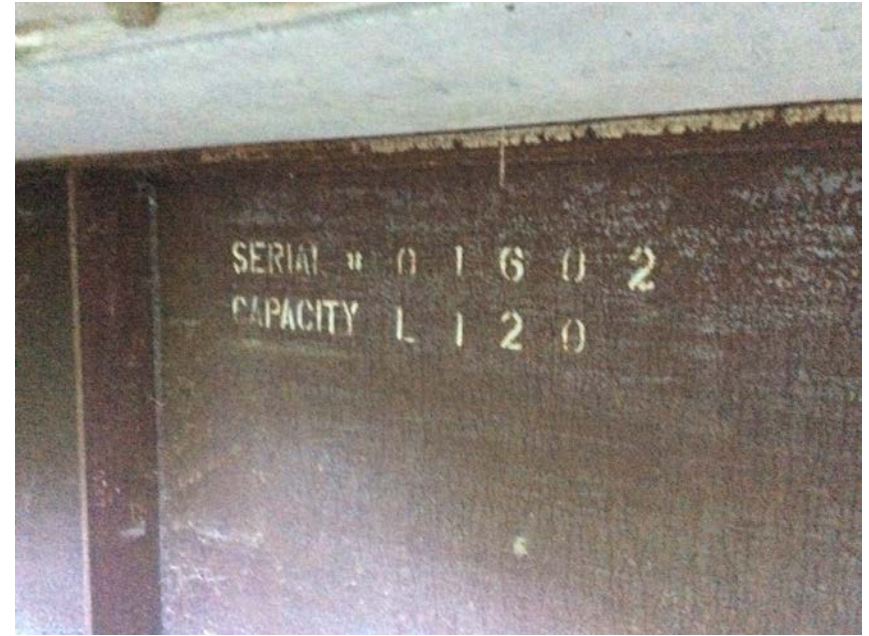
Structure Or Manufacturer ID

Serial/ID Plate Serial number 01602. L120

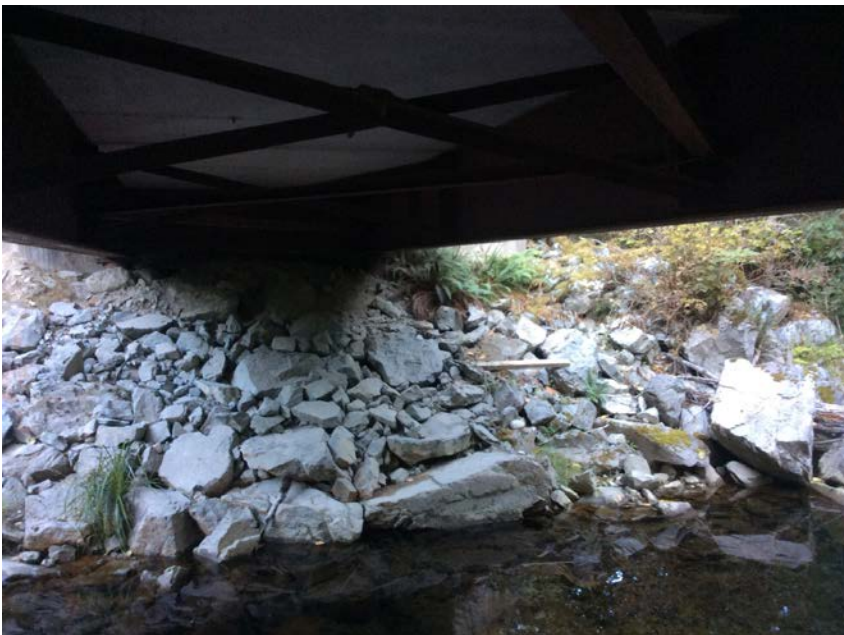
Right Bank Abutment when facing downstream

Comments    Unable to tell if right side riprap in stream is from installation or erosion. Check old photos.
