CK-2222

PITT RIVER 18.2km

2017 Inspection

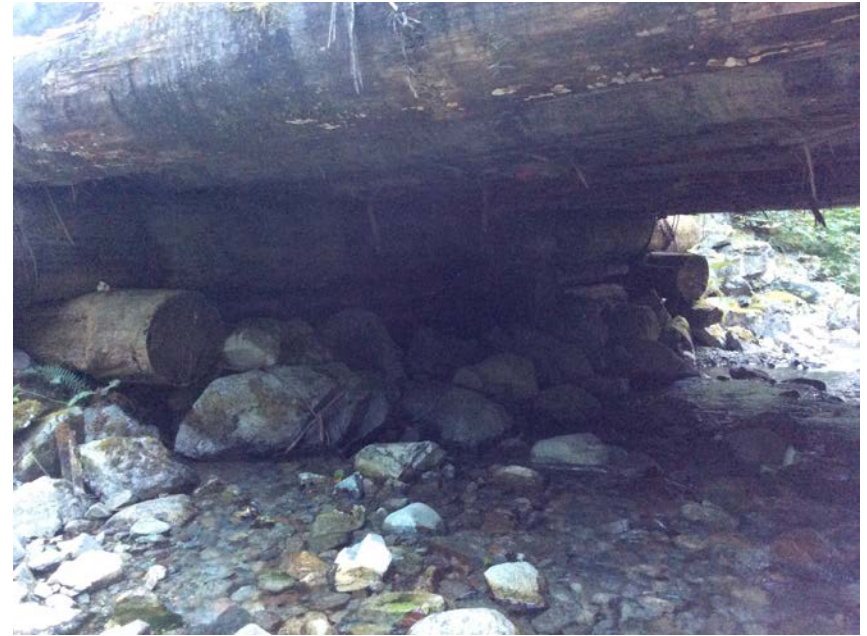
Left Bank Abutment when facing downstream

Log/Timber Cribs Good 2 log cribs. Well built

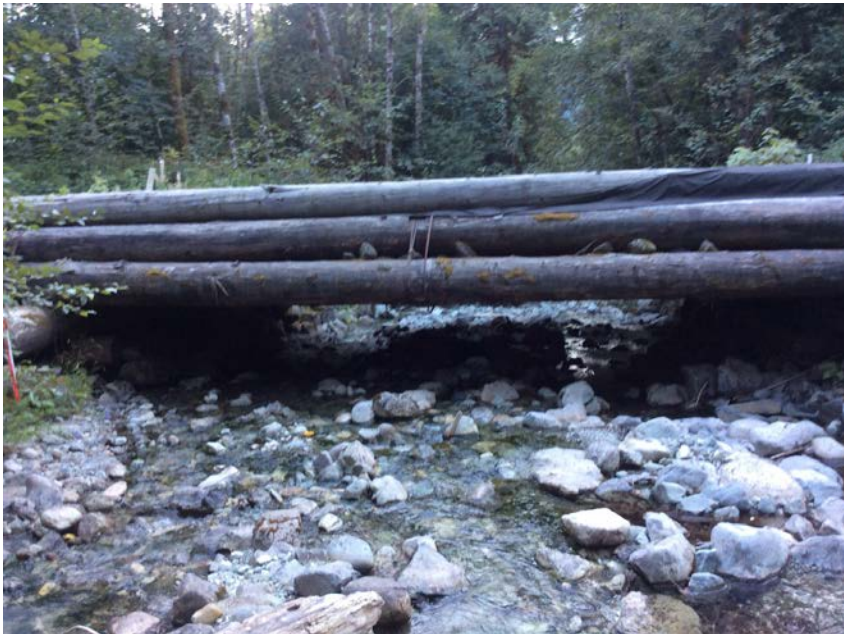
Upstream Profile

Good bridge. No concerns. Fairly recent work with new stringers.  
Must have 2nd layer of stringers for L100 at this span though.  
Active hauling adjacent to bridge.

| Repair Item | Priority | Repair Description |
|---|---|---|
| 1 | High | To increase the load rating restrict the running width by fastening additional 600mm diameter curb logs directly inside the existing ones - contact the undersigned for additional information |
