CK-2225

PITT RIVER 24.6km

2017 Inspection

| Crossing Name | Blue Creek |

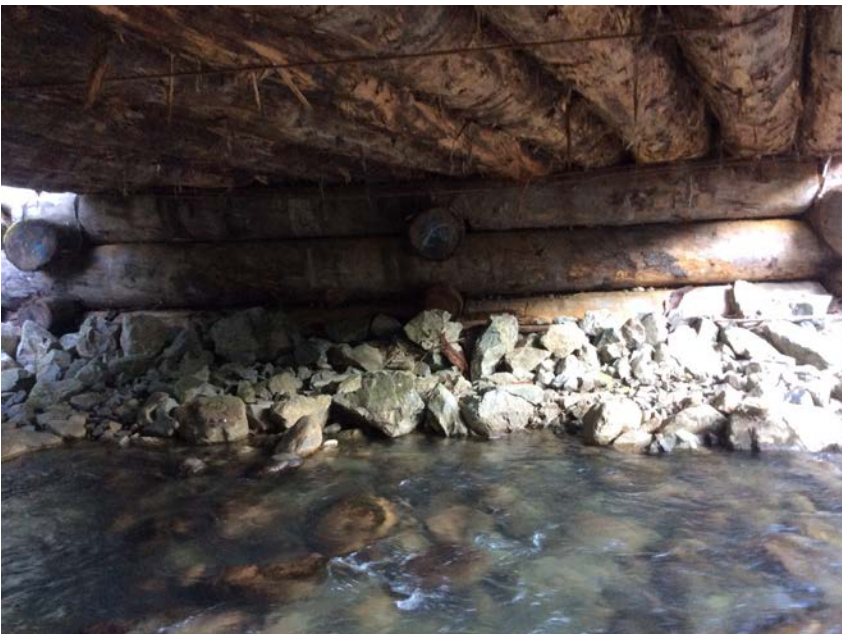
Left Bank Abutment when facing downstream

Fairly new install, skewed cribs

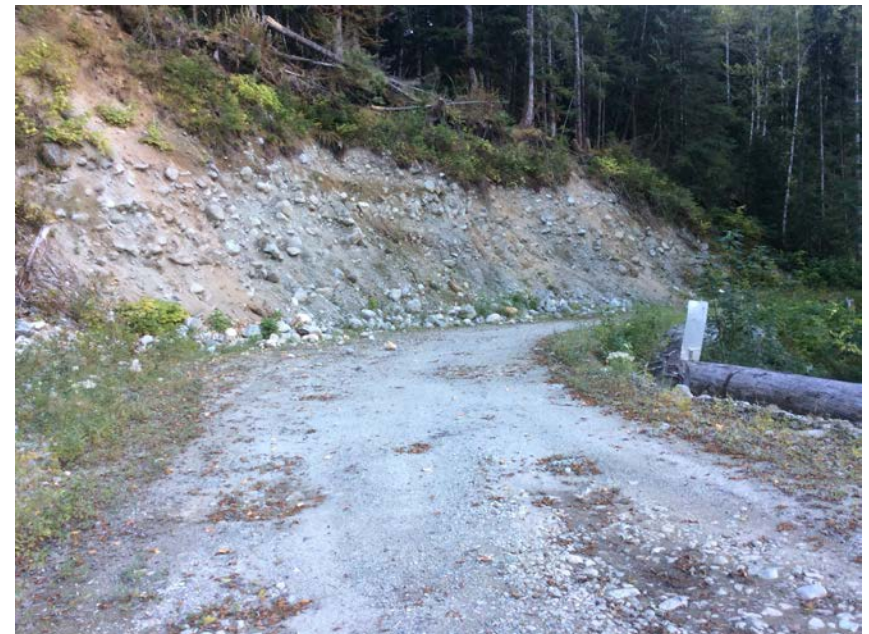
Left approach viewed from bridge

Sharp corner on left approach

| Repair Item | Priority | Repair Description |
|---|---|---|
| 2 | Medium | post bridge ahead signs |
