CK-2226

PITT-BOISE 0.3km

2017 Inspection

| Crossing Name | Pitt River |

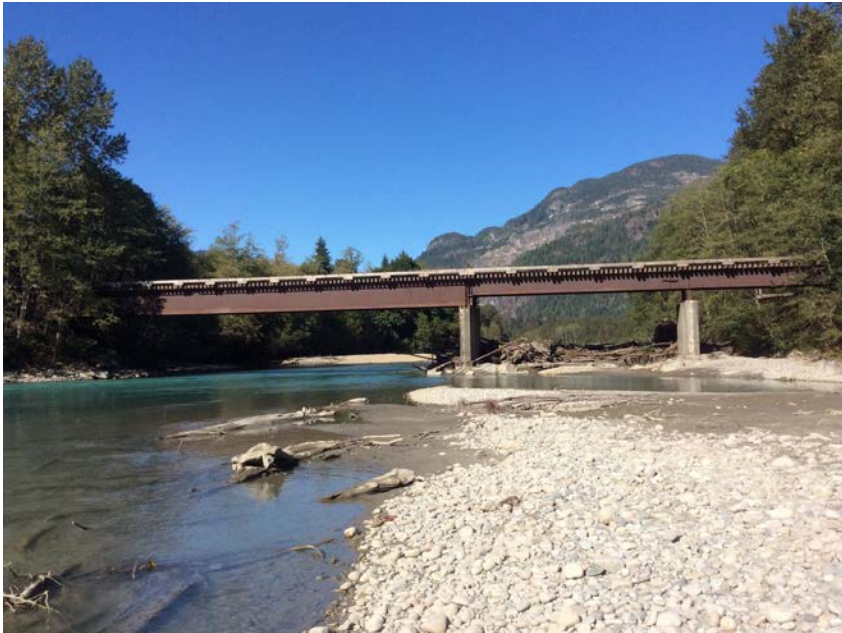
Downstream Profile

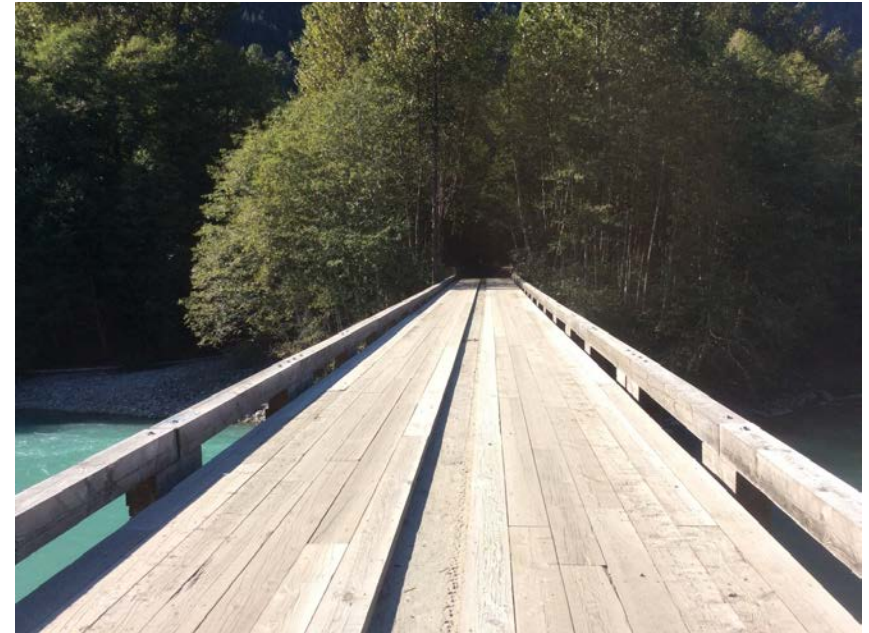
Right approach viewed from bridge

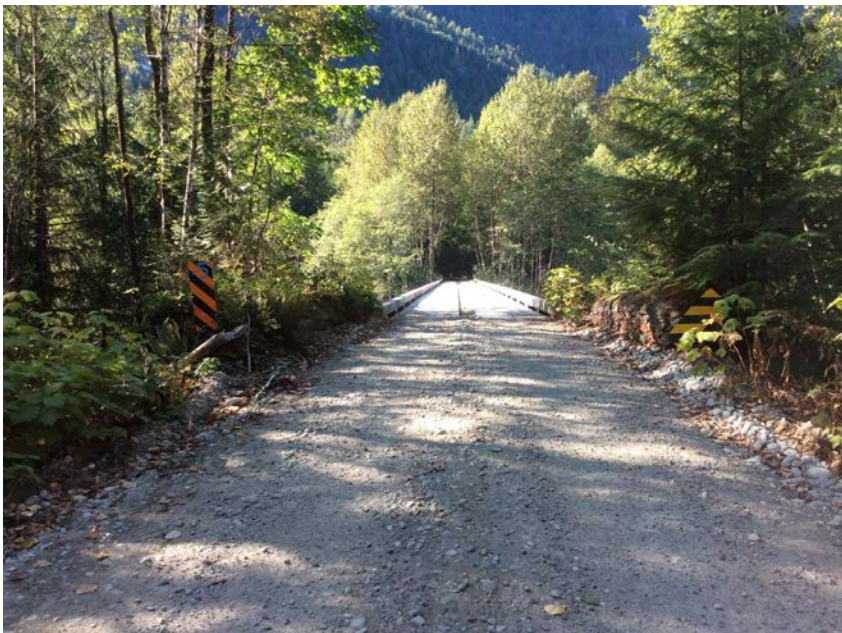
Approach from Left Bank when facing downstream

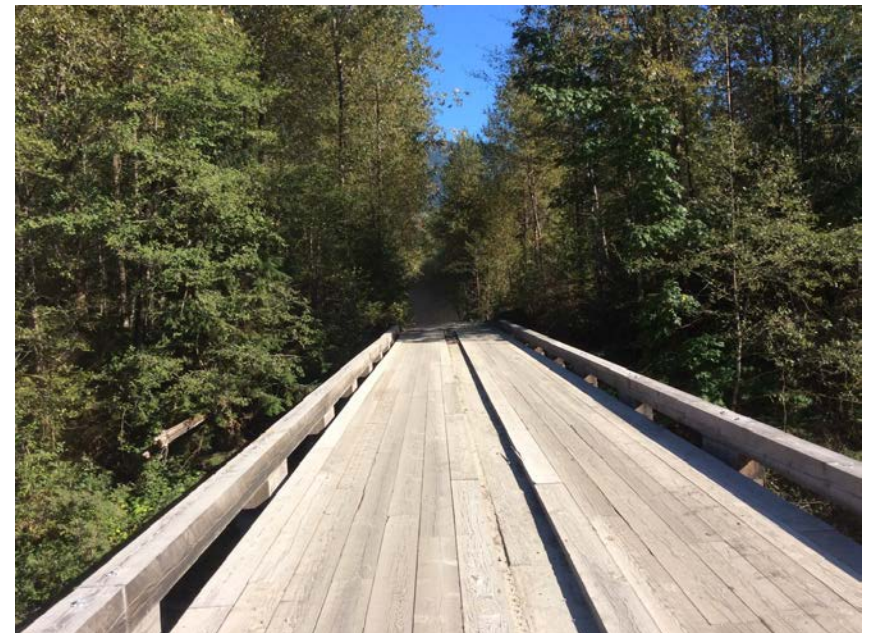
Left approach viewed from bridge

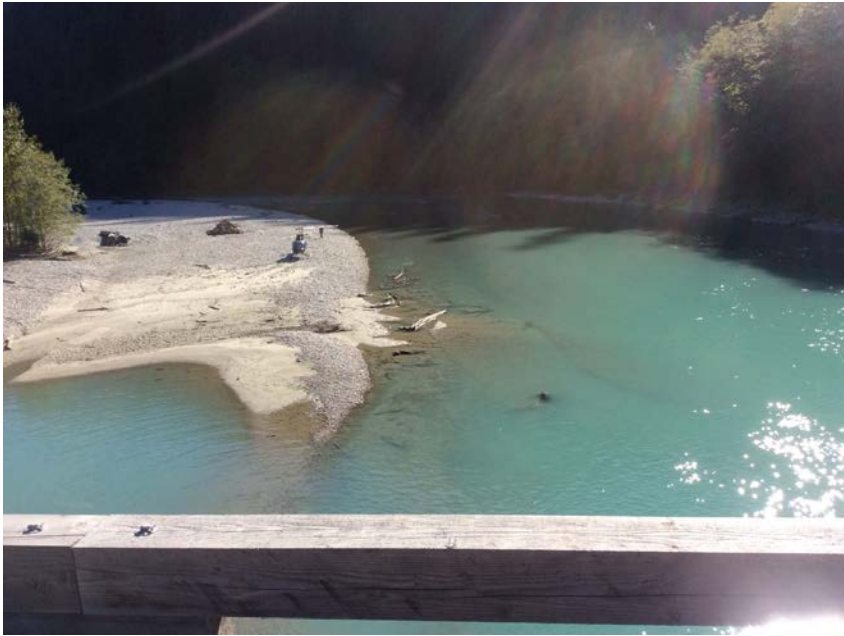
Downstream from Crossing

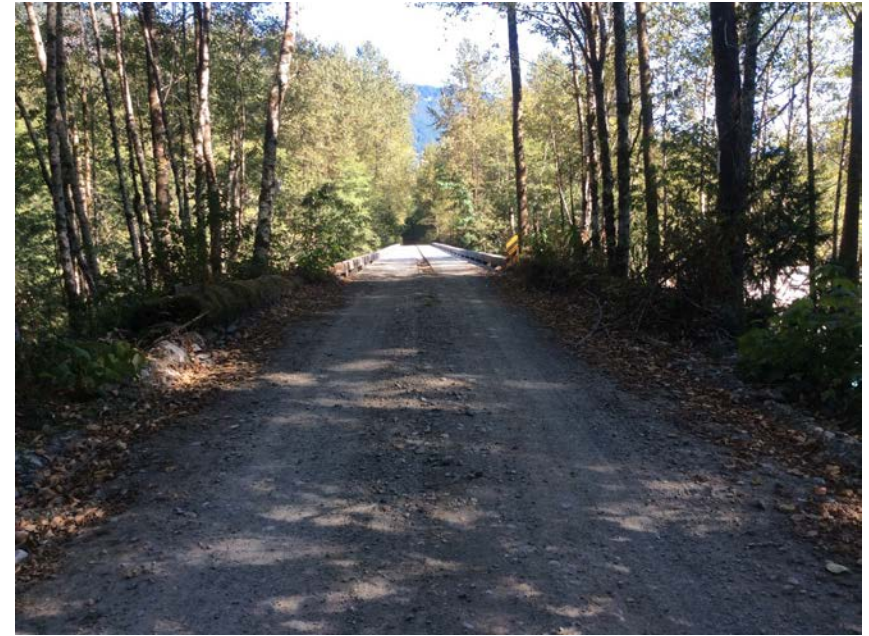
Approach from Right Bank when facing downstream

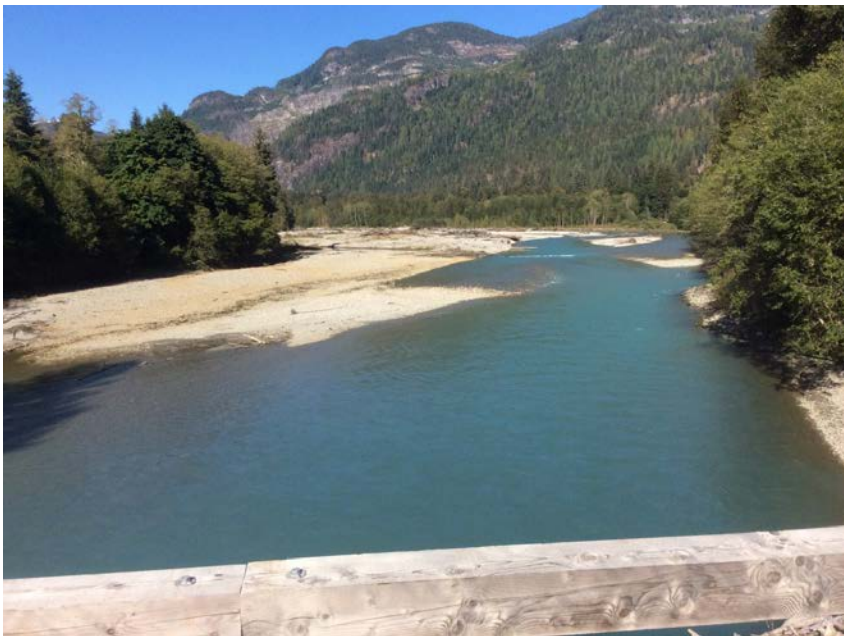
Upstream from Crossing

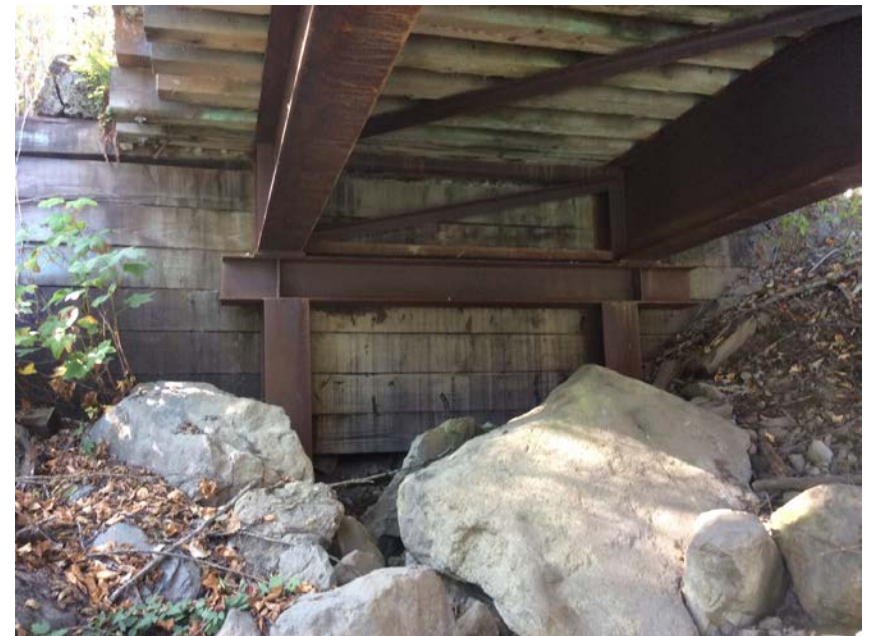
Right Bank Abutment when facing downstream

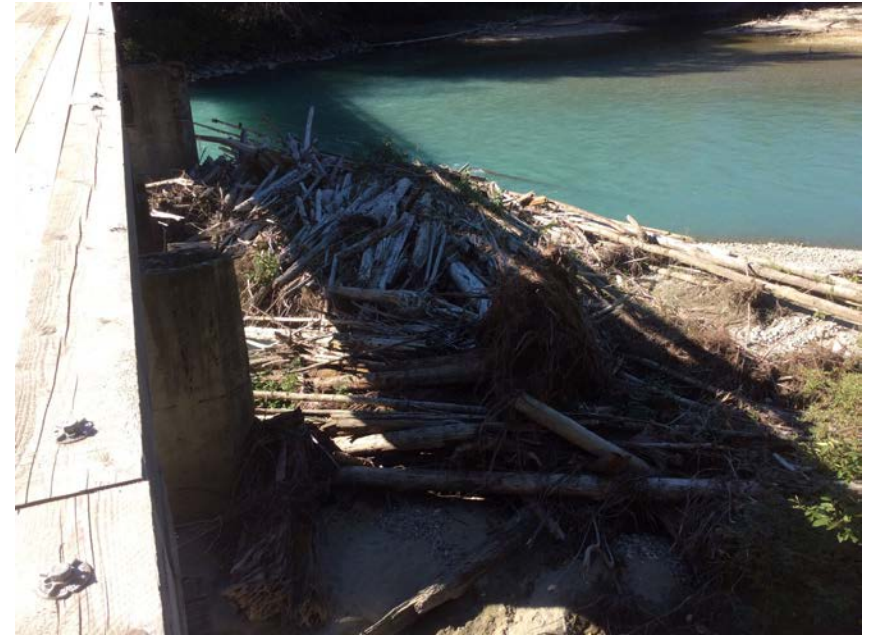
Comments    Spans 1 and 2 are blocked with debris and push stream to right side

Debris buildup

Remove debris buildup at spans 1 and 2. L100 or 91 tonnes load rating.

| Repair Item | Priority | Repair Description |
|---|---|---|
| 1 | Medium | Remove debris built up at spans 1 and 2 |

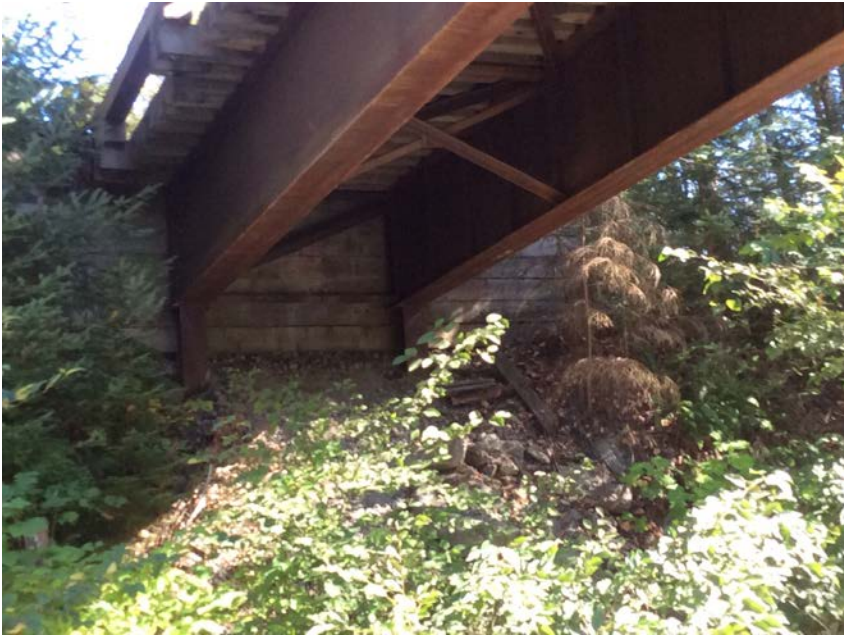
Left Bank Abutment when facing downstream
