CK-2236

SOWAQUA CREEK 9.6km

2017 Inspection

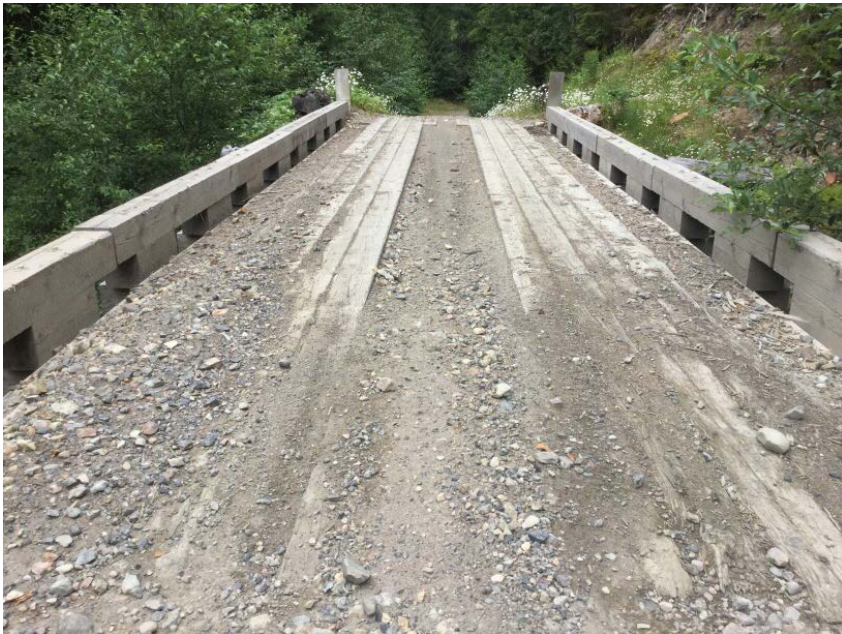
Deck

| Running Planks | Fair | Some planks have extensive wear |

Replace extensively worn planks. Post bridge ahead signs and monitor bridge following high flow events to confirm the stability of the abutments due to the limited riprap protection. Monitor the bearing plate condition due to the poor bearing (plates not fully on the log sill and log sill not trimmed flat) when in use. There is no indication of the term of this installation and it is considered temporary. The steel girders indicate L75 (68 tonnes) loading which can continue.

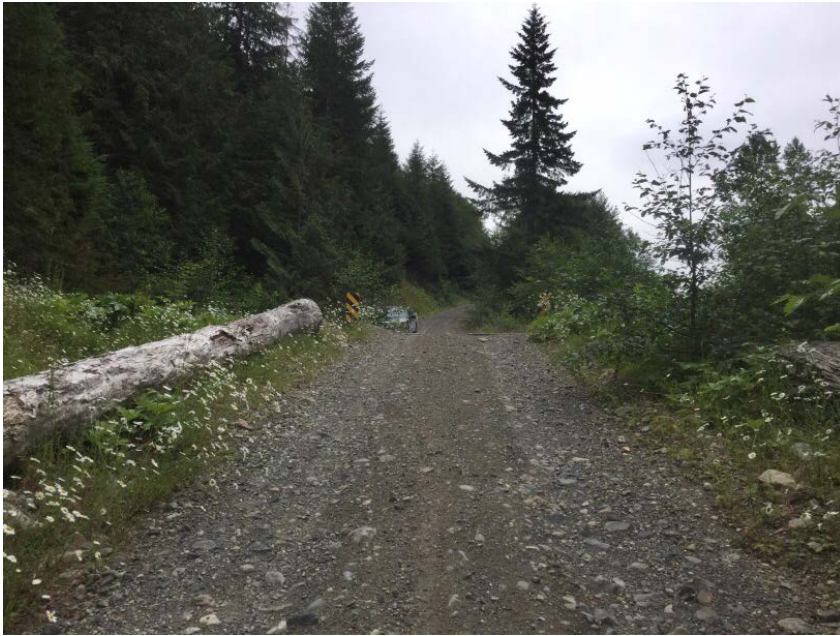
Approach from Right Bank when facing downstream

Heavy VC right approach

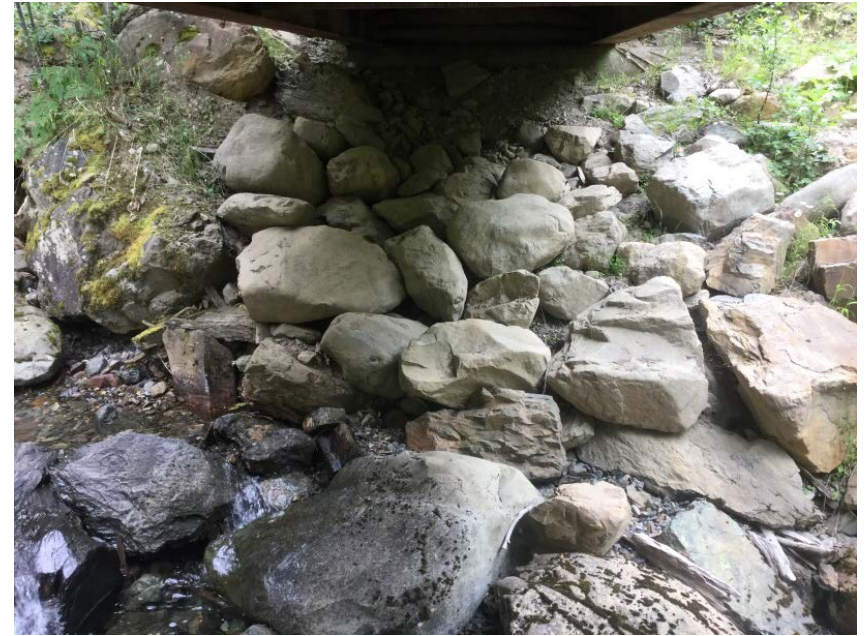
Left Bank Abutment when facing downstream

Single log sills, not square to girders

Not well keyed in or tied together, some rounded pieces

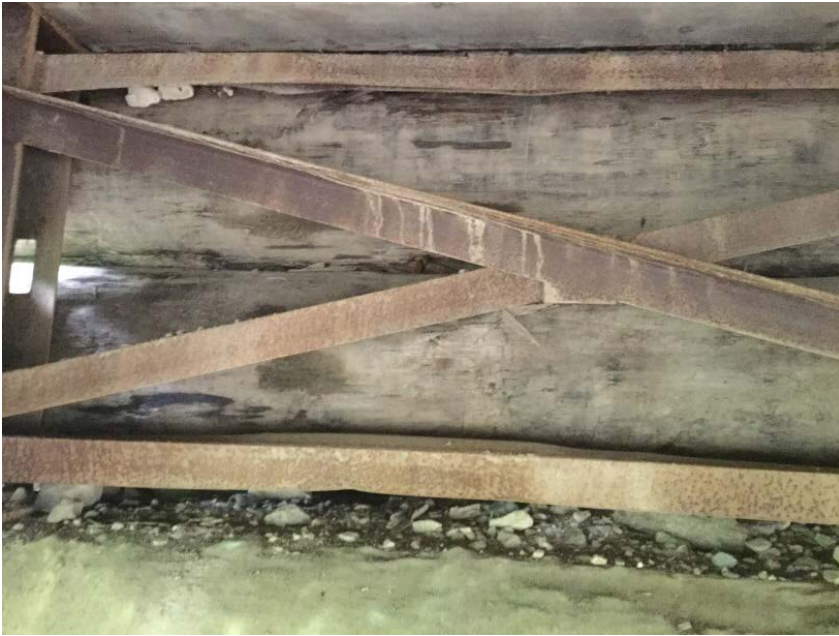
4 welded bays, slightly corroded, minor damage noted

Slight damage to right bank diaphragm

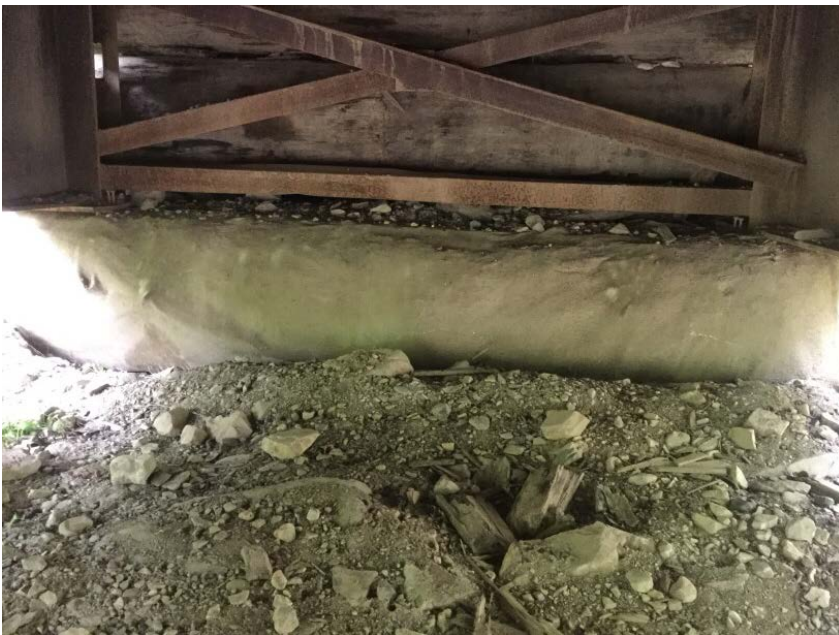
bearing plates not completely on log sills and poorly fastened

Girders only nailed to sill

The girders do not sit square on either log sill

| 2 | bearing plate deformation | Routine Inspection |
