CK-2237

SOWAQUA CREEK 14.6km

2017 Inspection

| Crossing Name | Montigny Creek |

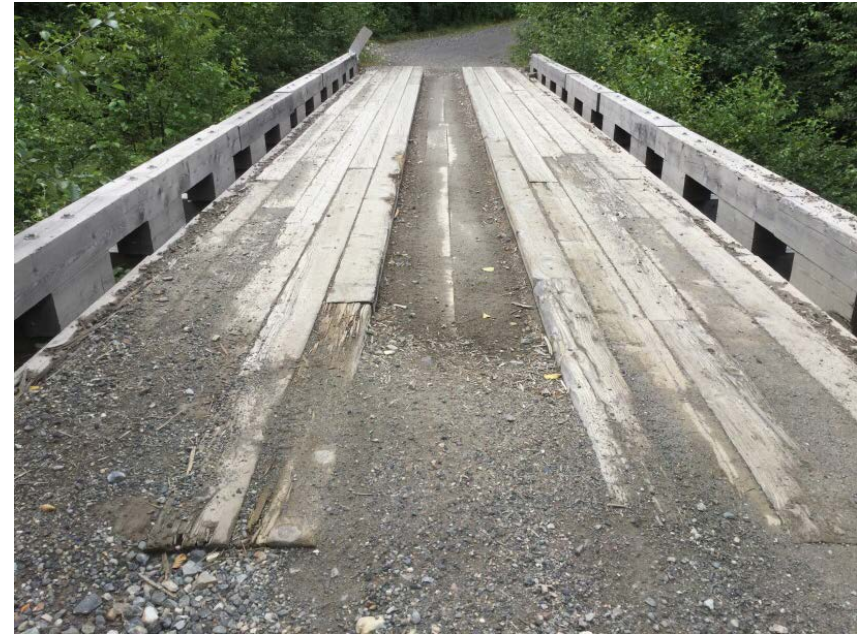
Deck

some planks have extensive wear

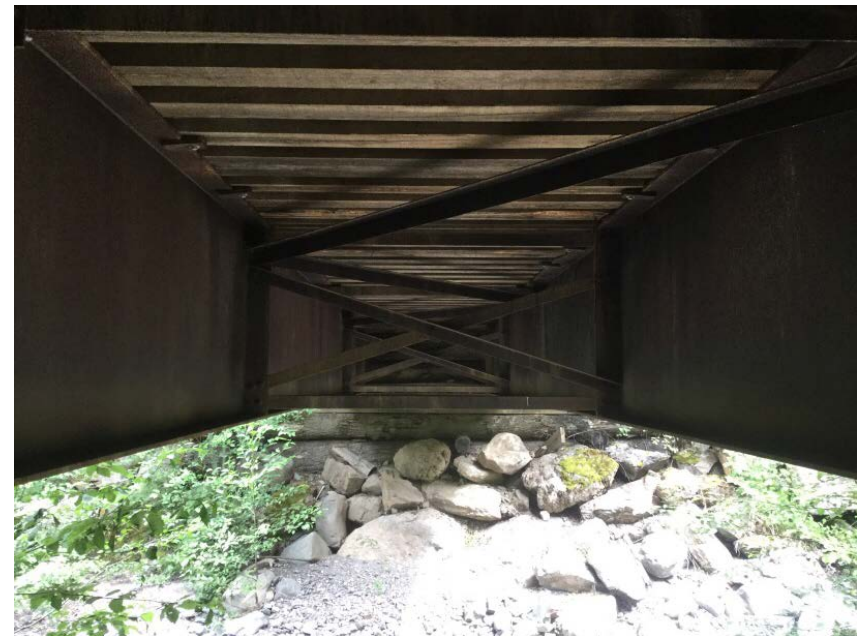
Superstructure

2 girders, part of a larger set, slightly corroded and not centered over stiffeners on I beam cap

4 bolted bays, slightly corroded and minor damage noted at right abutment

Slightly corroded, minor damage noted at right abutment
