CK-2248

SPUZZUM SEVEN 0.2km

2017 Inspection

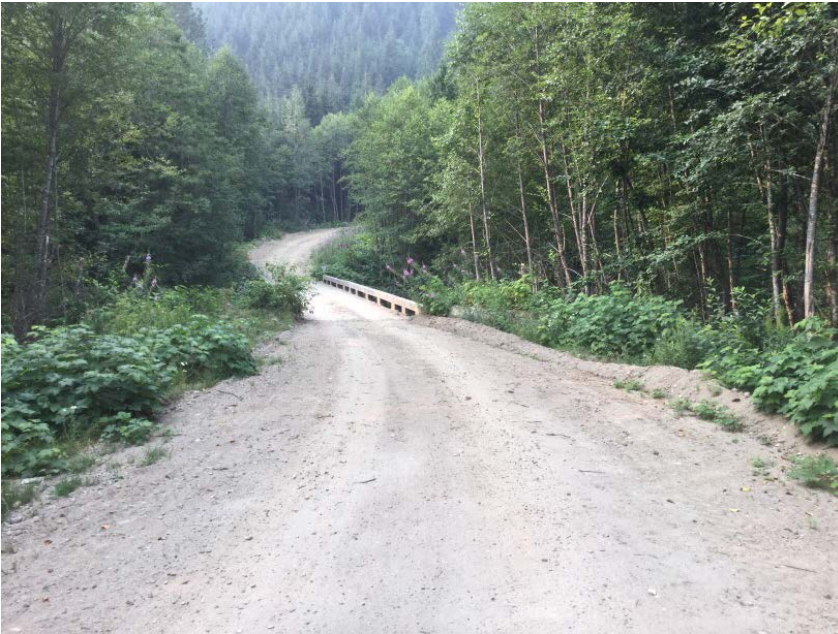
Approach from Left Bank when facing downstream

Brushing Required Y Minor

Delineator Missing  
Left ☐ 0 ☒ 1 ☐ 2

| Repair | | Repair Description |
|---|---|---|
| 1 | Medium | Brush approaches and clean sediment from deck |
| 2 | Low | Replace missing delineator |

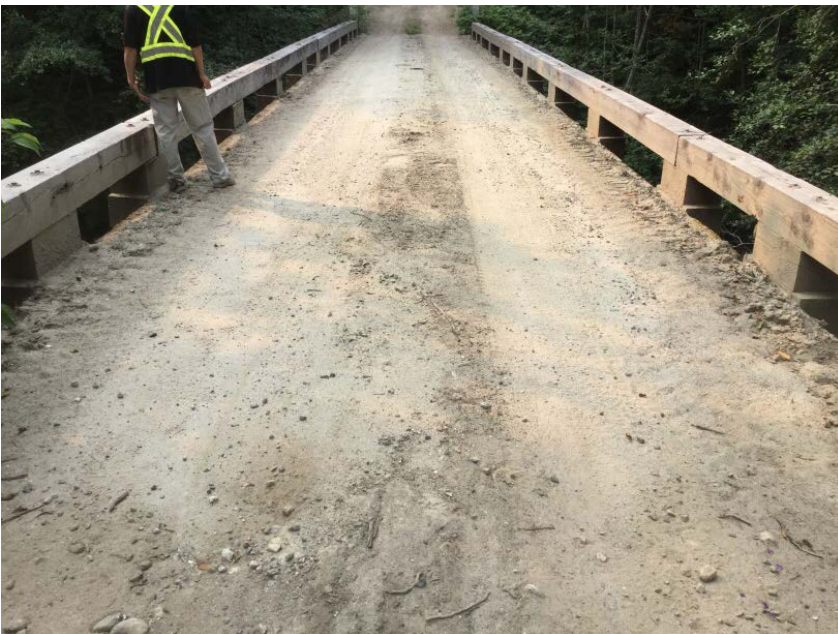
Running Surface      Fair

Overall Deck Condition      Good

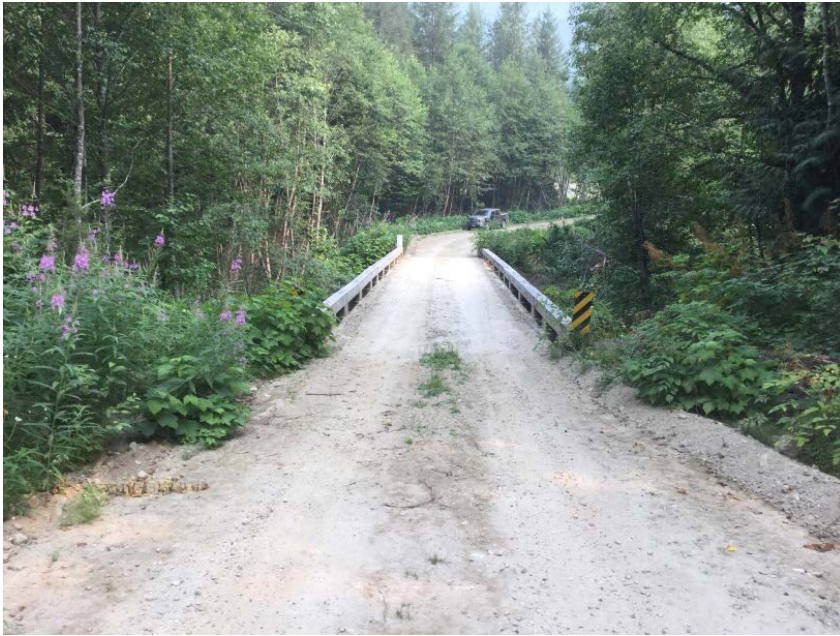
Approach from Right Bank when facing downstream

Fender Condition Fair Missing upstream right approach

| Repair | | Repair Description |
|---|---|---|
| 3 | Medium | Replace missing fenders and post bridge ahead signs |

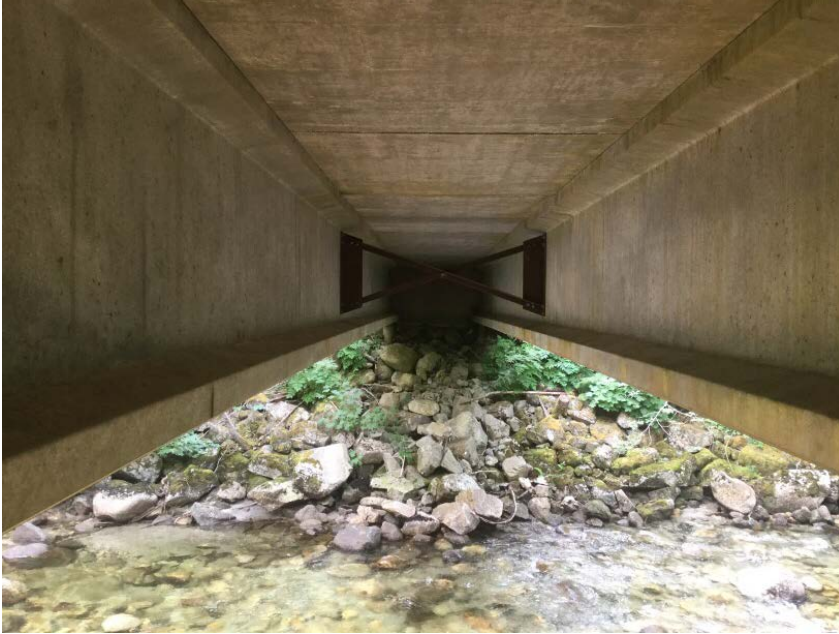
Superstructure

Girders **Good**Diaphragms **Good**
