CK-2253

SQUEAH 3.2km

2017 Inspection

CBR iPad Offline Ver 0.26

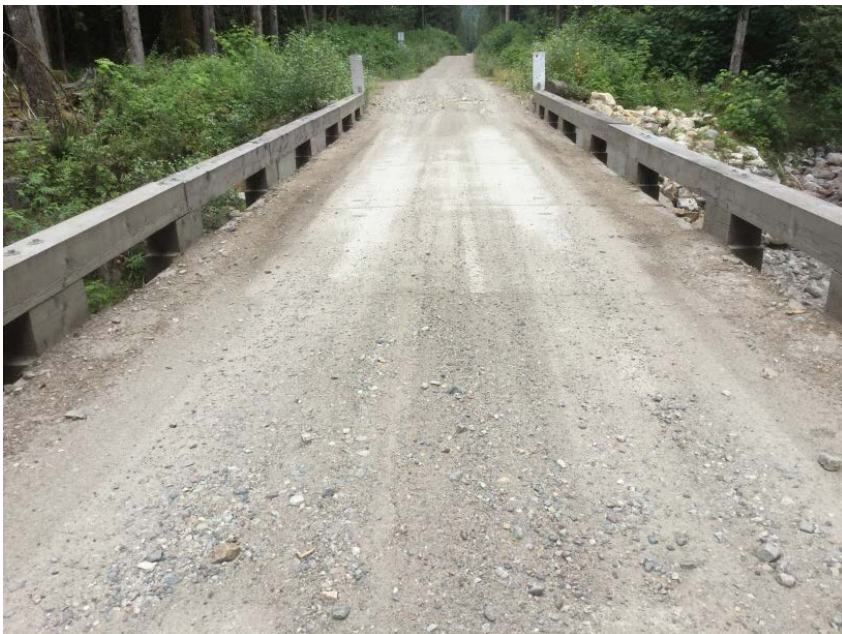
Overall Deck Condition      **Good**

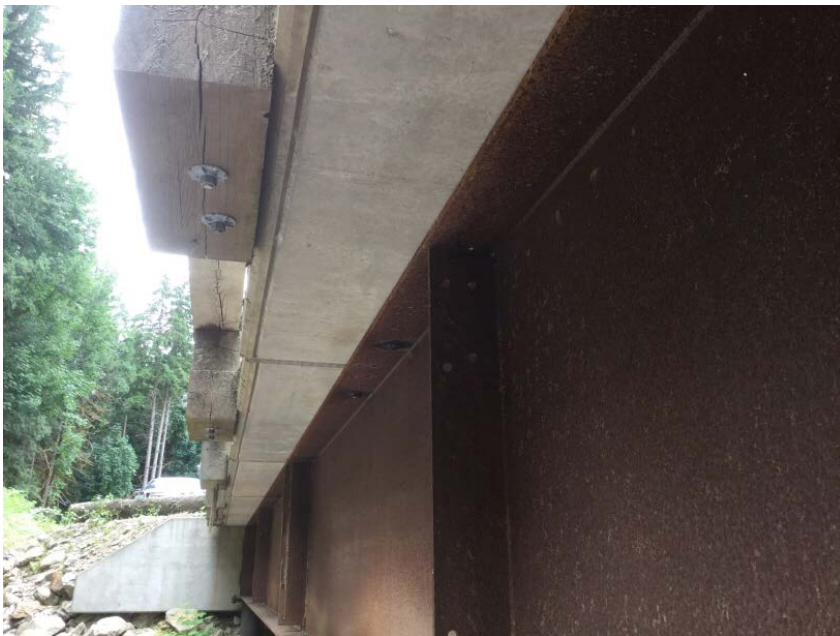
Deck bolts

Deck to Girder Bolts      **Good**

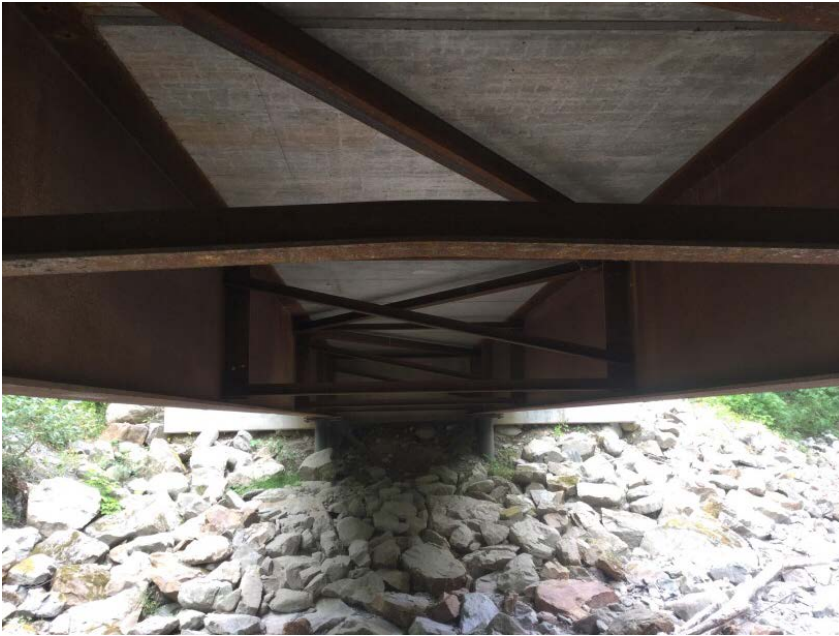
Superstructure

Girders Fair Slight corrosion

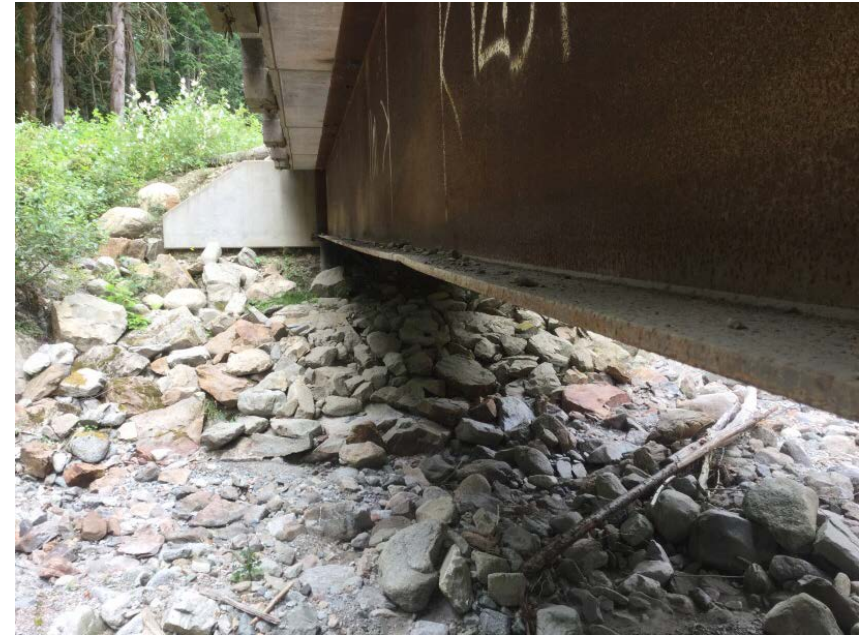
Minor damage to downstream girder, bottom flange

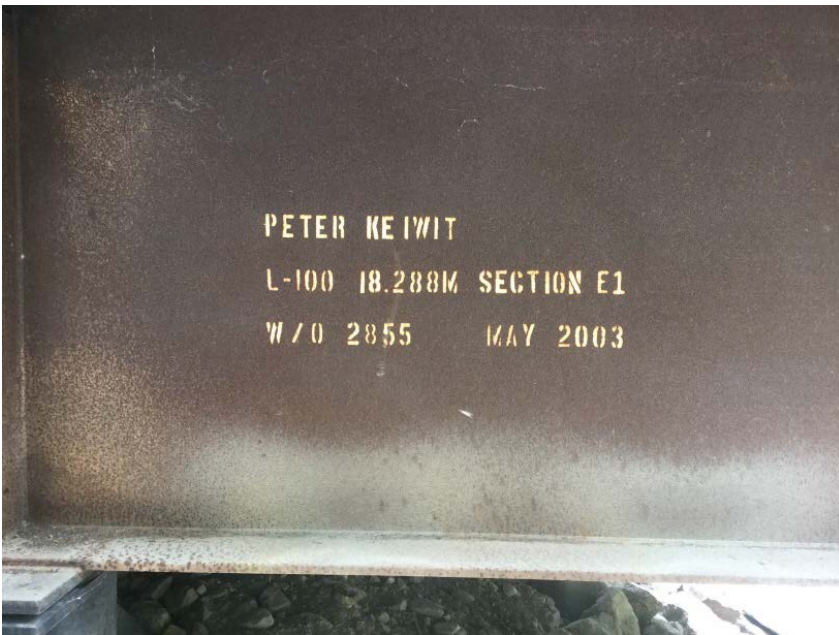
Structure ID

Serial/ID Plate Peterson Kiewit L100, 18.288 Section E1, W/O 2855, May 2003
