CK-2260

STAVE RIVER 3.5km

2017 Inspection

| Crossing Name | Roaring Creek |

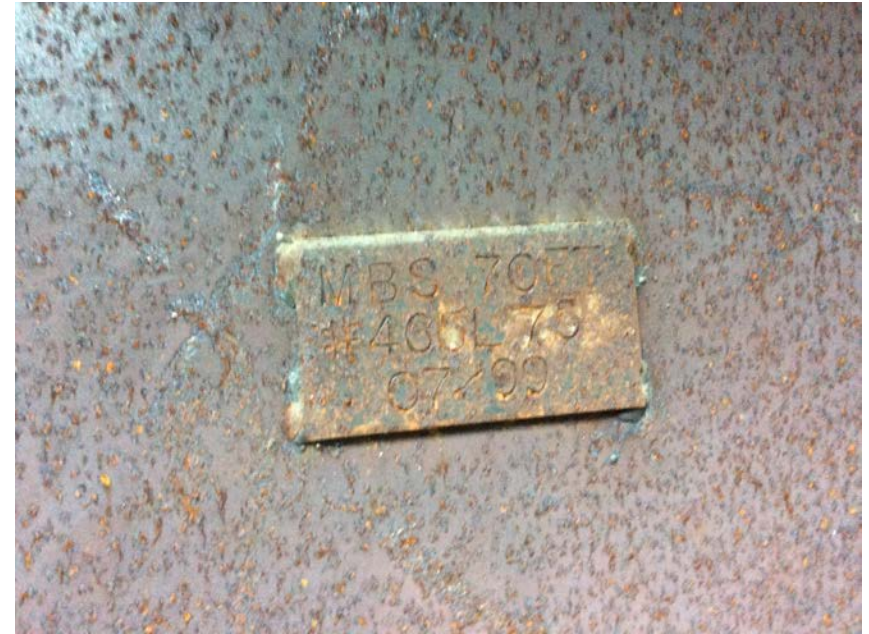
Structure Or Manufacturer ID

Serial/ID Plate As per photo

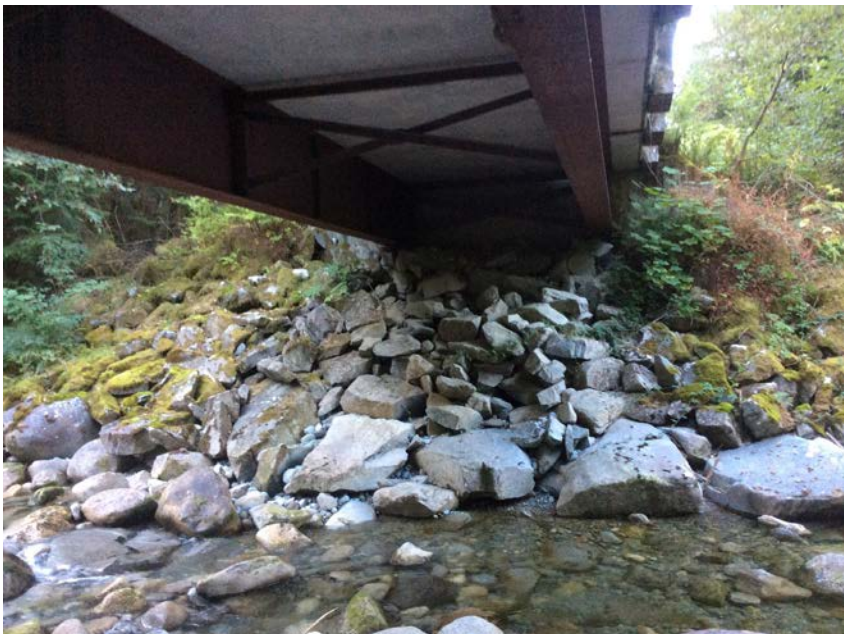
Left Bank Abutment when facing downstream

Ballast Wall Fair

Left bank ballast wall has exposed rebar at deck connection

| Repair Item | Priority | Repair Description |
|---|---|---|
| 2 | Low | Repair left bank exposed rebar in ballast wall |

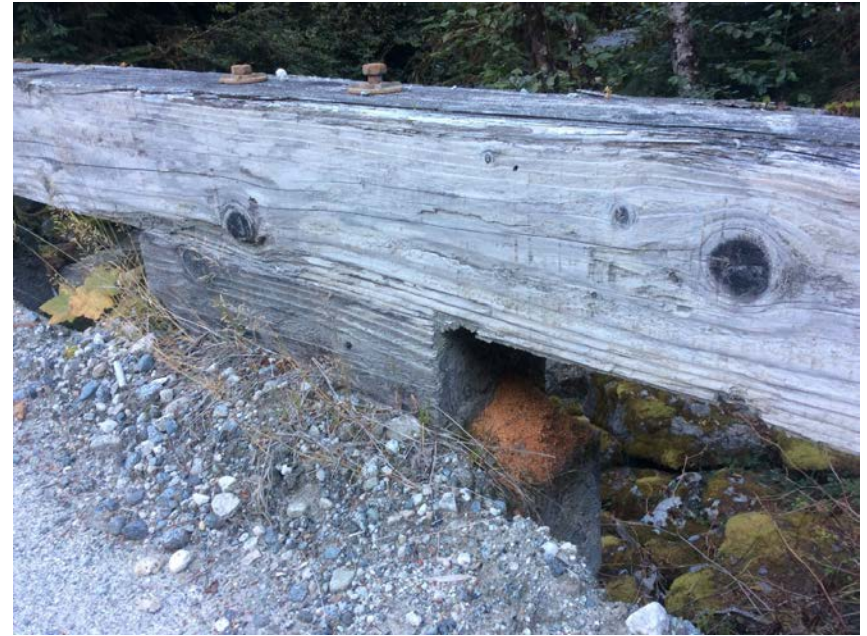
Guard Rail

Good structure. Needs new guardrails.

| Curb Rail/Blocks/Posts | Poor | Replace due to rot and insect damage |

Replace guardrail, risers and blocks. Repair damage to ballast wall. Post bridge ahead signs. Present load rating of L75 or 68 tonnes to continue.

| Repair Item | Priority | Repair Description |
|---|---|---|
| 1 | Medium | Replace all guardrails before industrial activity |
