CK-2261

STAVE RIVER 7.5km

2017 Inspection

| Crossing Name | Winslow Creek | | |

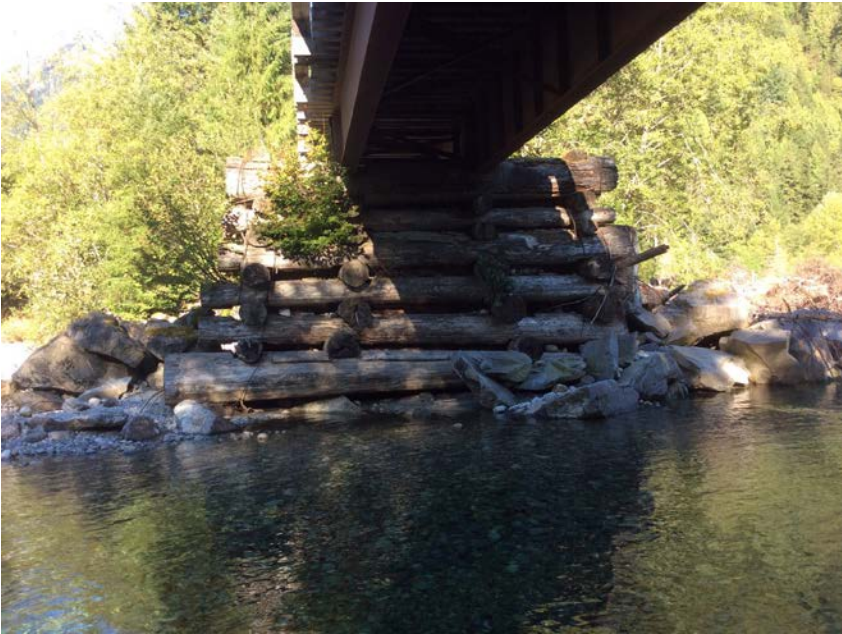
Right Bank Abutment when facing downstream

Log/Timber Cribs Poor

Visible rot

Tie Backs Poor

Visibly rotten

| Item | Priority | Repair Description |
|---|---|---|
| 1 | Medium | Replace bridge and substructure for industrial use. |

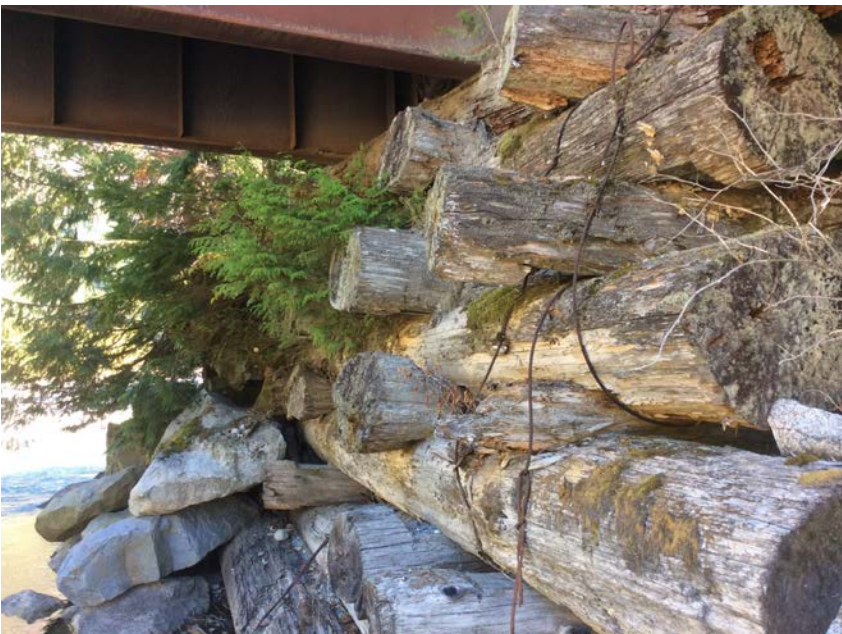
Left Bank Abutment when facing downstream

Wing Wall Poor

Left side wingwall visibly rotten

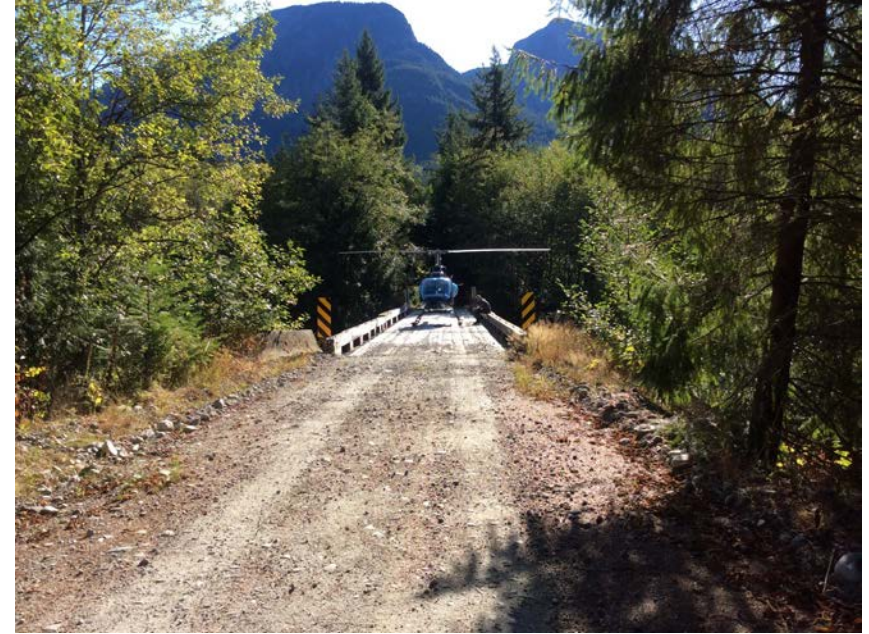
Approach from Right Bank when facing downstream

Fender Condition Poor

Right downstream no post was bumped off road edge

| Item | Priority | Repair Description |
|---|---|---|
| 3 | Medium | Replace missing no post barriers at downstream right approach |
