CK-2262

STAVE RIVER 9.4km

2017 Inspection

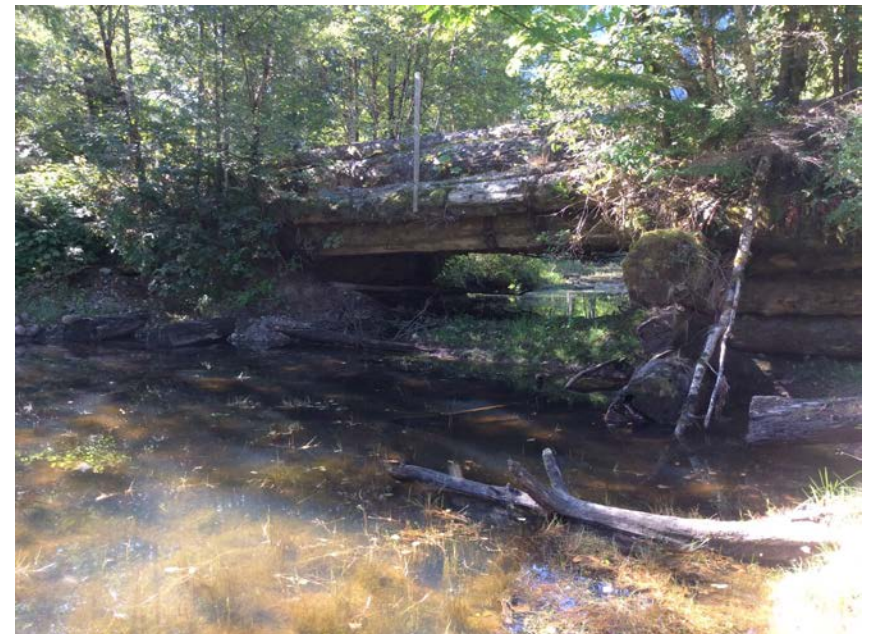
Upstream Profile

Comments    Beaver dam across stream under upstream end of bridge

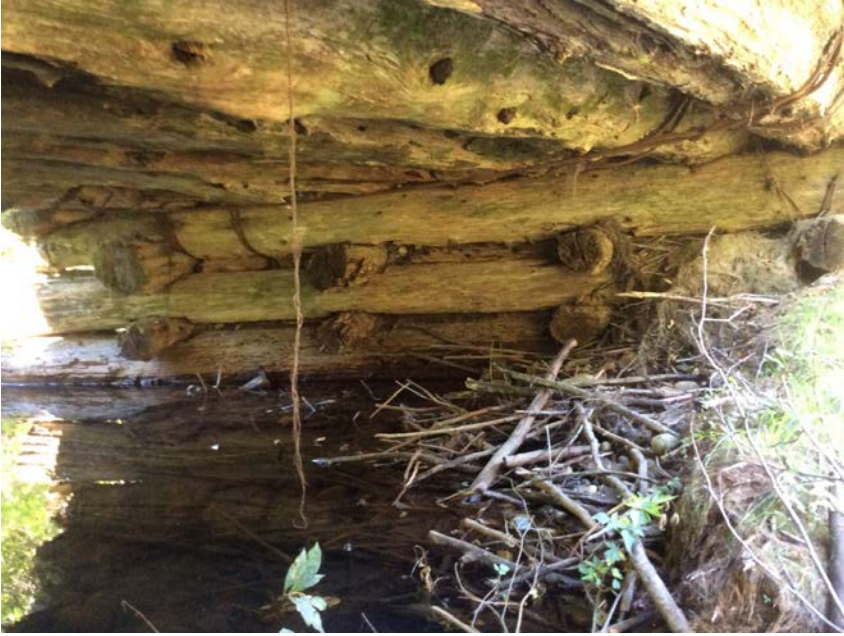
Right Bank Abutment when facing downstream

Log/Timber Cribs Poor Visibly rotten with age , extensive sap rot

Tie Backs Poor Visibly rotten with age, extensive sap rot

| 1 | High | Replace bridge |
