CK-2263

STAVE RIVER 10.3km

2017 Inspection

| Road Name | STAVE RIVER |

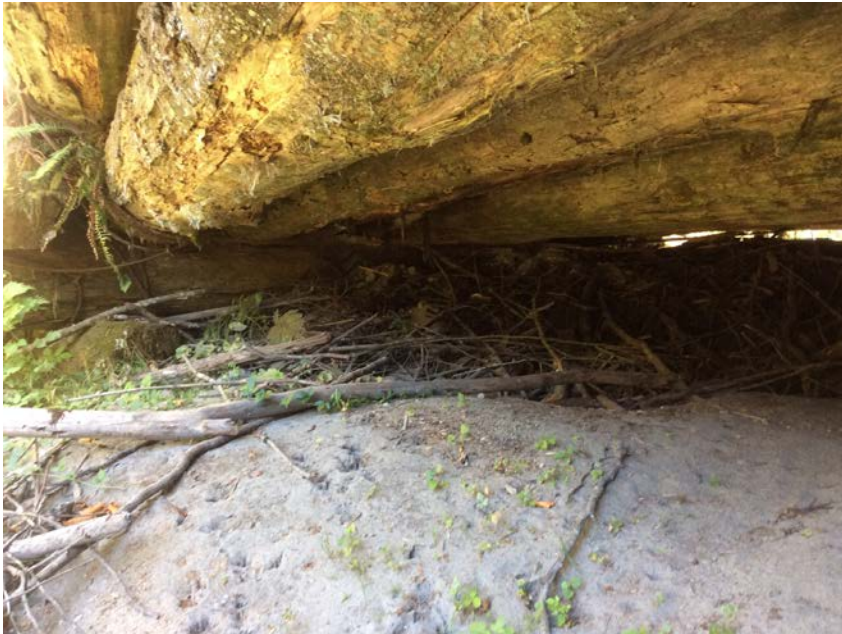
Right Bank Abutment when facing downstream

Log/Timber Cribs Poor Old and rotten, left side visibly leaning

Comments    Buildup of material in front of right abutment.
