CK-2264

STAVE RIVER 11.9km

2017 Inspection

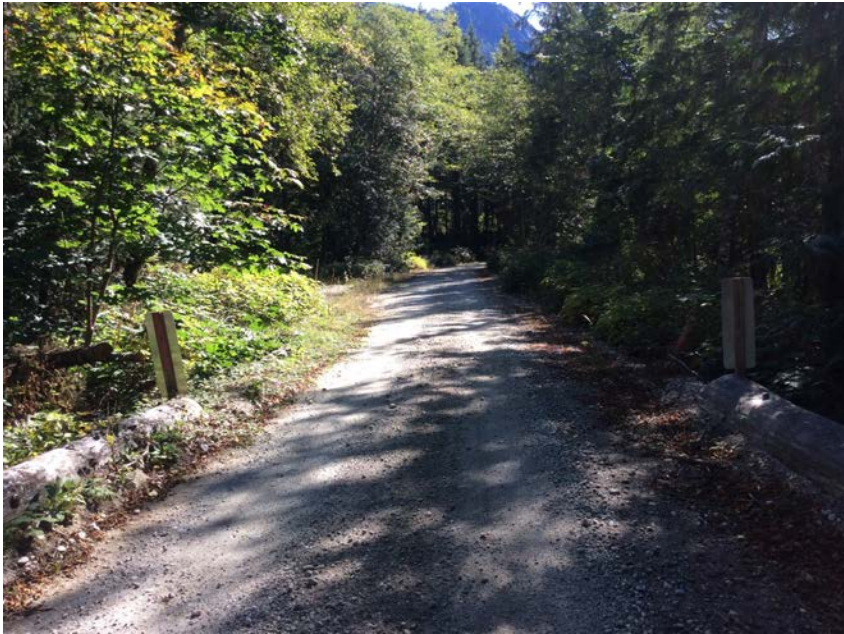
Left approach viewed from bridge

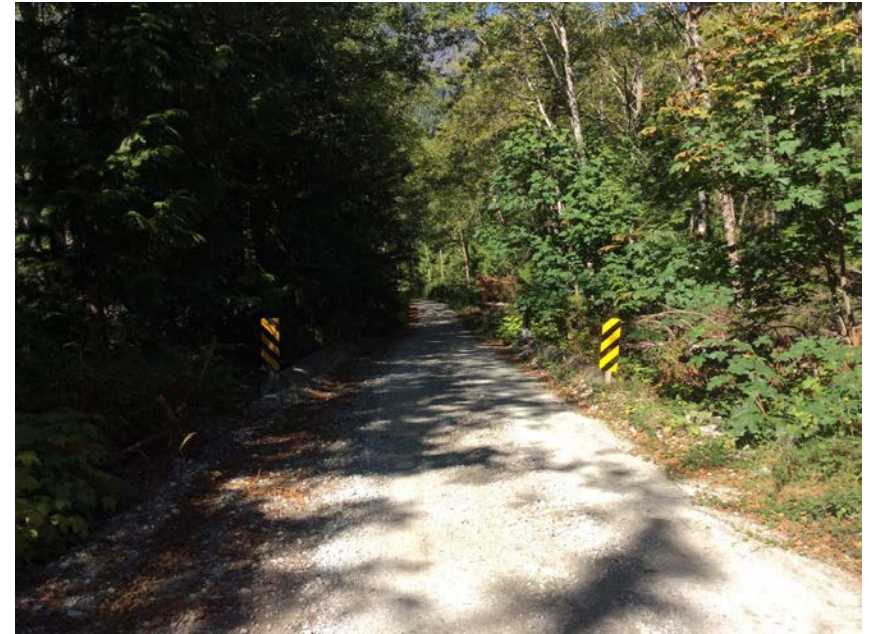
Approach from Left Bank when facing downstream

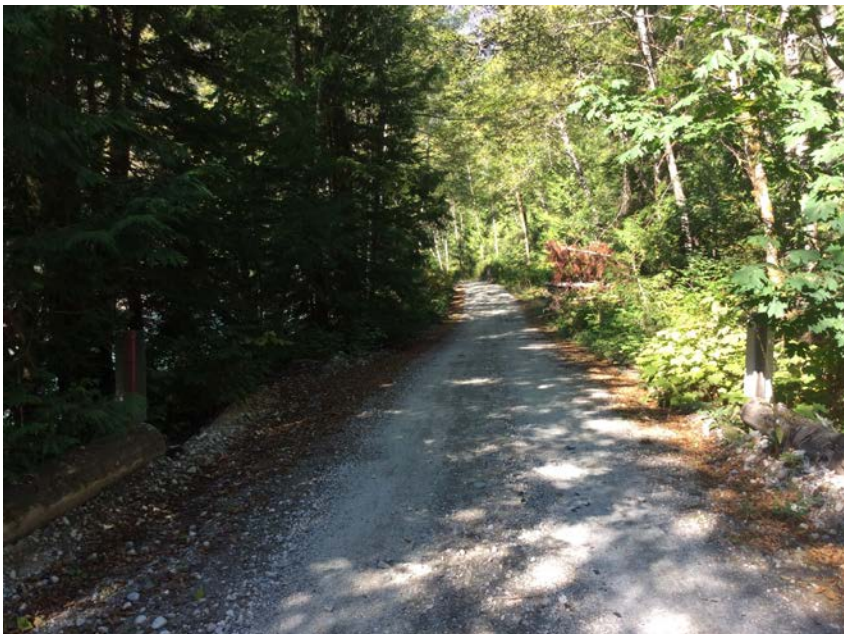
Right approach viewed from bridge

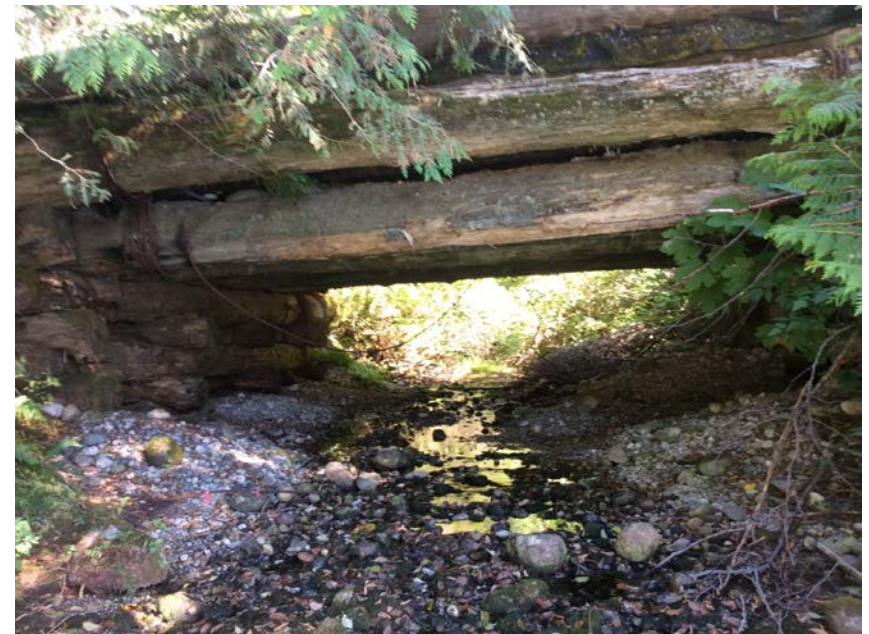
Downstream Profile

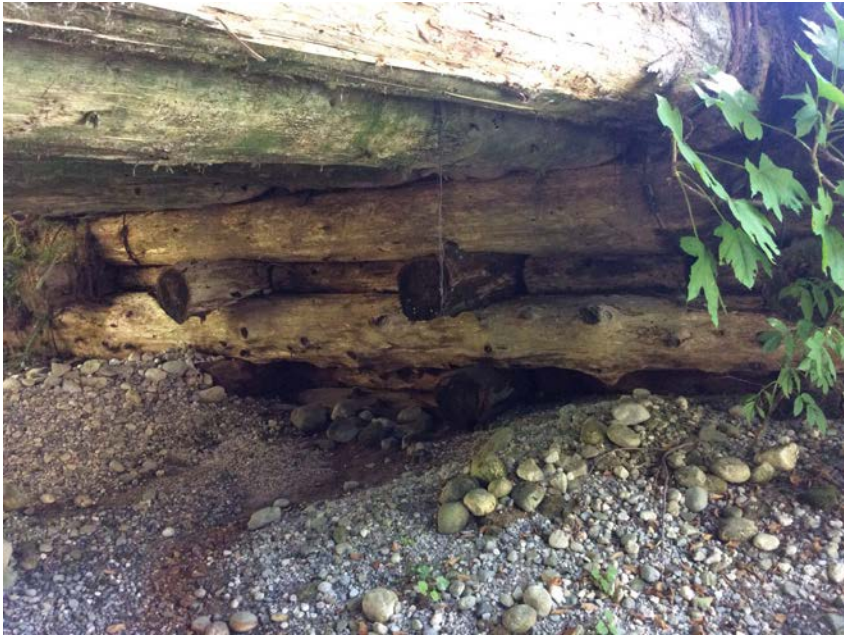
Log/Timber Cribs Poor Old and rotten. Open faced crib

Tie Backs Poor Old and rotten.

Hardware Poor Lashing is loose

Left Bank Abutment when facing downstream

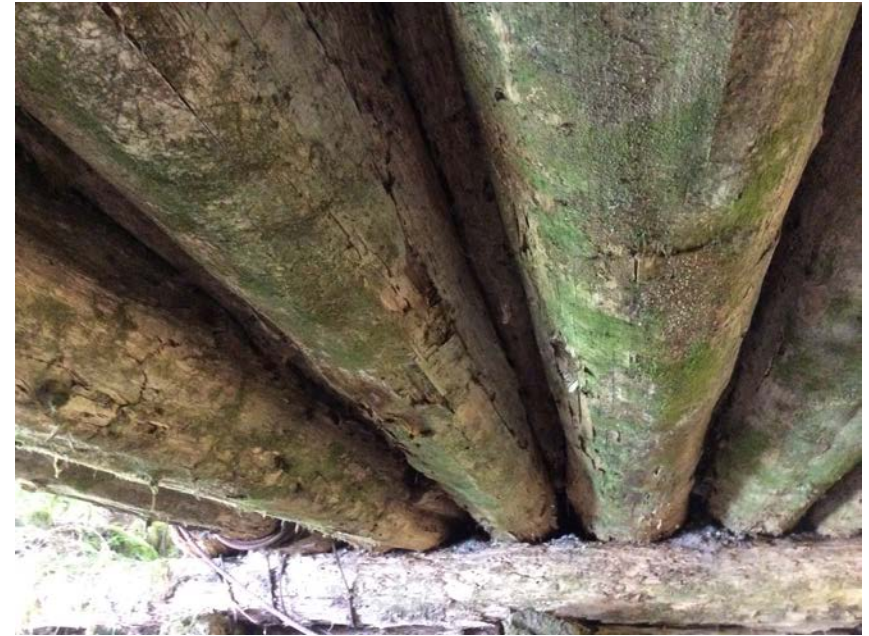
| Stringer<br>Number | Species | Peeled | Diameter<br>(mm) | Rot Depth<br>(mm) | Condition | Comment |
|---|---|---|---|---|---|---|
| 1 | Cw | Y | 650 | 40 | Fair | Sap rot |
| 2 | Cw | Y | 550 | 30 | Fair | Sap rot |
| 3 | Cw | Y | 650 | 30 | Fair | Sap rot |
| 4 | Cw | Y | 600 | 30 | Fair | Sap rot |
| 5 | Cw | Y | 550 | 30 | Fair | Sap rot |
| 6 | Cw | Y | 550 | 30 | Fair | Sap rot |
| 7 | Cw | Y | 570 | 30 | Fair | Sap rot |
| 8 | Cw | Y | 600 | 40 | Fair | Sap rot |

Stringers

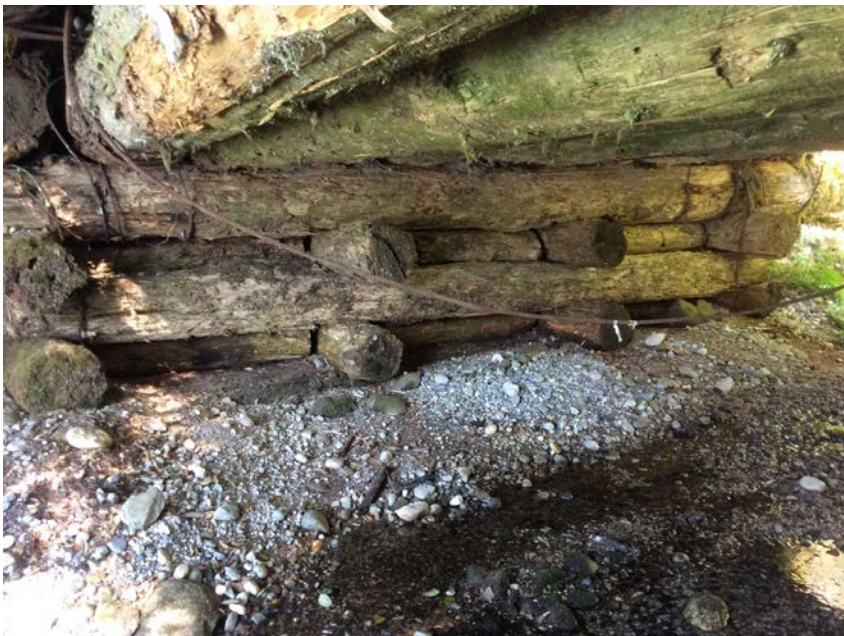
Right Bank Abutment when facing downstream

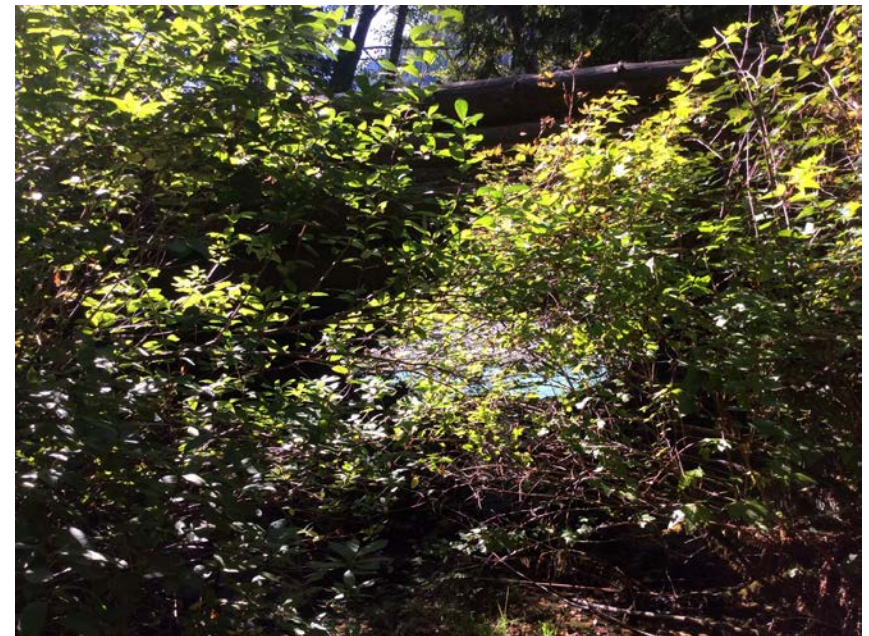
Upstream Profile
