CK-2266

STAVE RIVER 15.8km

2017 Inspection

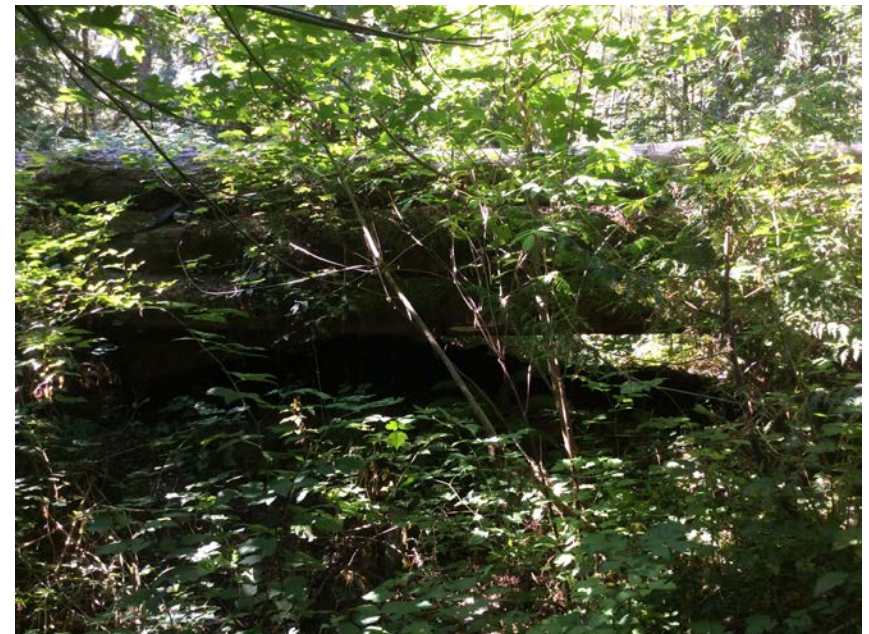
Upstream Profile

Continue with 30T load rating. Replace for industrial use.  
 Numerous conks on stringers. Structure is fairly low to ground so low risk to excavators Crossing to replace structure.  
 Possible 2nd layer of stringers

| 1 | Medium | Replace structure for industrial use. |

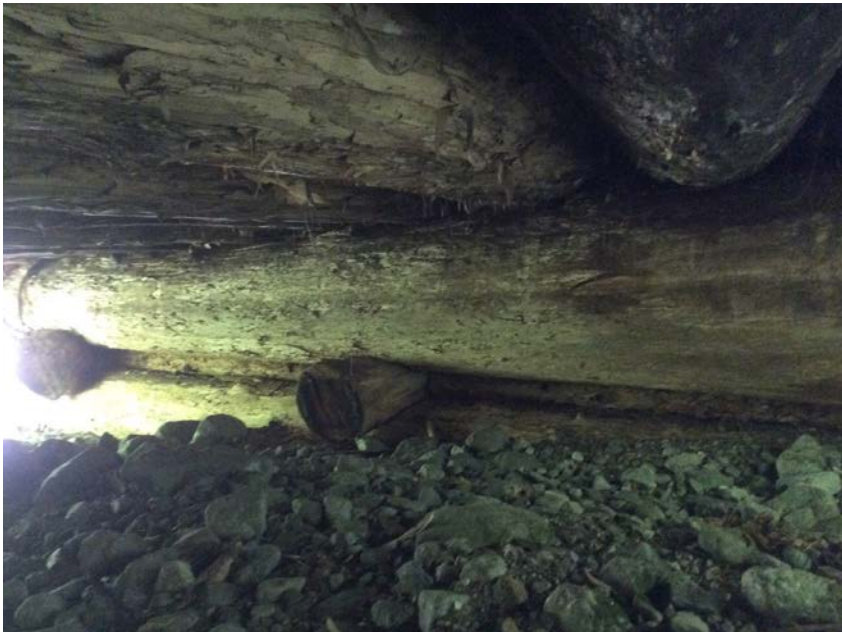
Right Bank Abutment when facing downstream

Log/Timber Cribs Poor Visibly rotten

Tie Backs Poor Visibly rotten
