CK-2267

STAVE RIVER 17.8km

2017 Inspection

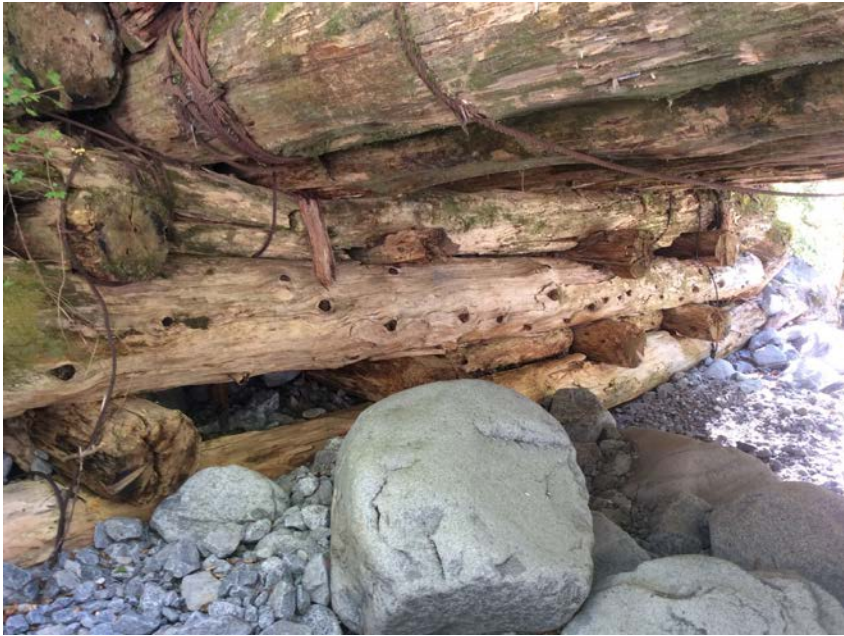
Left Bank Abutment when facing downstream

Log/Timber Cribs Poor Visibly rotten with face logs broken on left upstream side.

Tie Backs Poor Visibly rotten

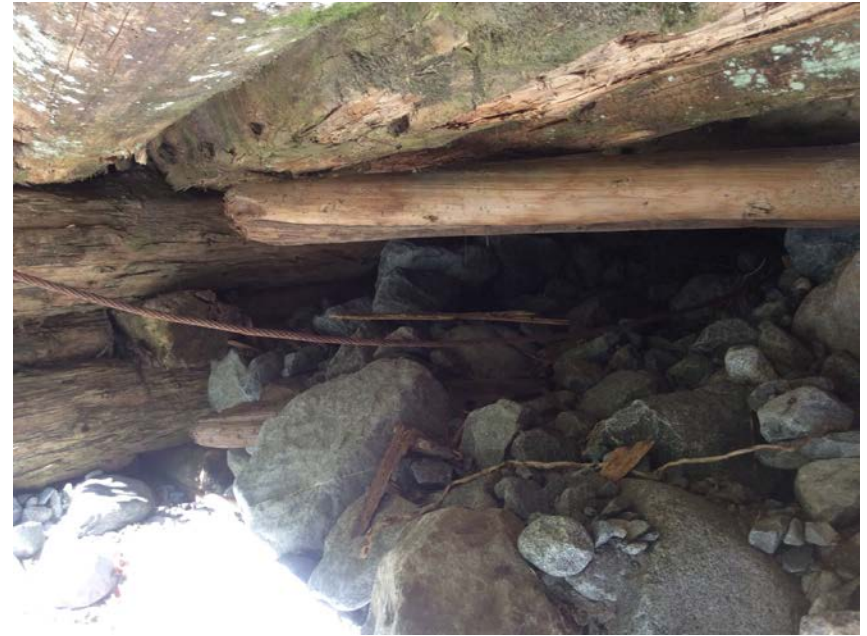
Right Bank Abutment when facing downstream

Comments Bedload buildup on right side of structure between crib and needlebeam

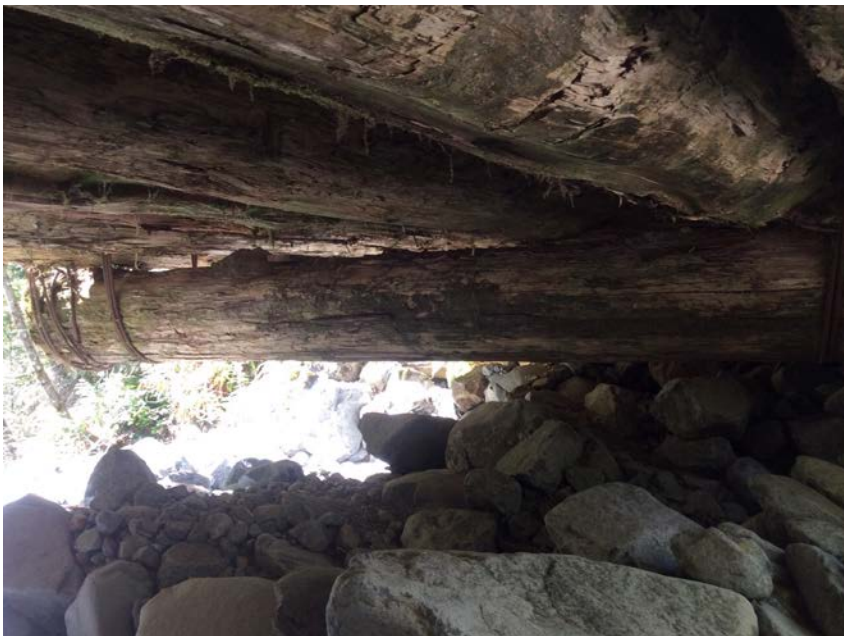
Needlebeam

Needle Beam Poor

Rotten and not shimmed to all stringers

Needle Lashing/  
Shimming Poor

Not shimmed to any stringers

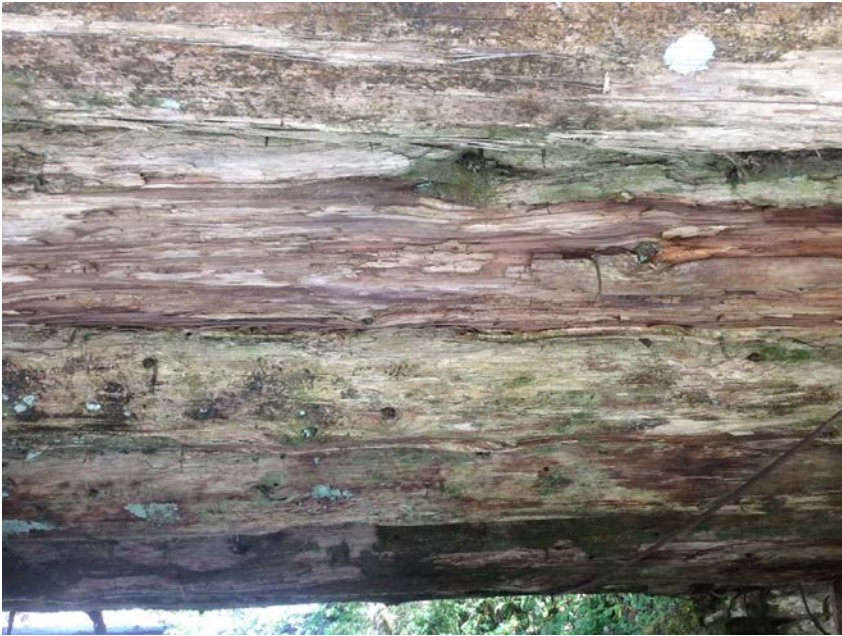
Replace structure. Continue with 10T load rating  
Possible second layer of stringers but unable to assess.  
Stringers not measured due to load rating and poor condition overall.

| 1 | Medium | Replace structure |
