CK-2268

STAVE RIVER 20km

2017 Inspection

| Structure Class | Major Culvert |

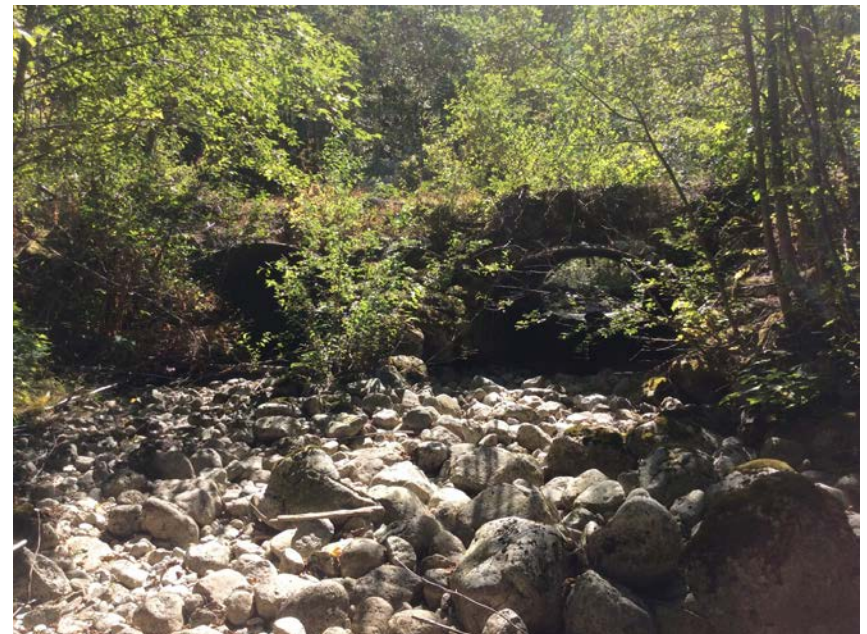
| Inlet | Good | |

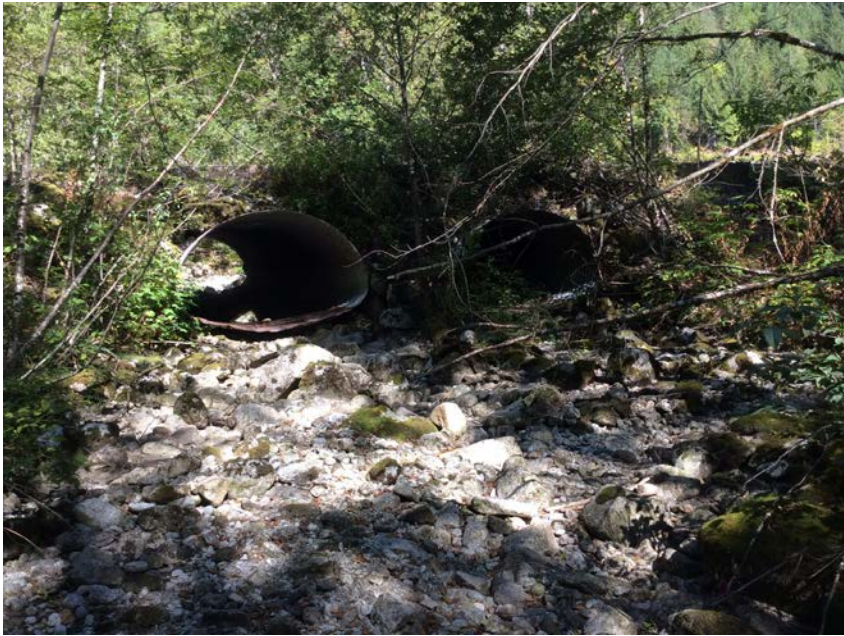
| Outlet | Fair | Right culvert has plugged pool and minor erosion under outlet. |
