CK-2270

STAVE RIVER 22.2km

2017 Inspection

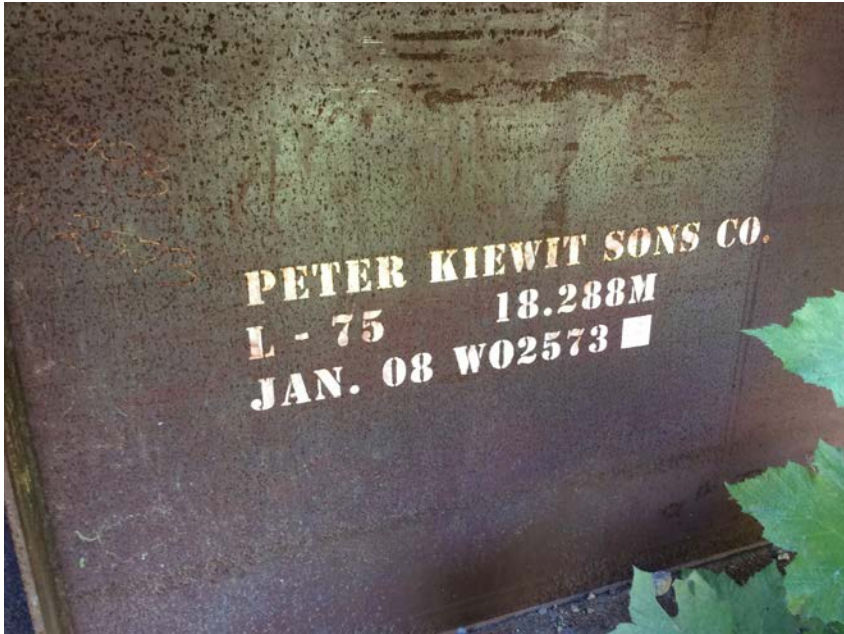
Structure Or Manufacturer ID

Serial/ID Plate WO2573 Jan 08 L75

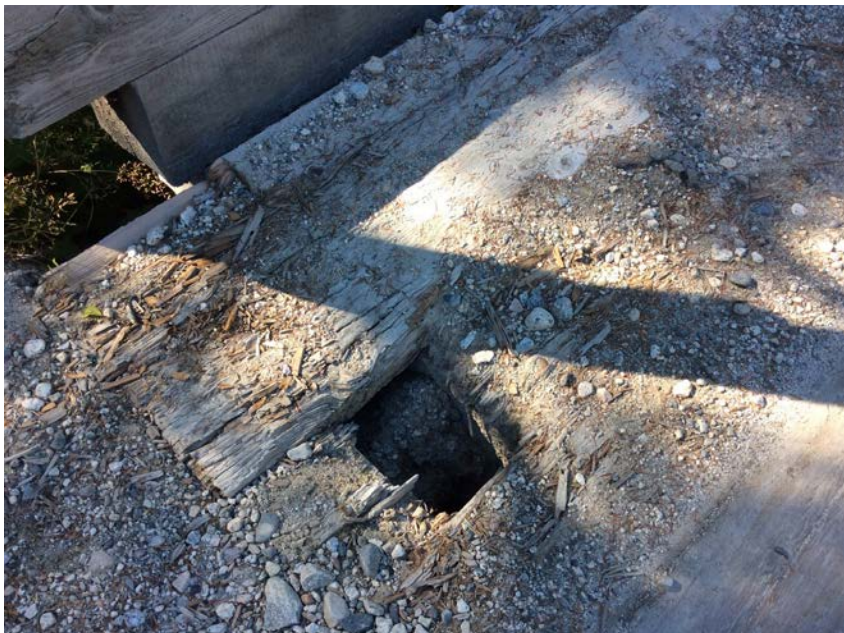
Deck

Running Planks Fair Small hole in right end deck panel

| Item | Priority | Repair Description |
|---|---|---|
| 2 | High | Replace rotten/missing section of plank - 100mm x 250mm x 3.05m |
