CK-2271

STAVE RIVER 24.6km

2017 Inspection

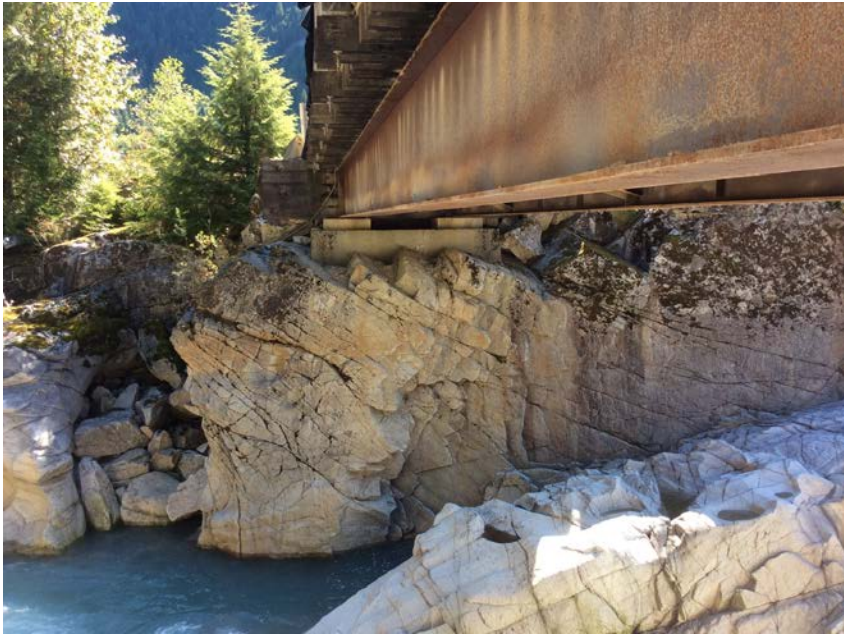
Right Bank Abutment when facing downstream

Cast in place pads on right side

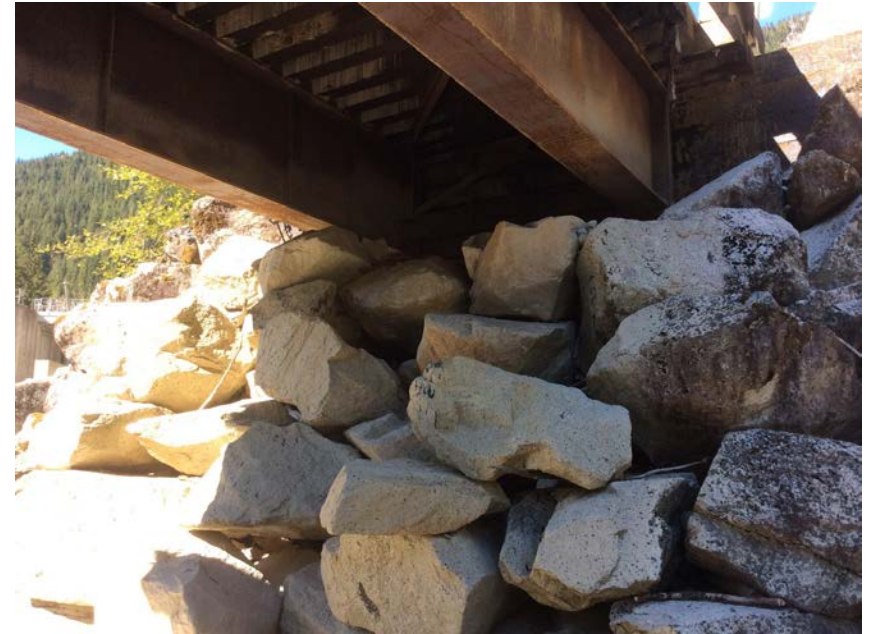
Left Bank Abutment when facing downstream

Post and pad on left side

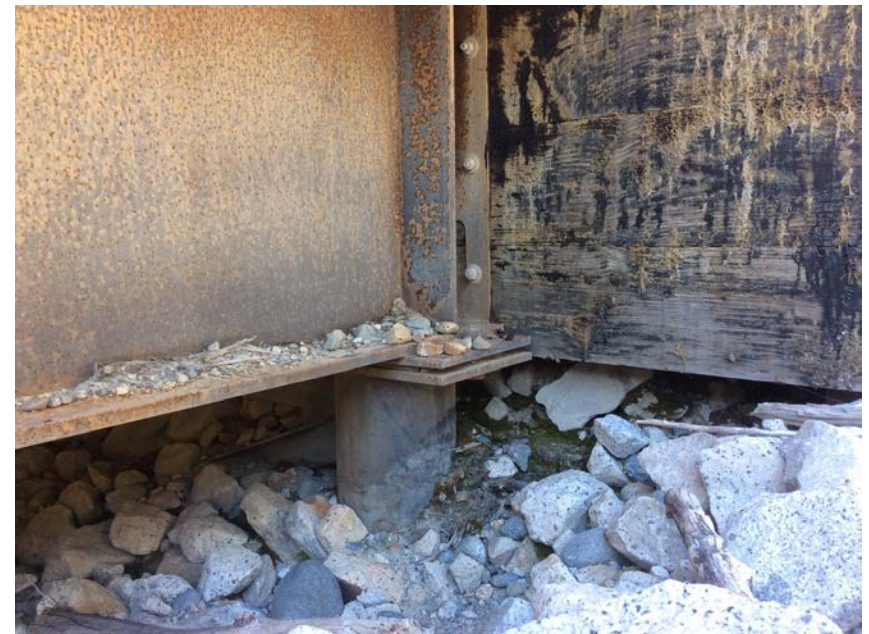
Bearing

Good

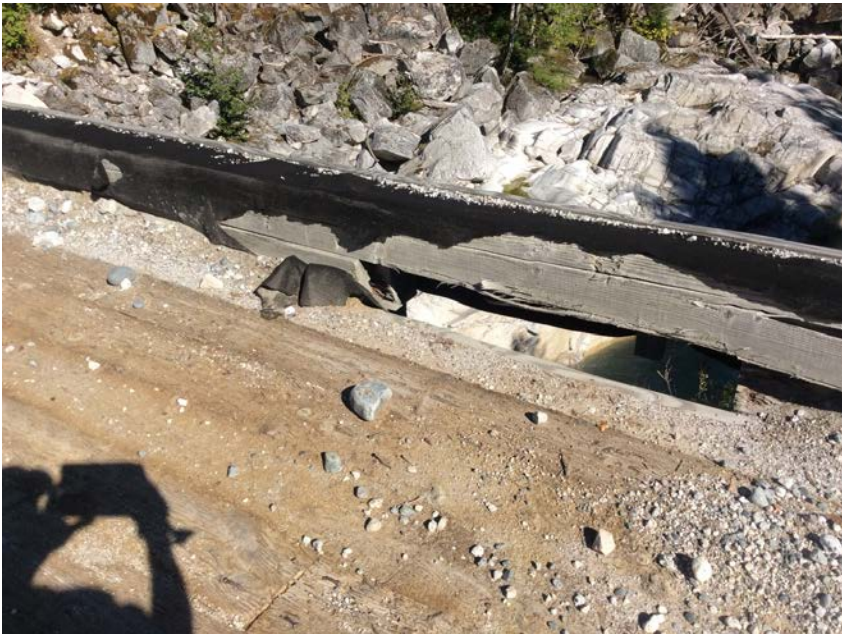
Guard Rail

| Curb Rail/Blocks/Posts | Fair | Woven geotextile is being used to try and keep gravel Fill from falling between guardrails and deck but it is torn in numerous places and not working. |

| Repair Item | Priority | Repair Description |
|---|---|---|
| 2 | Medium | Replace planks , 2 worn ties and guardrail system |
