CK-2272

STAVE RIVER 26.7km

2017 Inspection

| Structure Class | Major Culvert | | |

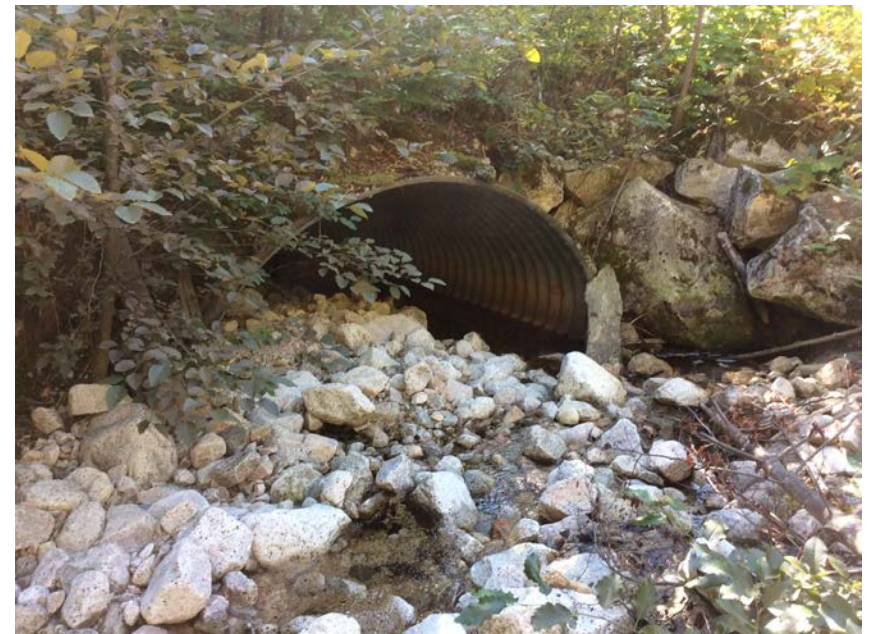
Good culvert but bedload has built up inside inlet of culvert due to angle of stream on approach. Stream has to turn 90 degrees to get into culvert and dumps its bedload.

| Embedment Materials | Poor | Inlet has infilled too much |

Comments Bedload has built up inside inlet.

Clean inlet and bedload from within the culvert. Monitor the bedload. Present load rating of L75 or 68 tonnes to continue.

| Item | Priority | Repair Description |
|---|---|---|
| 1 | Medium | Clean inlet and bedload from within the culvert |

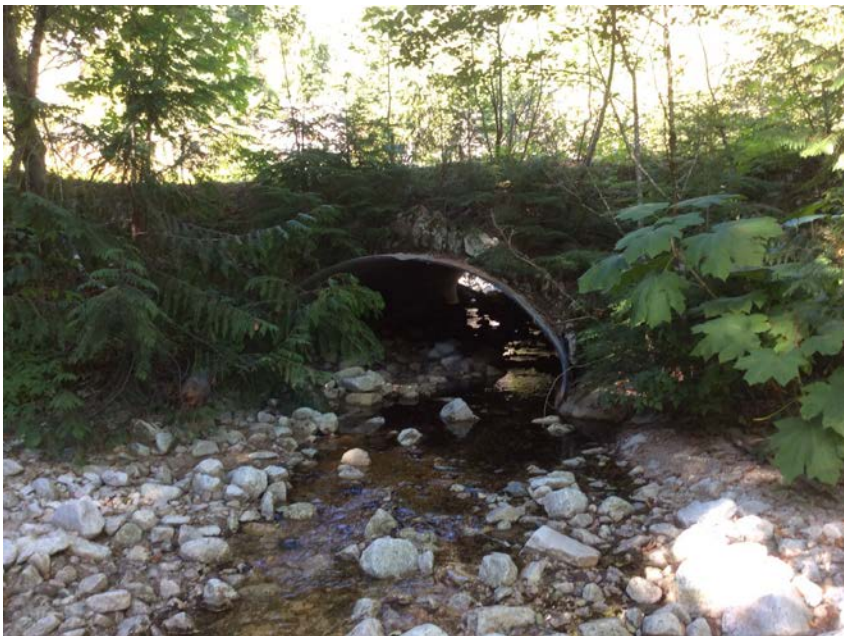
| Outlet | Good | |
