CK-2278

SUMALLO RIVER 1.4km

2017 Inspection

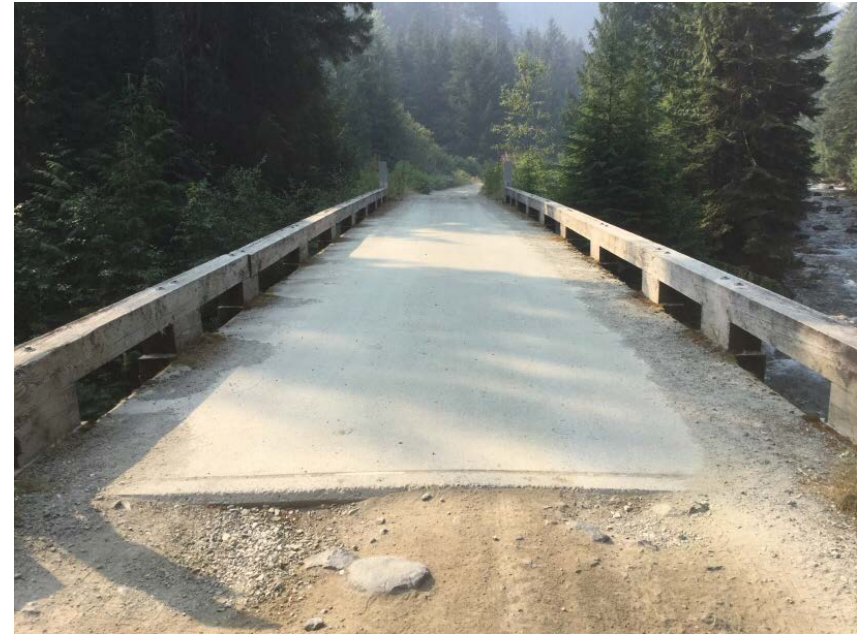
| Curb Rail/Blocks/Posts | Poor | Rotting risers and blocks |

| Hardware | Poor | Loose rail bolts |

| Overall Deck Condition | Poor | Due to rail condition |

1 Medium Replace guardrail, risers and blocks - traffic counter attached to riser upstream right bank

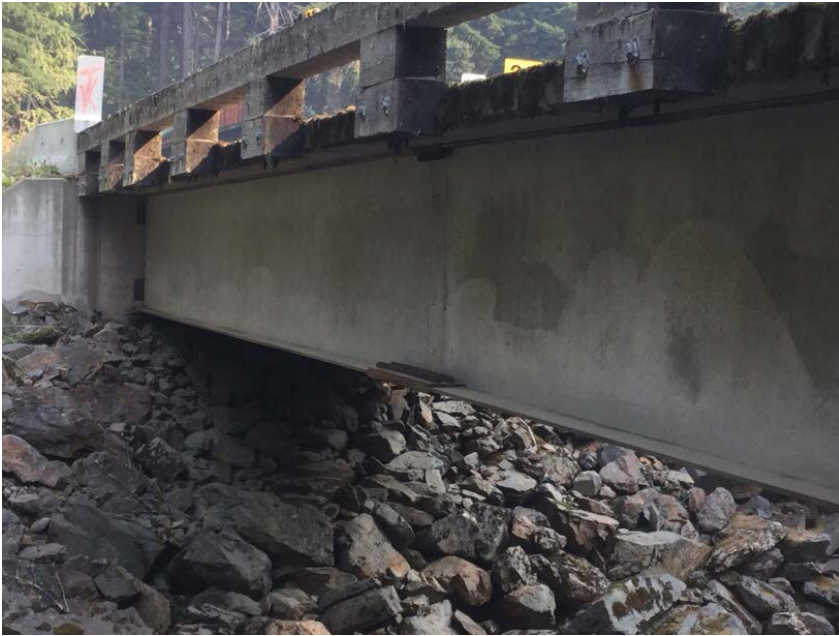
Splice plate on composite girders
