CK-2279

SUMALLO RIVER 4.7km

2017 Inspection

| Crossing Name | Tearse Creek (structure #11) |

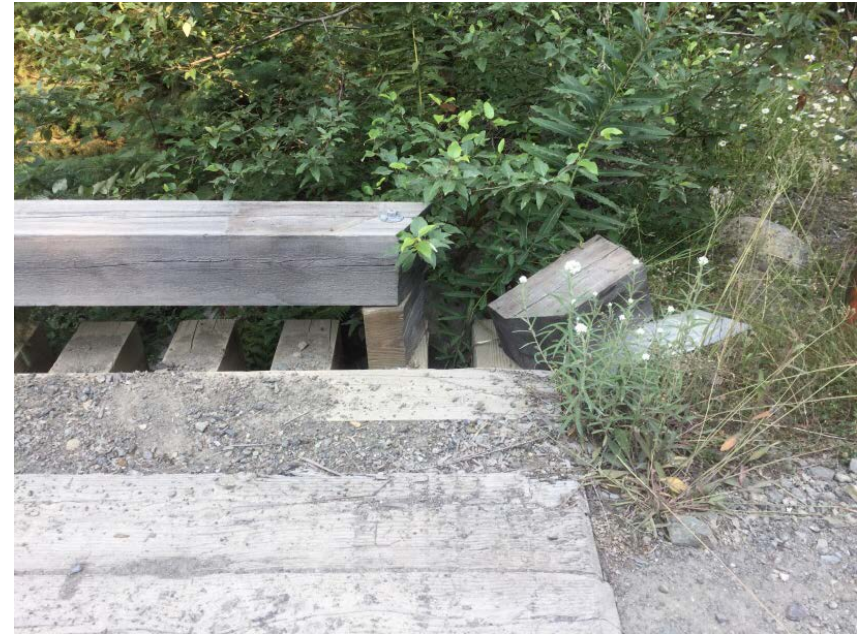
1 section of guardrail and 1 riser needs to be replaced

Guardrail bolts require tightening

Guardrail and riser damage

| Item | Priority | Repair Description |
|---|---|---|
| 1 | Medium | Replace 3m section of guardrail, 1 riser and tighten all guardrail bolts |
