CK-2284

TSILEUH CREEK 4.4km

2017 Inspection

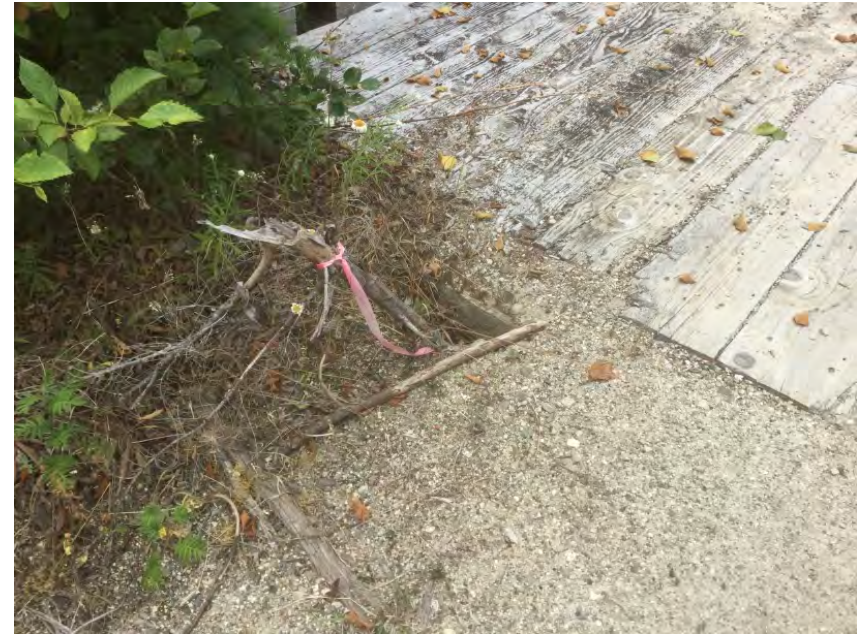
Eroding under crib at left bank, 80%

Failing fill at right bank

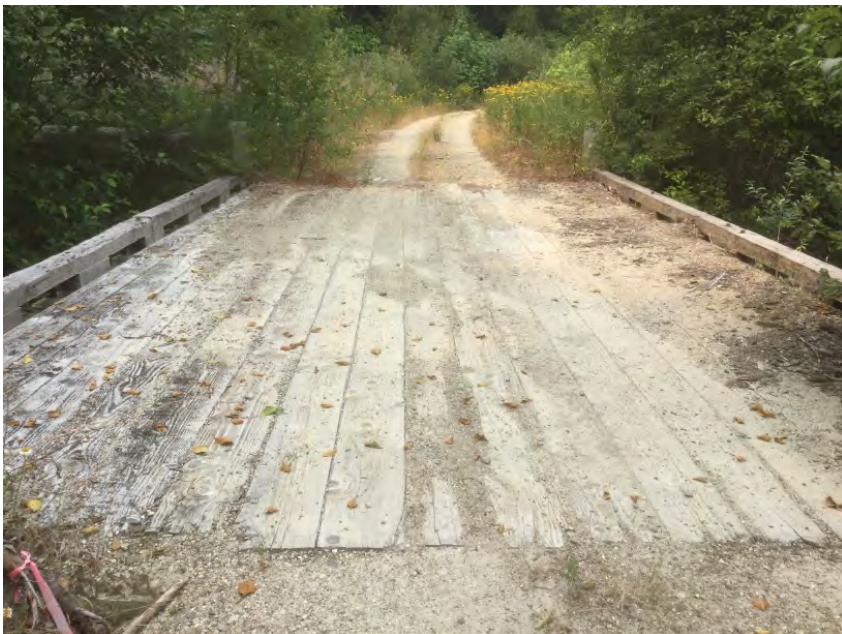
Overall Deck Condition

Poor

Rotten

Deck

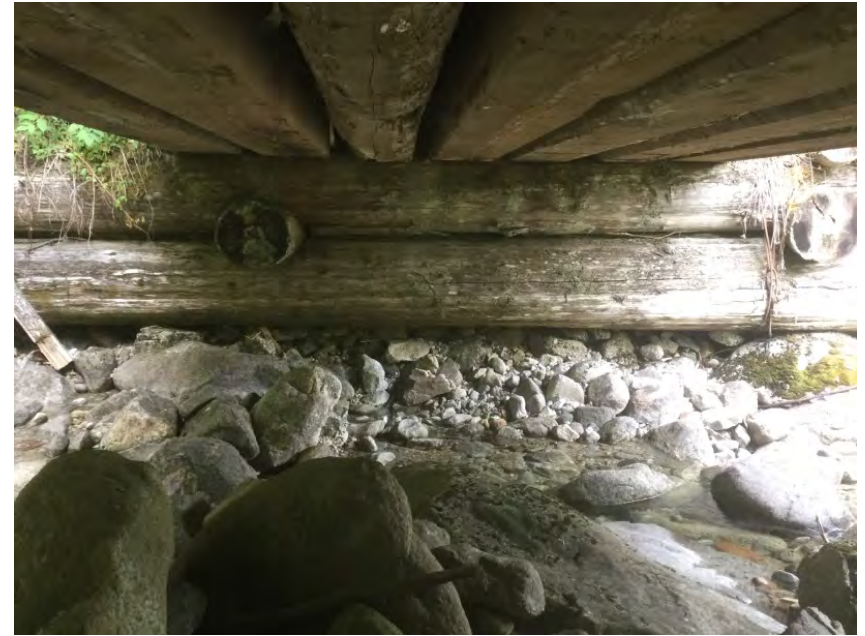
Left Bank Abutment when facing downstream

Log/Timber Cribs Fair

Face logs have up 50mm sap rot

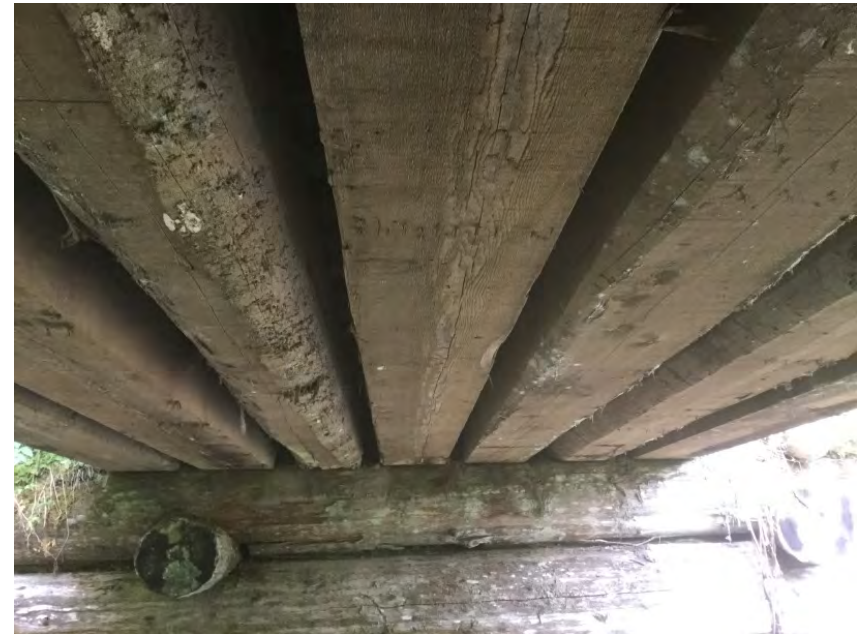
Stringers

All stringers in poor condition

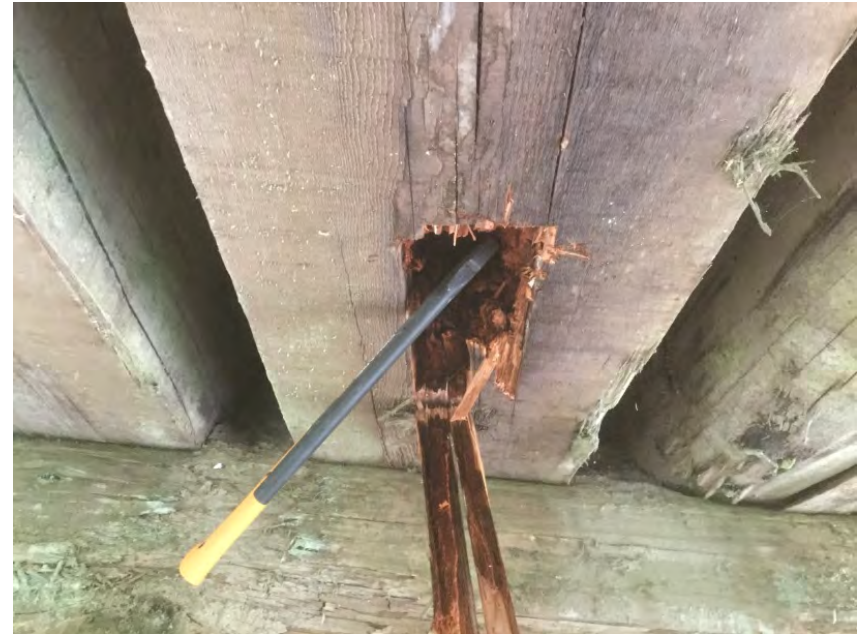
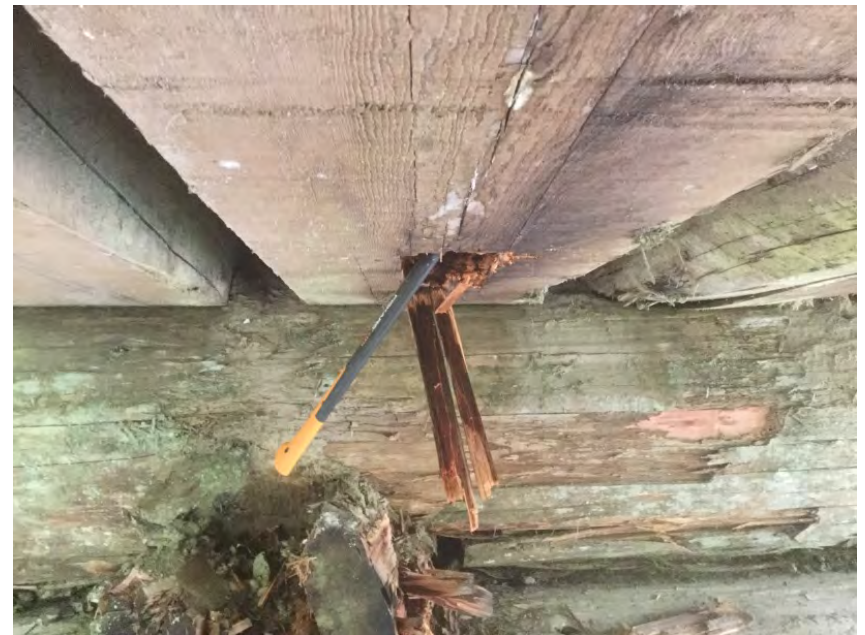
| Stringer<br>Number | Species | Peeled | Diameter<br>(mm) | Rot Depth<br>(mm) | Condition | Comment |
|---|---|---|---|---|---|---|
| 2 | Fd | Y | 670mm x 620mm | | Poor | rotten |

Stringer 2 condition

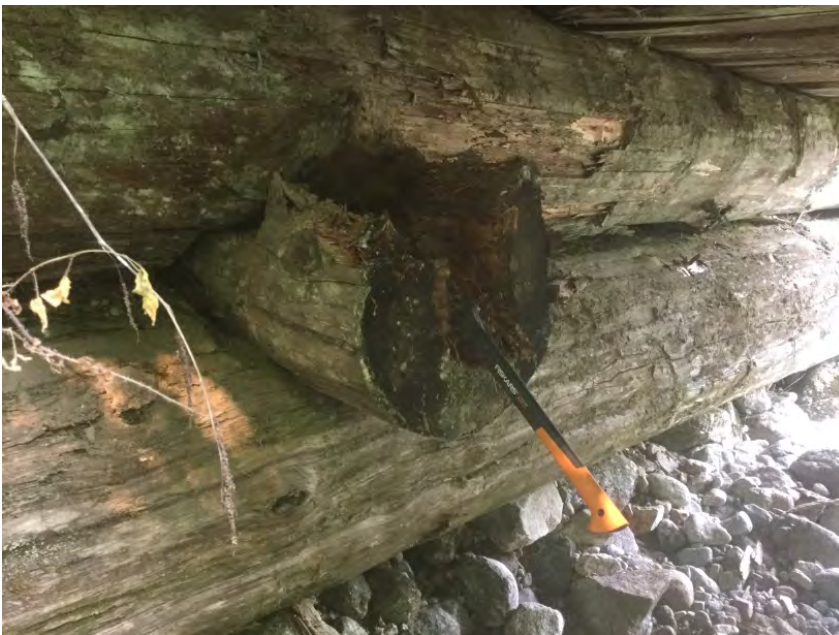
Tie Backs Poor

3x and rotting

Tieback condition on left abutment

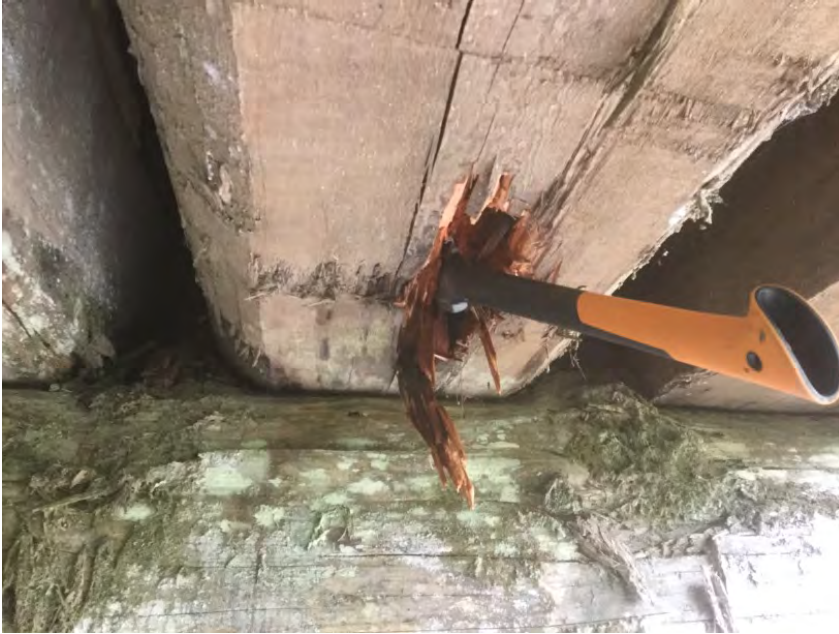
| Stringer<br>Number | Species | Peeled | Diameter<br>(mm) | Rot Depth<br>(mm) | Condition | Comment |
|---|---|---|---|---|---|---|
| 6 | Fd | Y | 670mm x 620mm | | Poor | rotten |

Stringer 6 condition

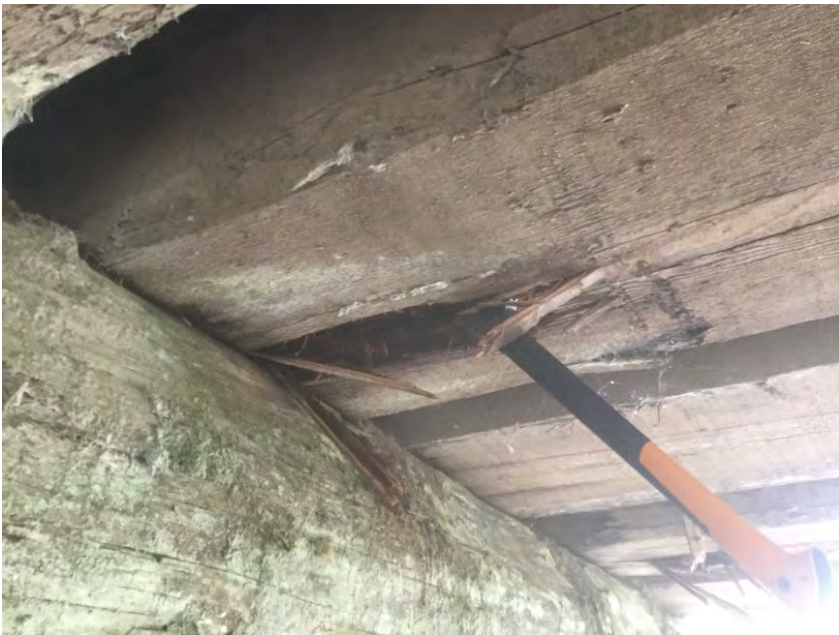
| Stringer<br>Number | Species | Peeled | Diameter<br>(mm) | Rot Depth<br>(mm) | Condition | Comment |
|---|---|---|---|---|---|---|
| 4 | Fd | Y | 670mm x 620mm | | Poor | rotten |

Stringer 4 condition
