CK-2291

UZTLIUS CREEK 17.7km

2017 Inspection

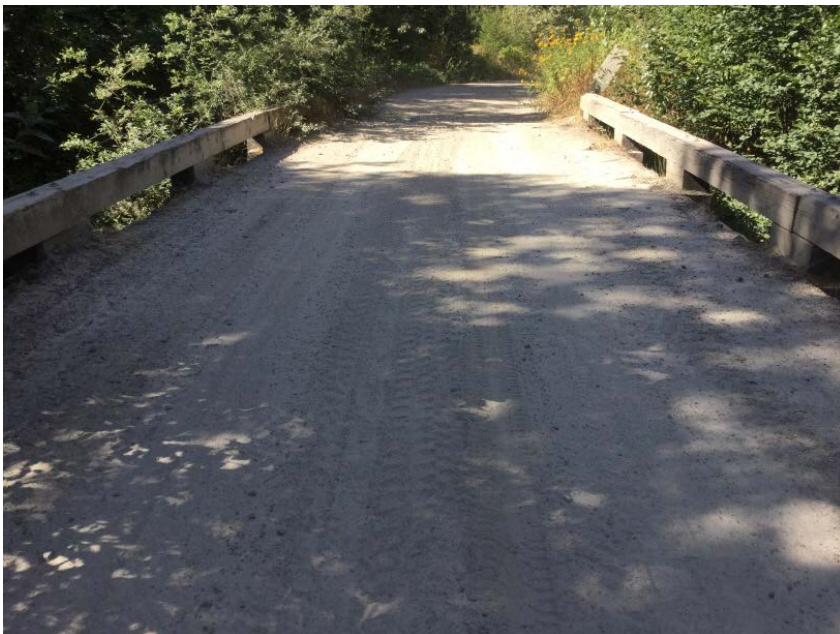
Deck

Running Surface Fair

| Repair | | Repair Description |
|---|---|---|
| 3 | Low | Clean sediment off deck and post bridge ahead signs |

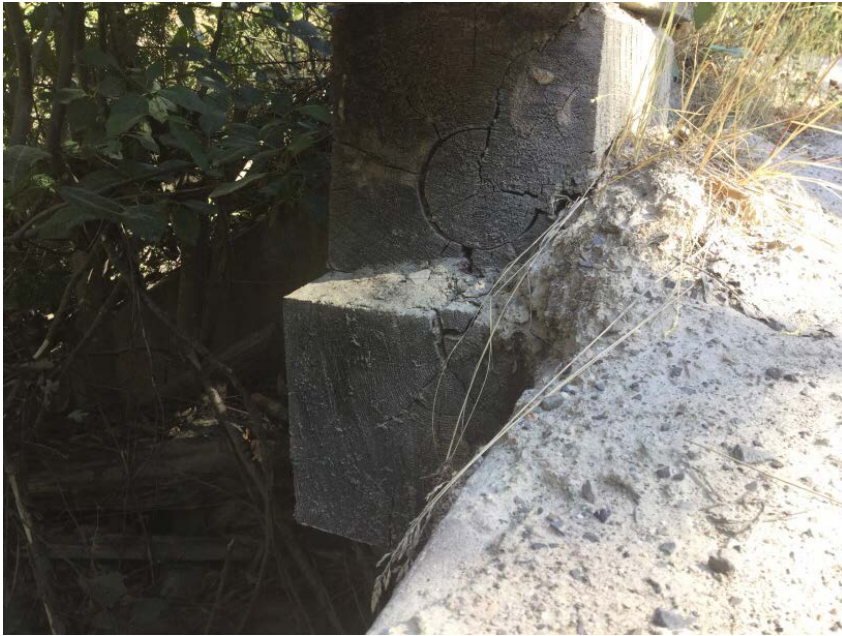
Curb Rail/Blocks/Posts Poor Rotting and loose

Hardware Poor loose rail bolts

Overall Deck Condition Poor Due to rail condition

Riser and block condition - typical

| Repair | | Repair Description |
|---|---|---|
| 1 | Medium | Replace guardrail, risers and blocks |

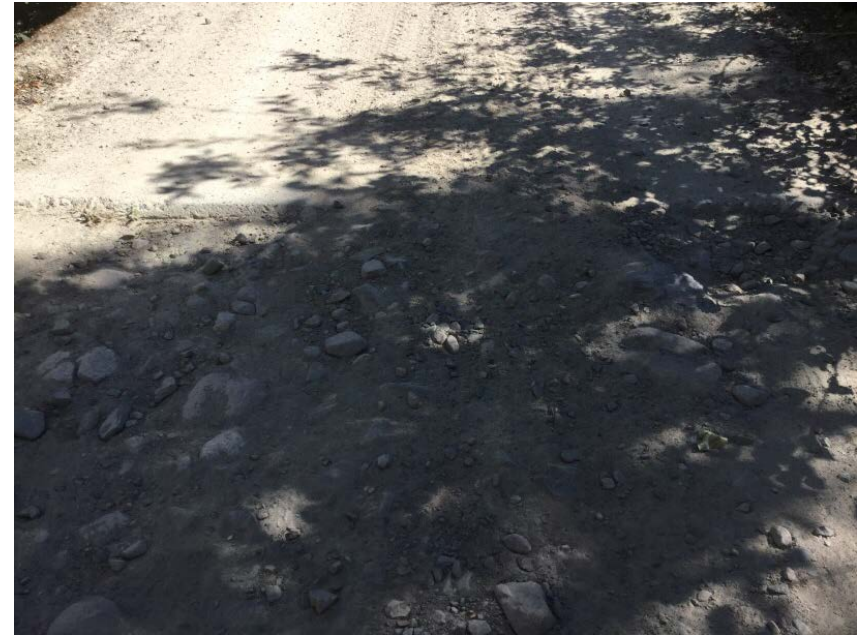
Potholes left approach

| Repair | | Repair Description |
|---|---|---|
| 2 | Medium | Brush and grade approaches |

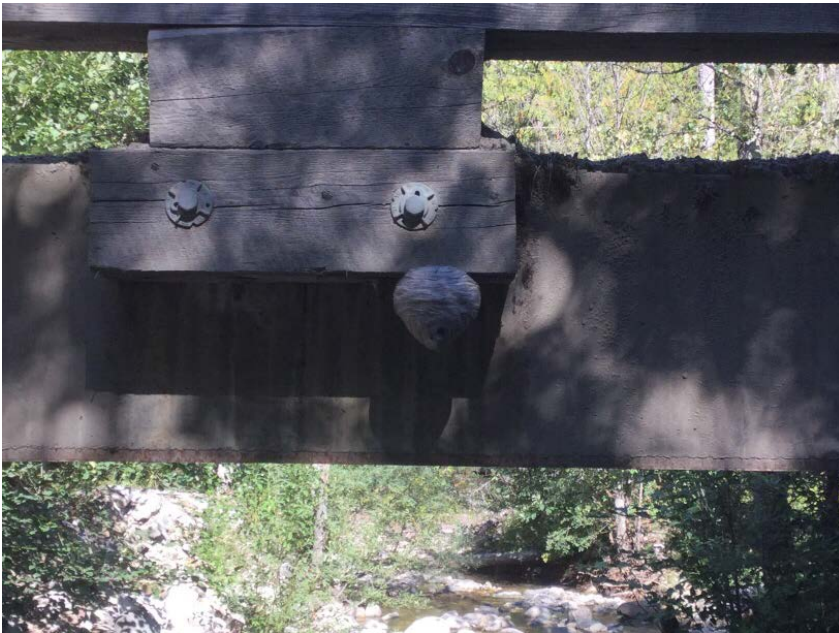
Bee hive
