CK-2296

UZTLIUS CREEK 24.5km

2017 Inspection

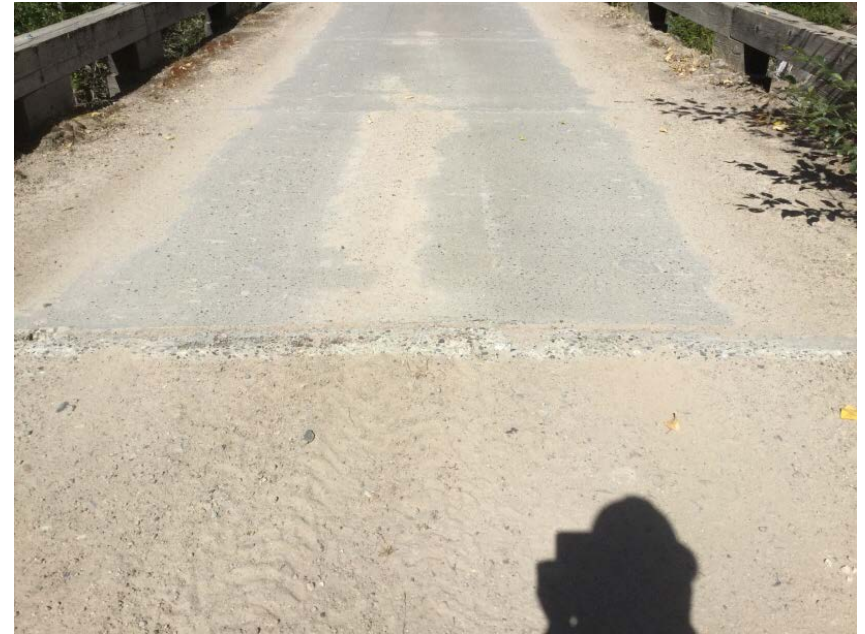
Curb Rail/Blocks/Posts      **Poor**      rot in risers and sideblocks

Hardware      **Fair**Overall Deck Condition      **Poor**      due to riser and sideblock condition

| Item | Priority | Repair Description |
|---|---|---|
| 1 | Medium | Replace guardrail, risers and blocks |

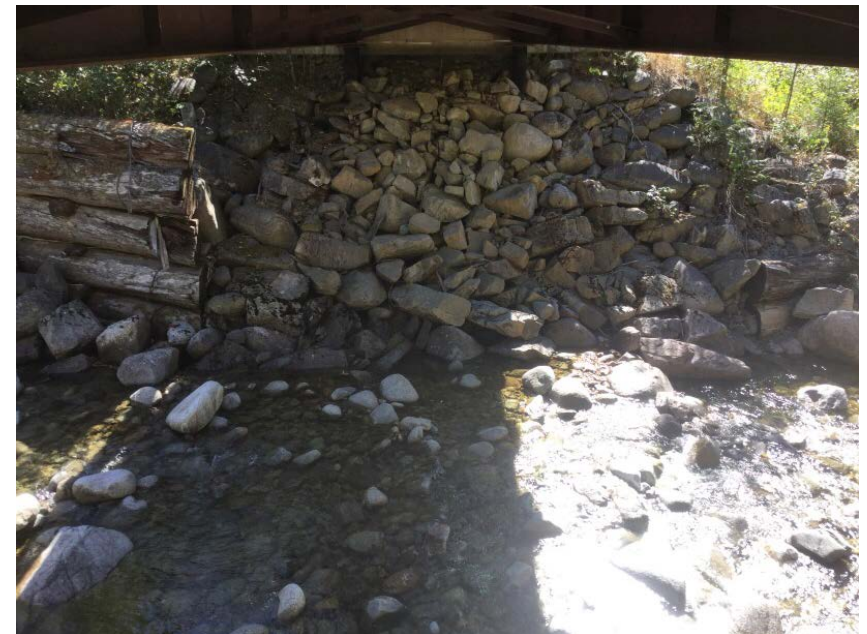
Left Bank Abutment when facing downstream

Bracing Good Only on left bank

Riprap Good Steep at left bank. 1.25:1
