CK-2297

UZTLIUS CREEK 25.9km

2017 Inspection

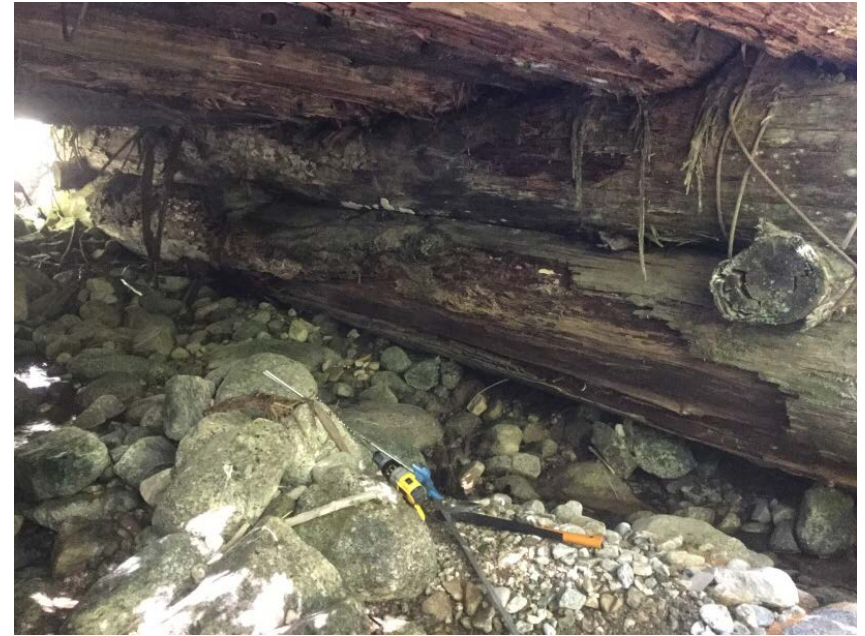
Left Bank Abutment when facing downstream

Log/Timber Cribs Poor Fd face logs with fruiting bodies visible and min 150mm sap rot

Tie Backs Poor Rotten and shearing off

Riprap Poor None in front of cribs

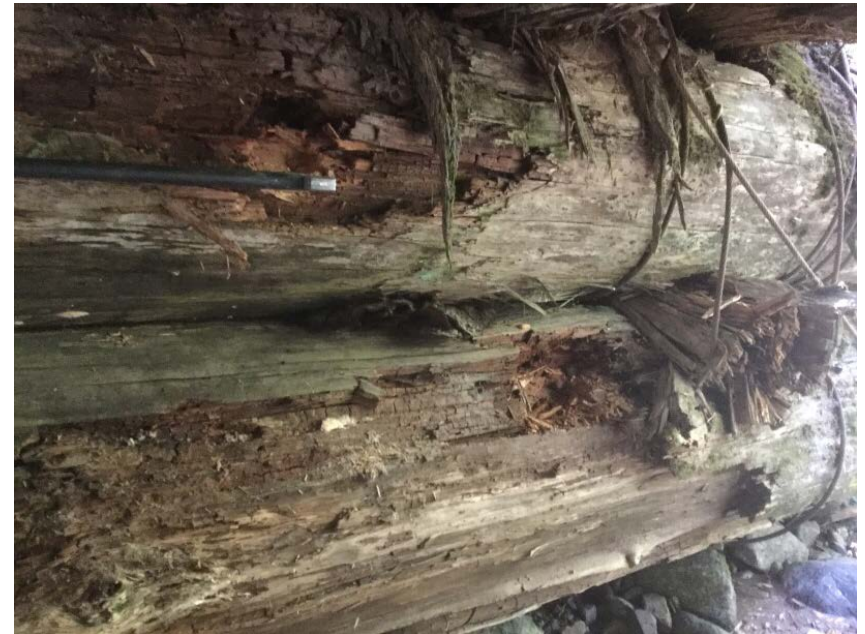
Cribs in poor condition, greater than 150mm sap rot
