CK-2300

UZTLIUS CREEK 13.4km

2017 Inspection

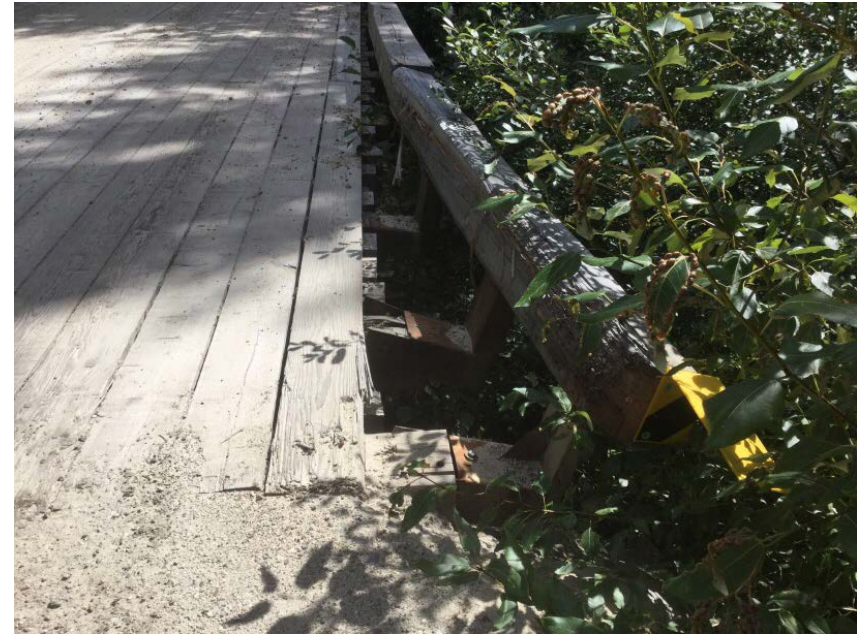
Curb Rail/Blocks/Posts Fair Damaged downstream right approach

Damaged guardrail at downstream right approach

| Repair Item | Priority | Repair Description |
|---|---|---|
| 2 | High | repair damaged section of guardrail |

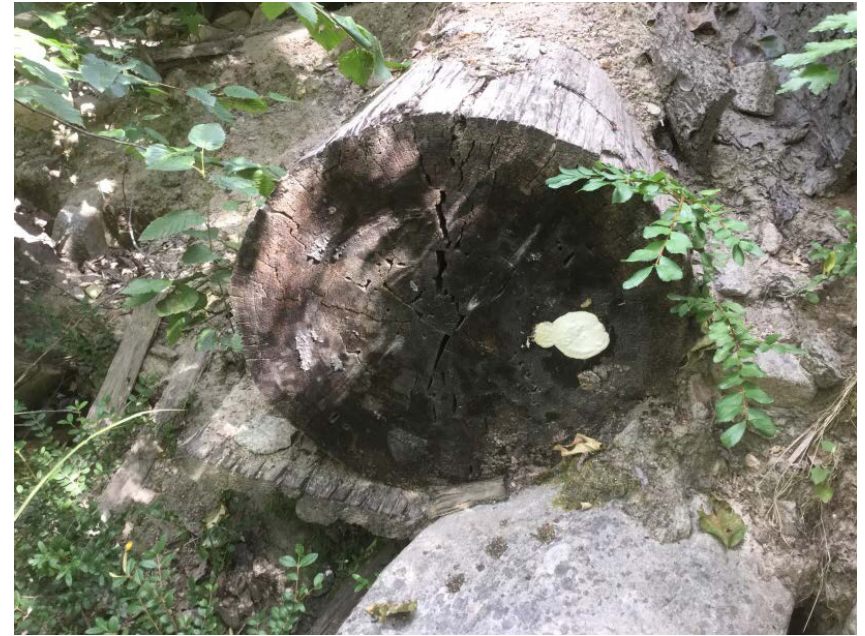
Caps or Sills Poor Significant sap rot at ends

Log sill at left bank in poor condition

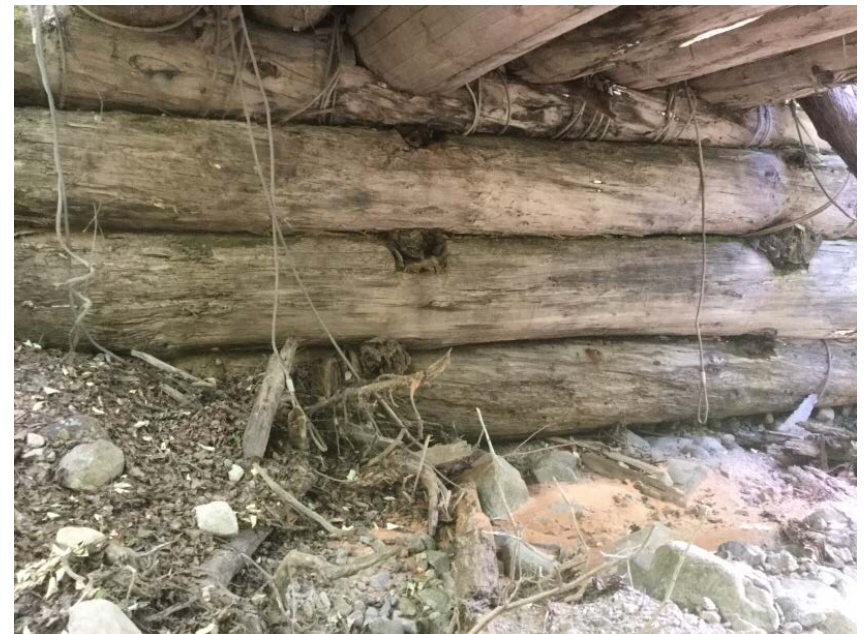
Log/Timber Cribs Poor on old structure log stringer structure and are containing fill for the overlaying steel girder structure. Both end are scoured

Left Bank Abutment when facing downstream

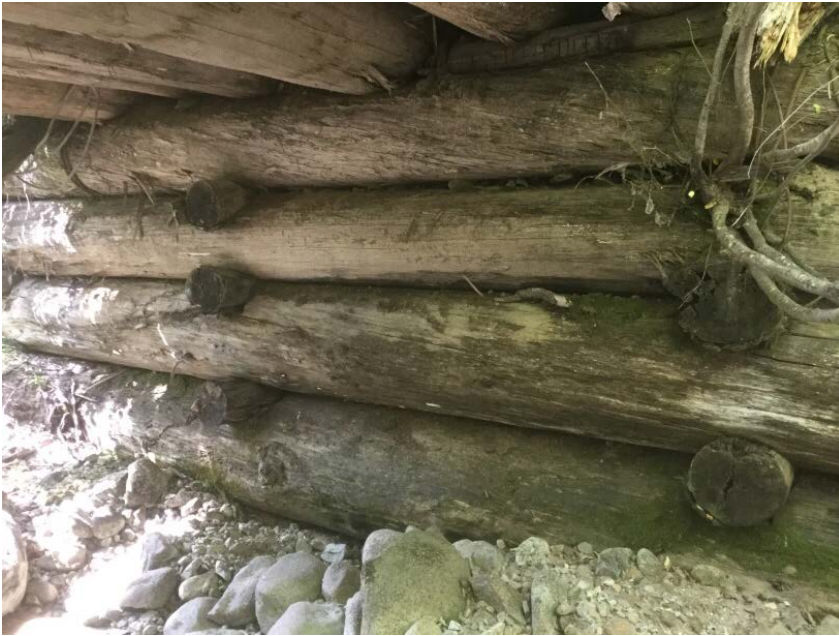
Right Bank Abutment when facing downstream

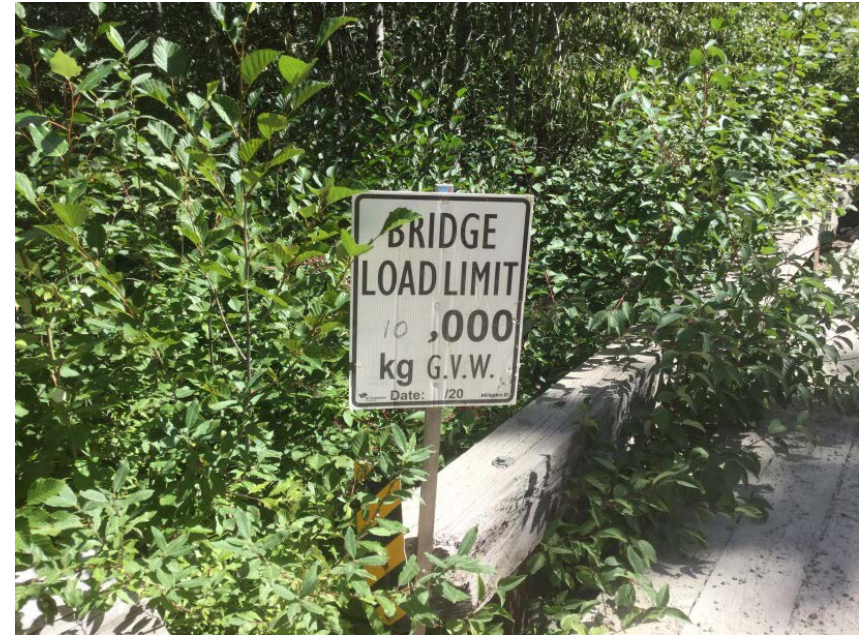
Load Rating Sign

Posted Load Rating 10 Tonnes

| Repair Item | Priority | Repair Description |
|---|---|---|
| 3 | High | update load rating sign |

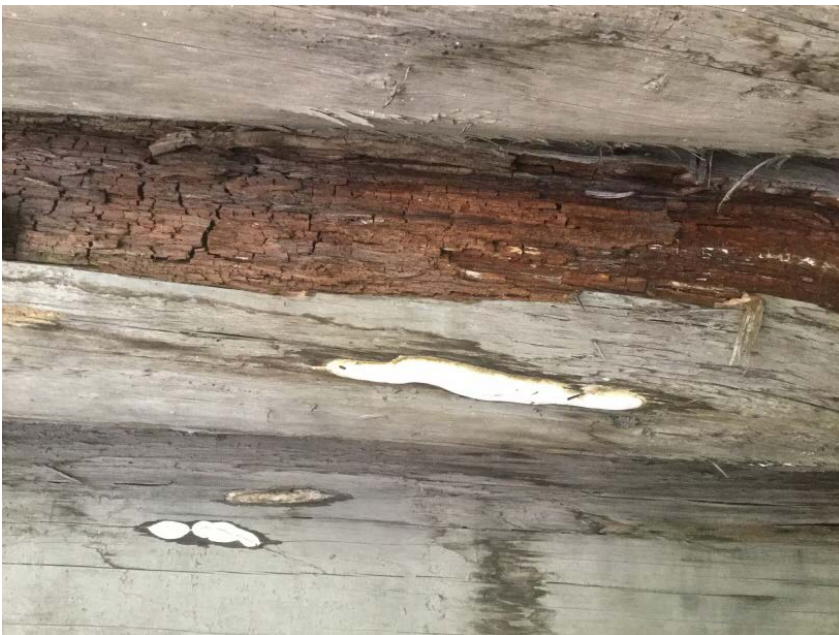
Monitor old stringers for failure

All stringers rotten

Log stringer condition

| Repair Item | Priority | Repair Description |
|---|---|---|
| 1 | High | remove or replace the entire structure |
