CK-2319

GARNET CREEK 9km

2017 Inspection

| Structure Class | Temporary Bridge |

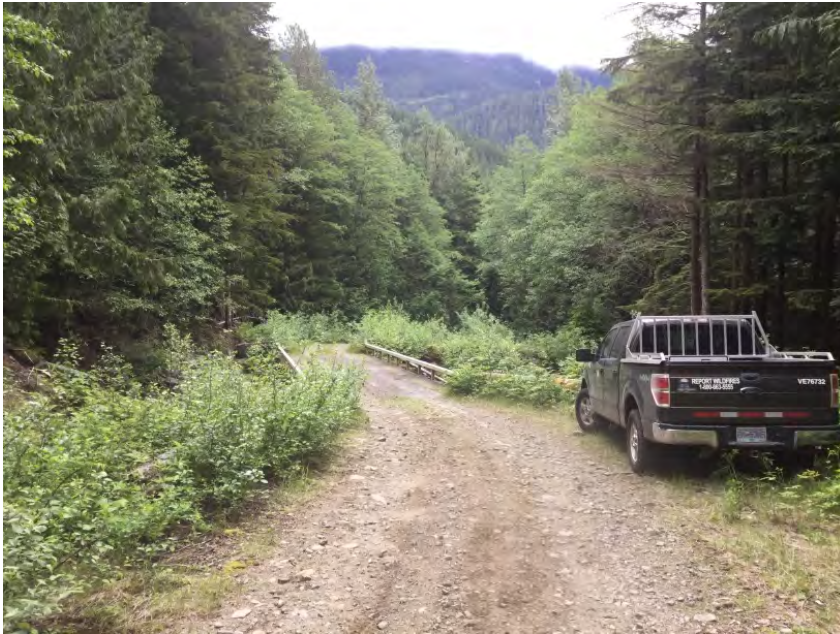
Approach from Right Bank when facing downstream

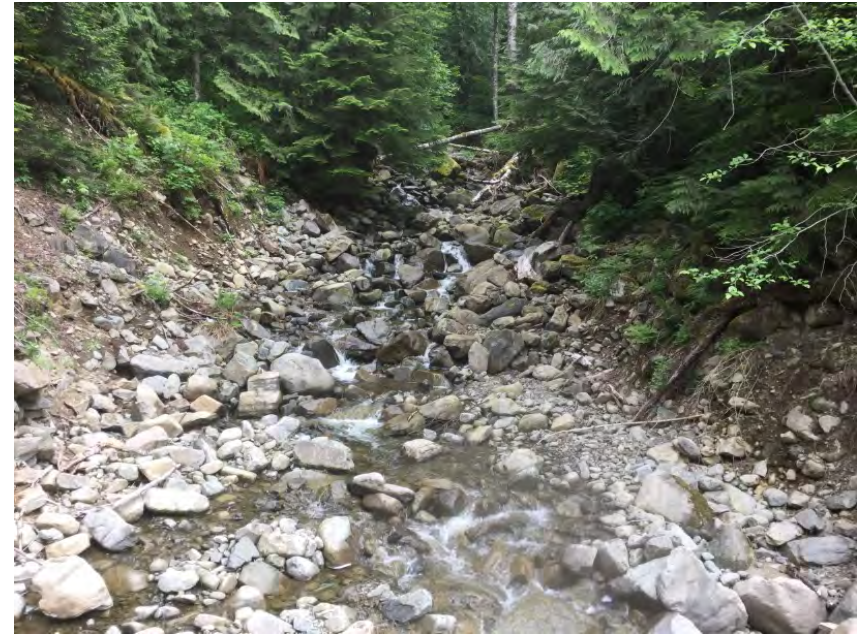
Looking upstream from deck

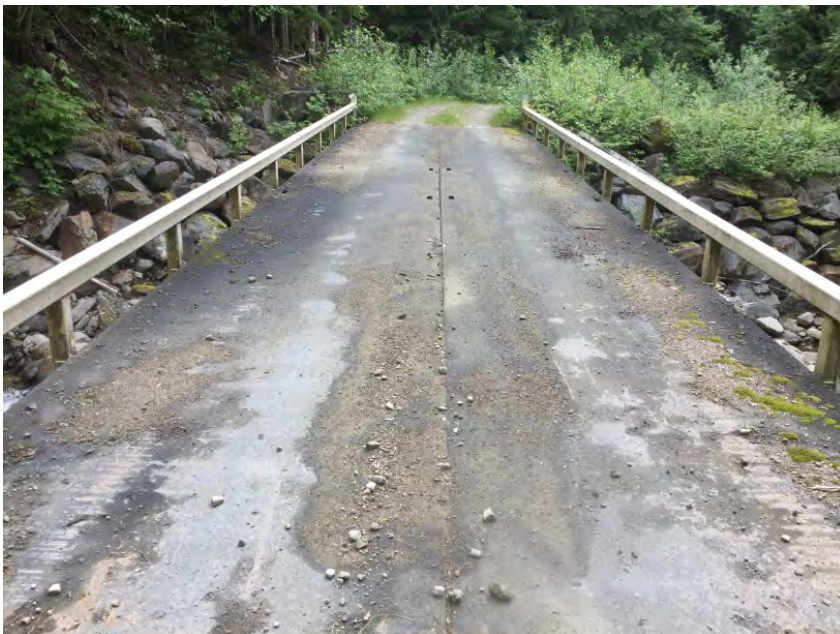
Deck

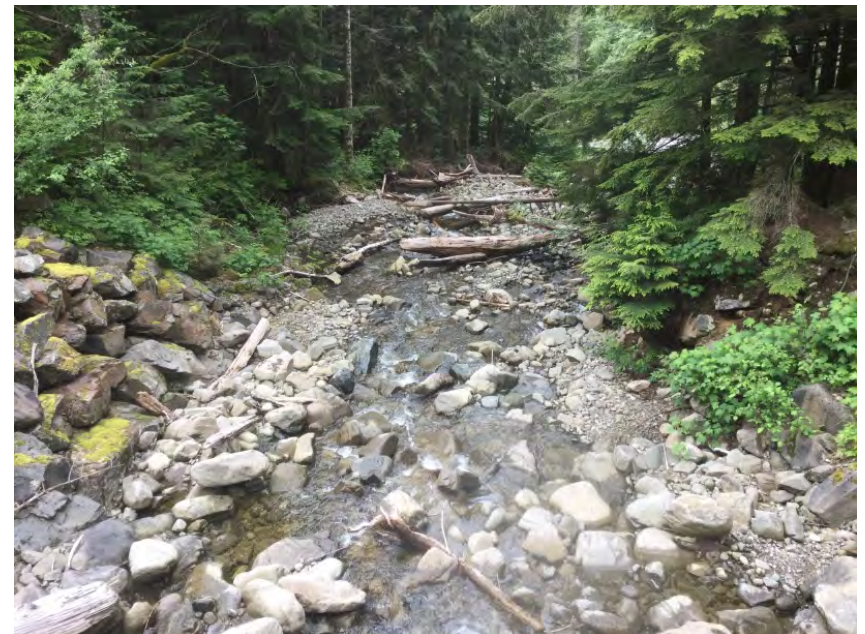
Looking downstream from deck

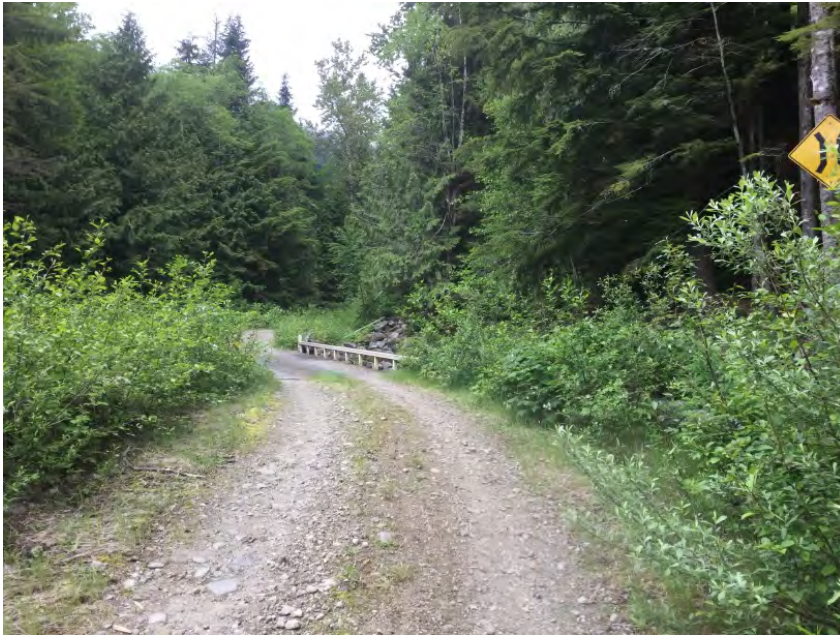
Approach from Left Bank when facing downstream

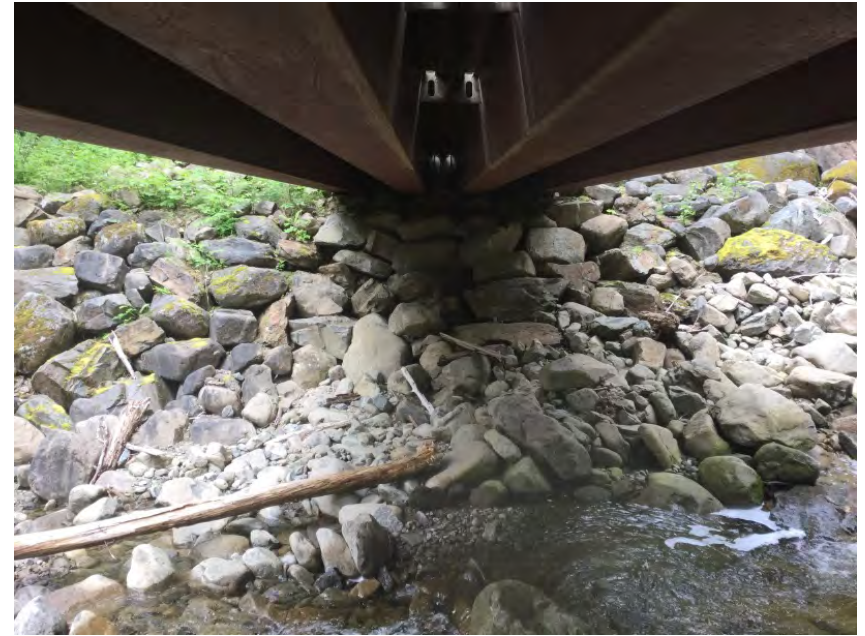
Right Bank Abutment when facing downstream

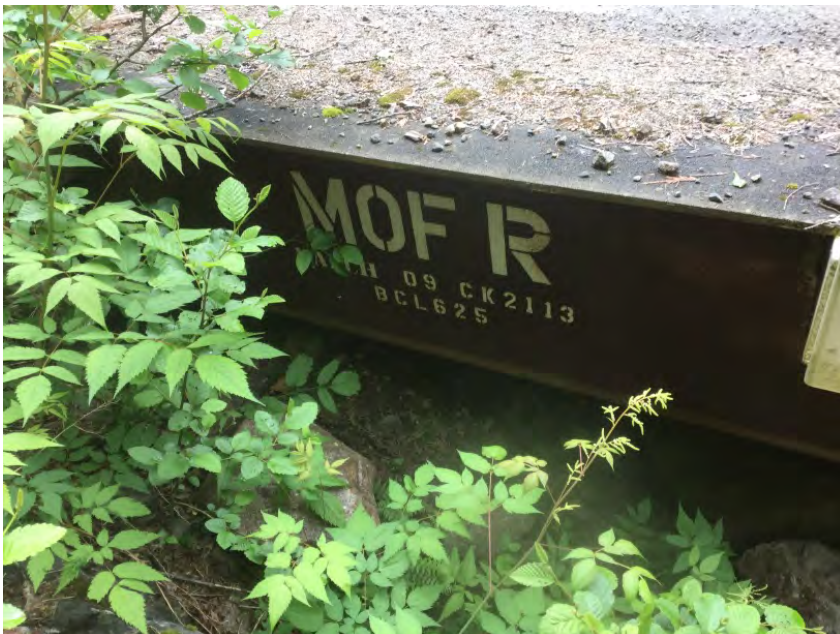
Structure ID - wrong site ID

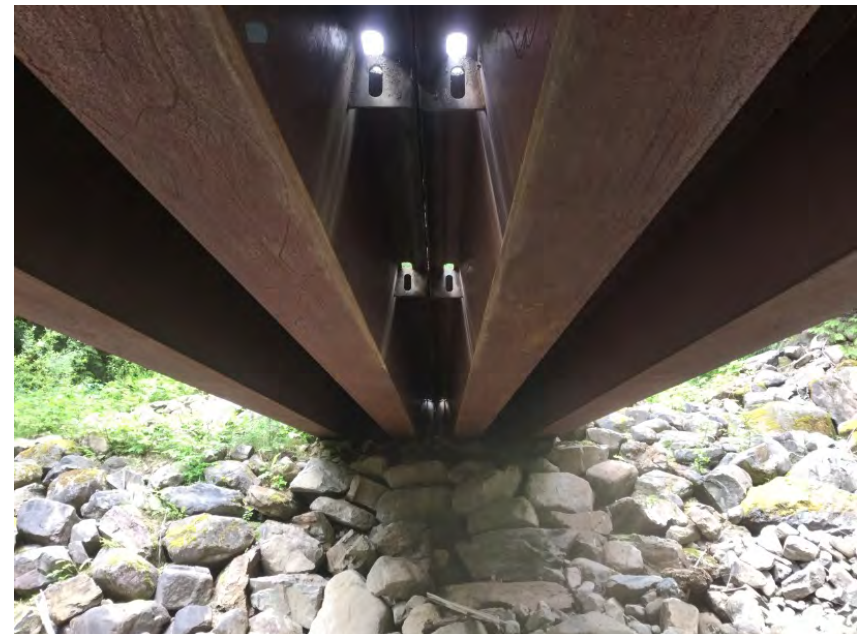
Superstructure
