CK-2320

NAHATLATCH 22.5km

2017 Inspection

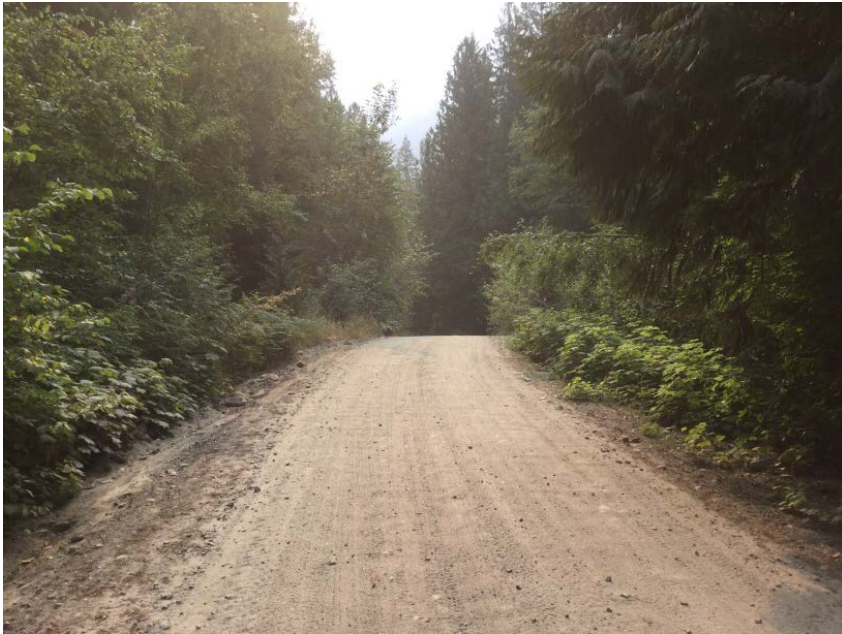
Brushing Required Y

Approach from Right Bank when facing downstream

| 1 | Medium | Brush approaches |

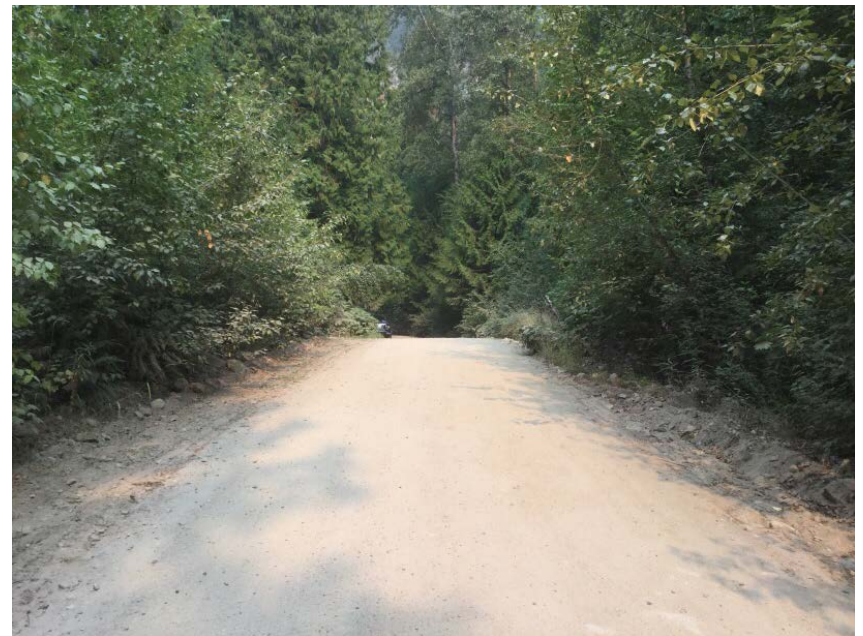
Approach from Left Bank when facing downstream

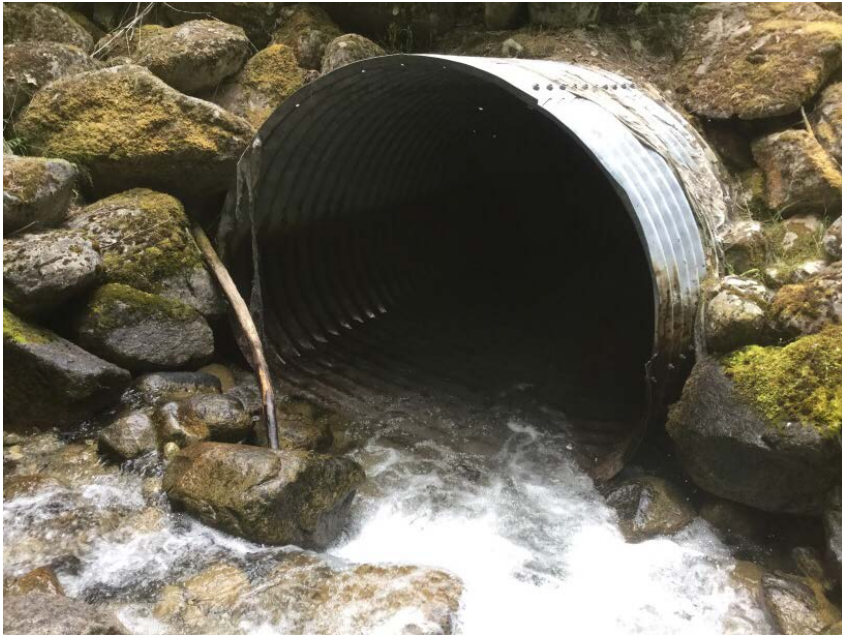
Inlet

Monitor the aggradation at the inlet and scour at the outlet

| Item | Monitor Description | Frequency |
|---|---|---|
| 1 | aggrading inlet | Routine inspection |

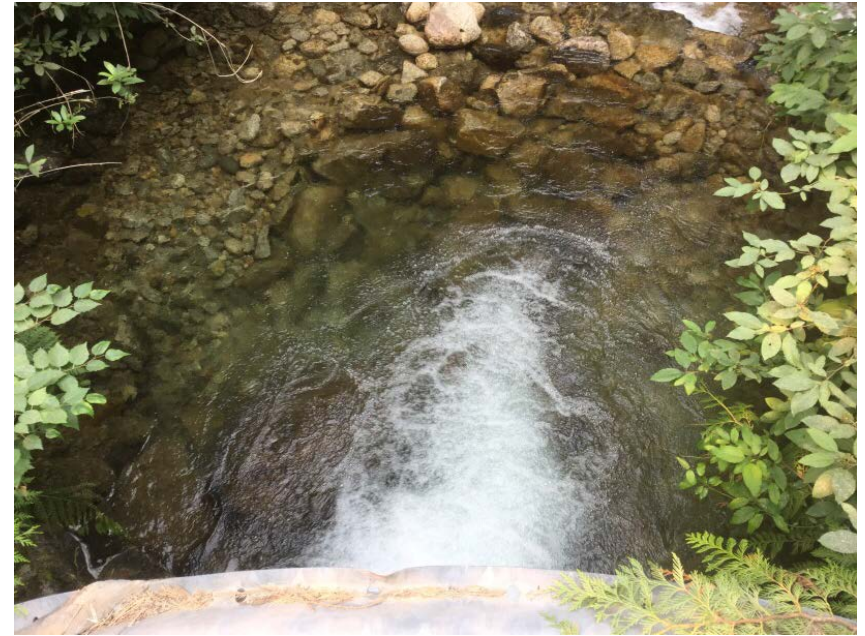
Outlet

Fair

Scoured 0.5m but still functional

| 2 | outlet scour | Routine inspection |

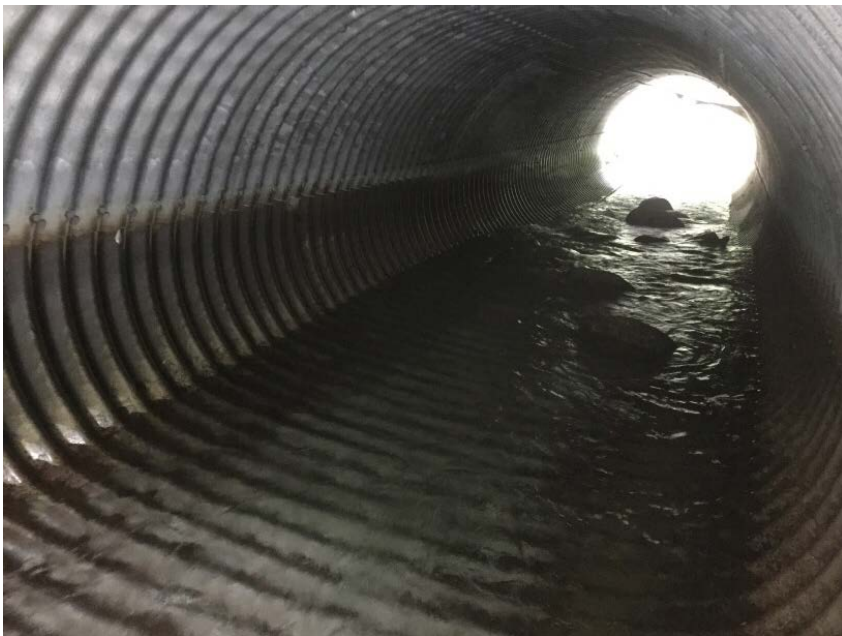
minor rust on the floor

Looking through culvert from inlet
