CK-2332

STAVE RIVER 1.4km

2017 Inspection

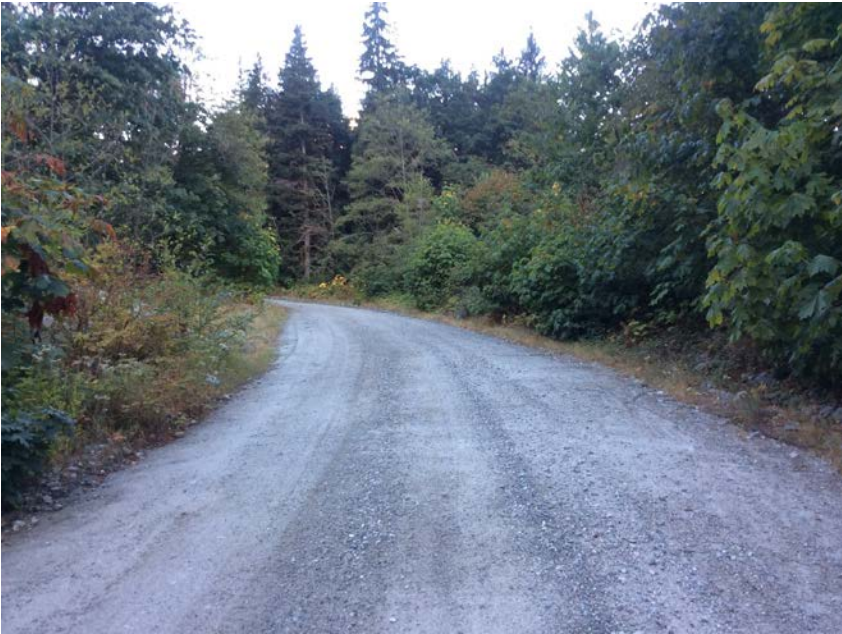
Left approach viewed from bridge

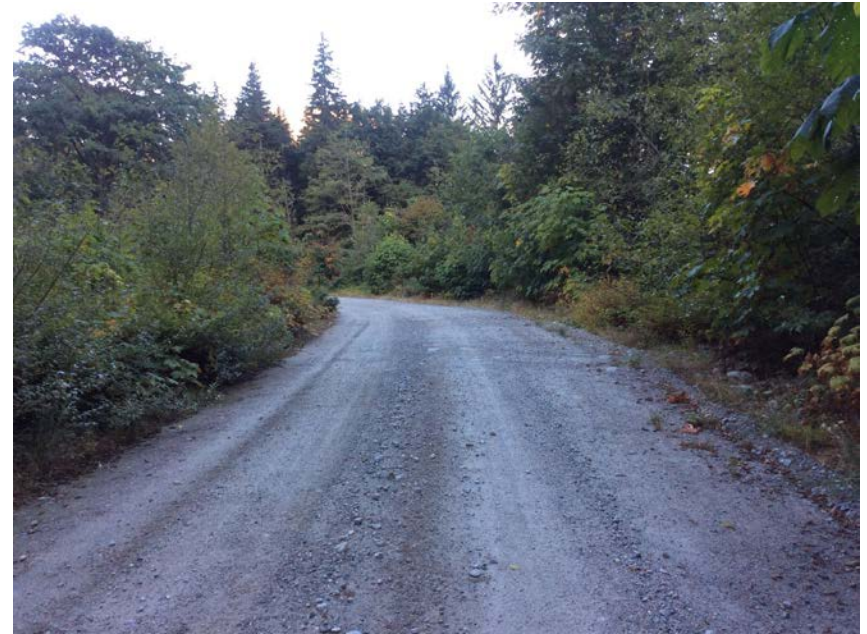
Approach from Right Bank when facing downstream

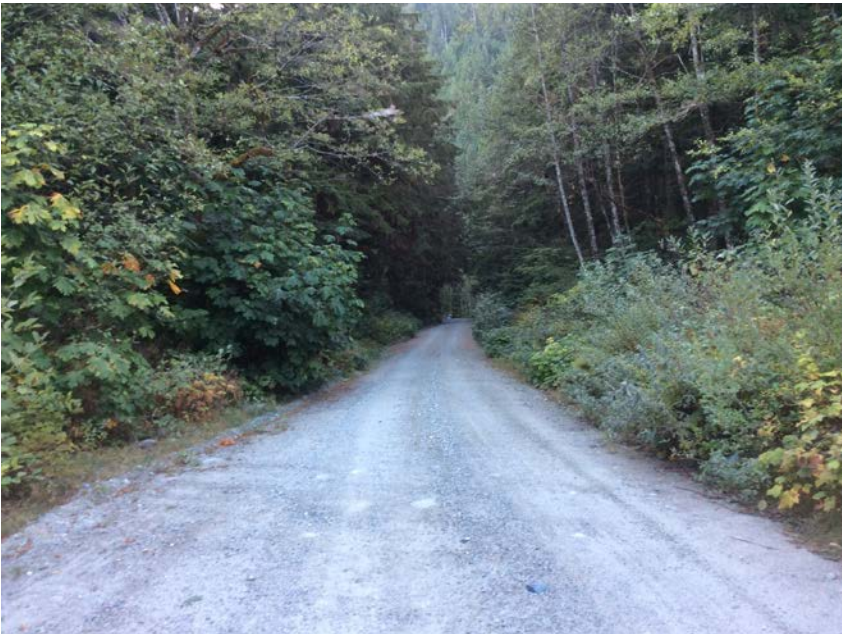
Right approach viewed from bridge

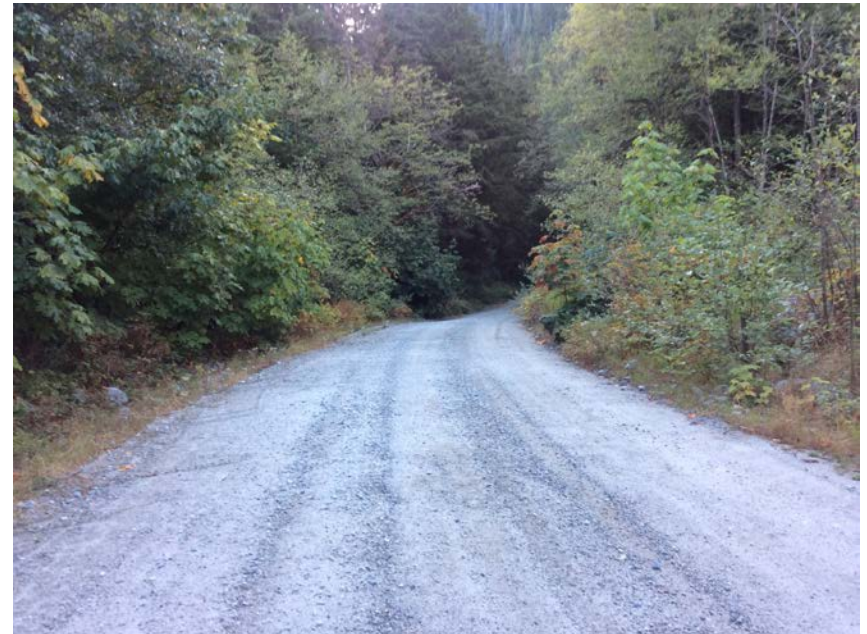
Approach from Left Bank when facing downstream

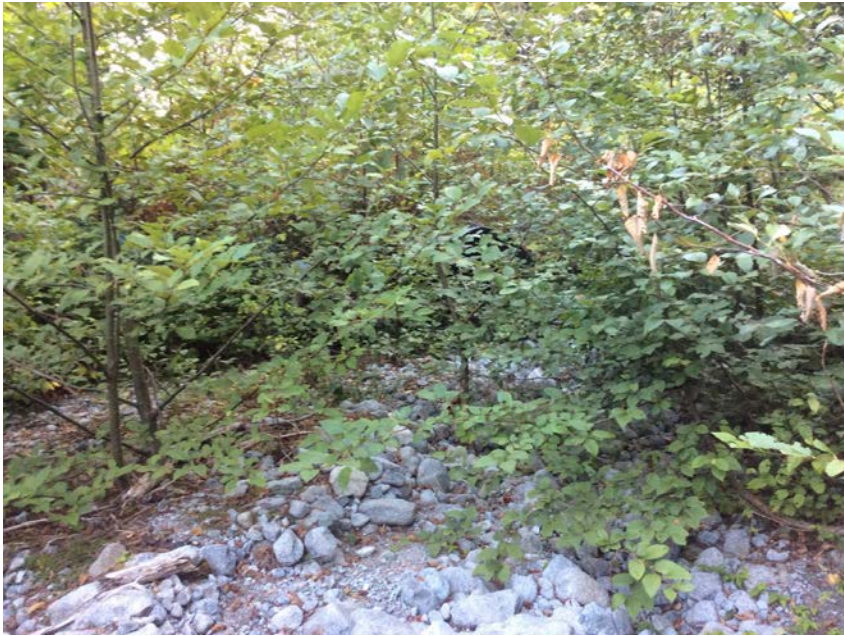
Inlet Fair Left culvert has damaged inlet and small buildup of bedload. Right culvert appears nicely embedded

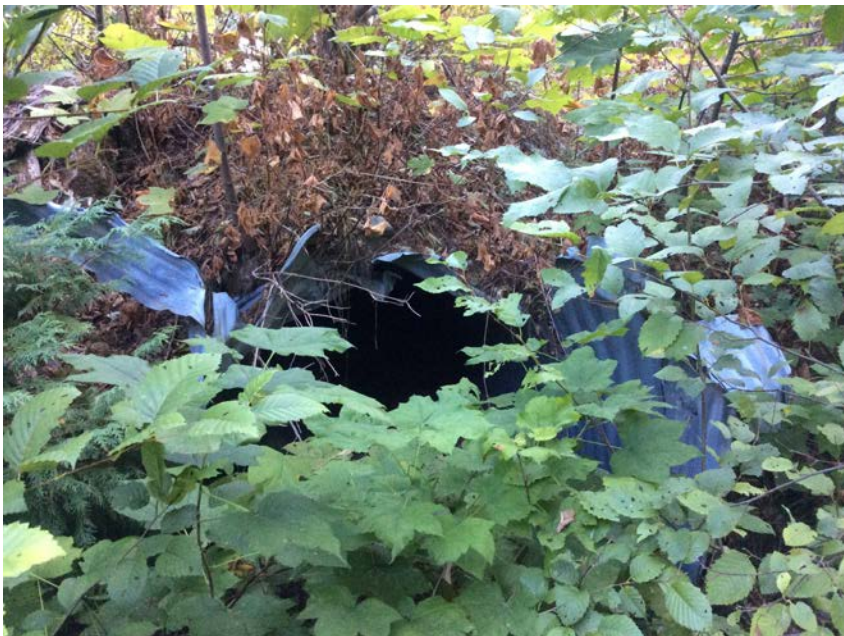
Damaged inlet likely from excavator cleaning bedload

| Item | Monitor Description | Frequency |
|---|---|---|
| 1 | bedload | Routine inspection |
