CK-2342

STAVE RIVER 20.1km

2017 Inspection

| Structure Class | Major Culvert |

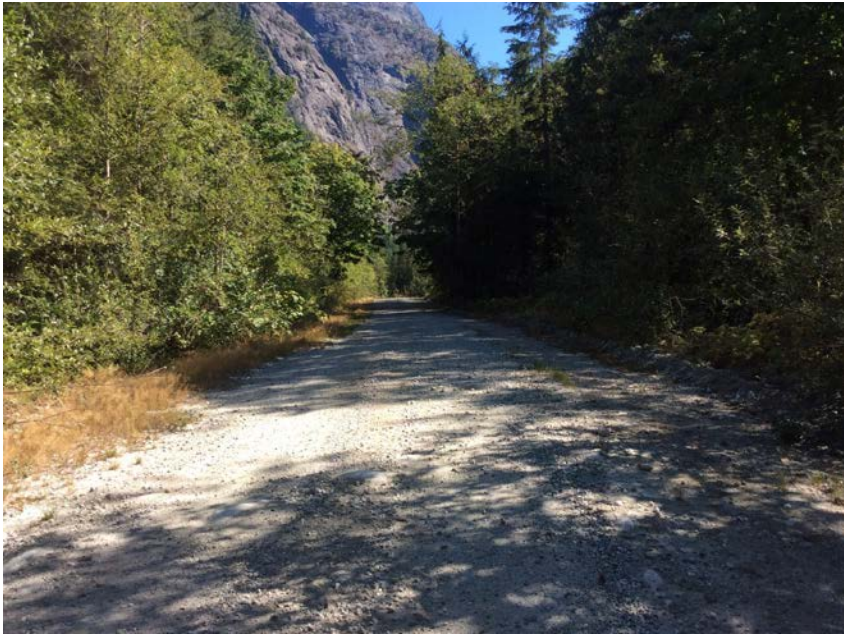
Approach from Right Bank when facing downstream

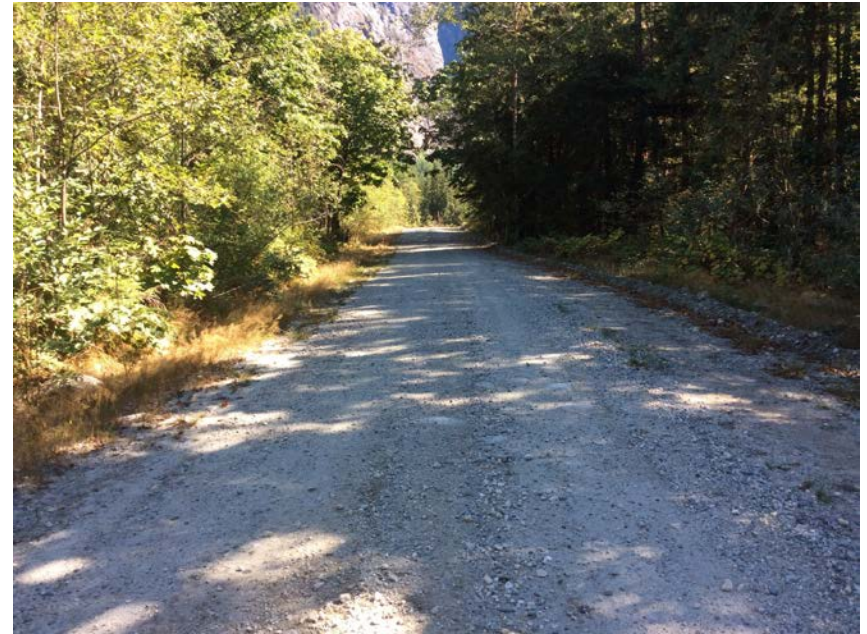
Left approach viewed from bridge

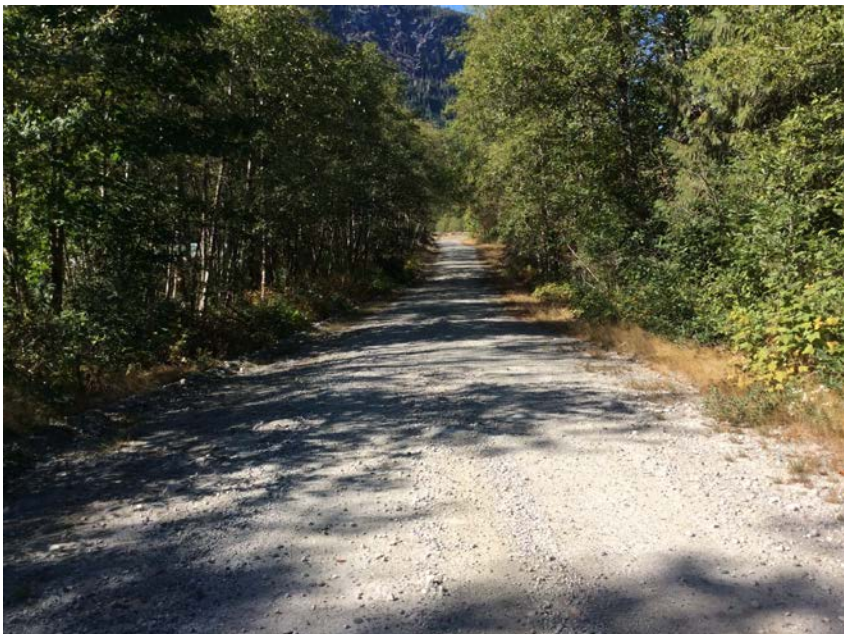
Right approach viewed from bridge

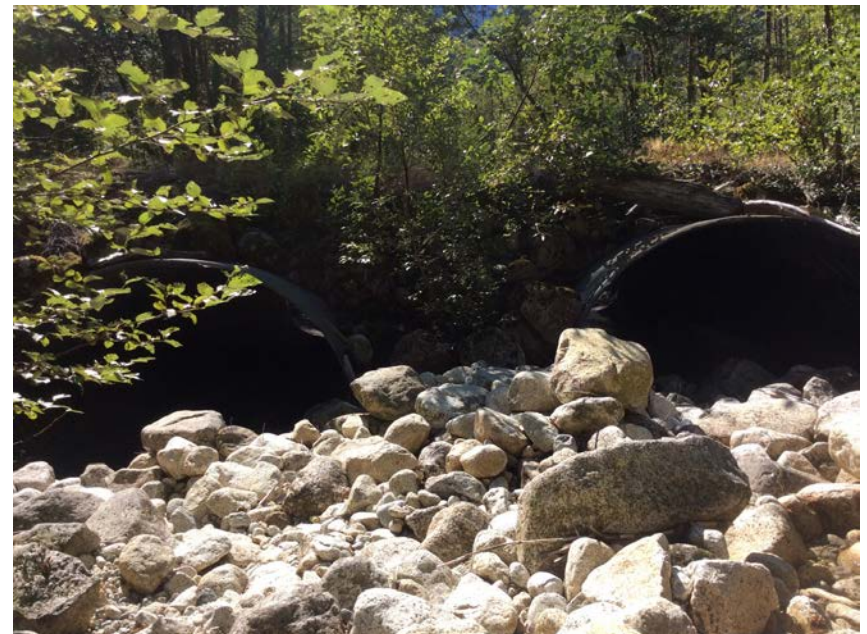
Inlet

Comments Bedload buildup at inlet Of left structure. Only sees flow at high flow

Clean inlet and monitor plunge pool at outlet of right culvert. Present load rating of L75 or 68 tonnes to continue.

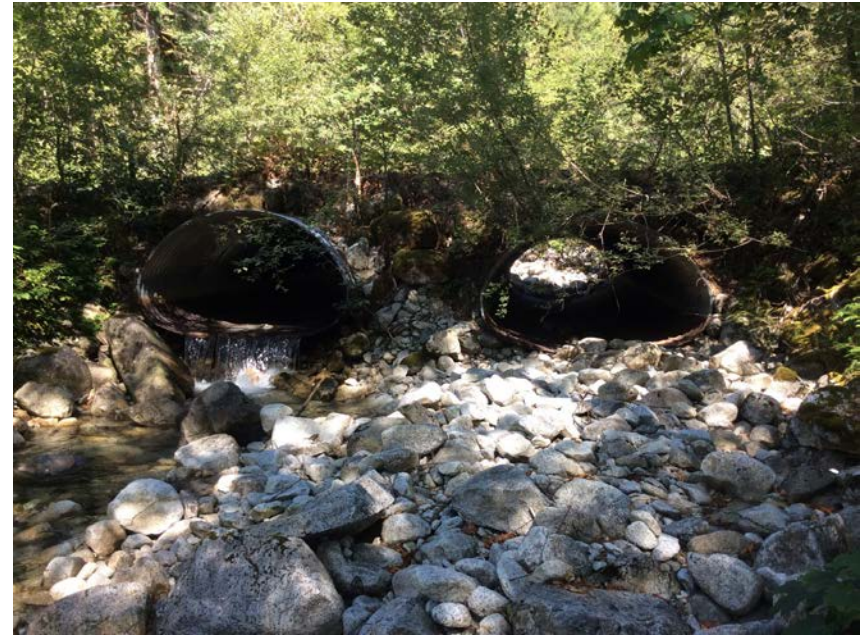
| Outlet | Fair | Plunge pool below right Culvert with undermining extending 1.5m back from end |

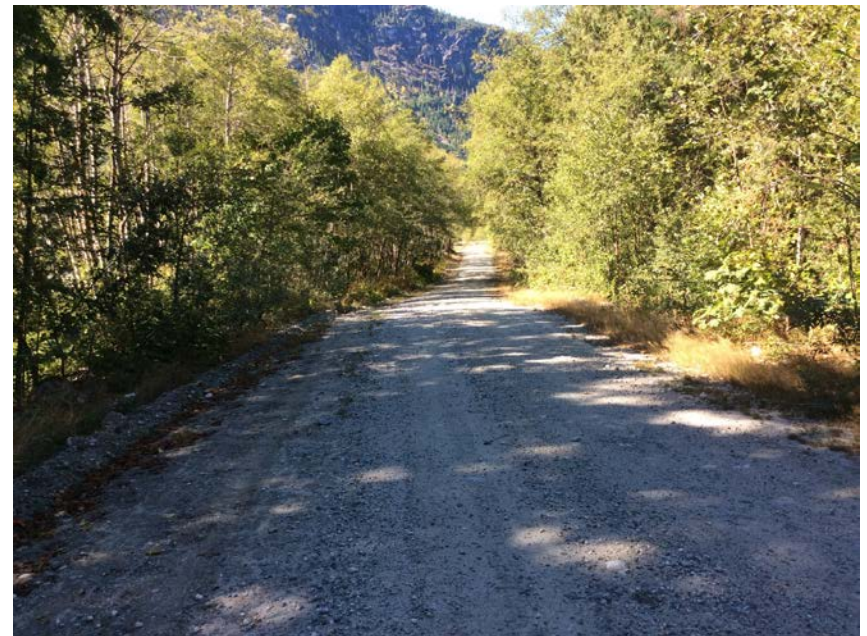
Approach from Left Bank when facing downstream
