CK-2350

STAVE RIVER 6.7km

2017 Inspection

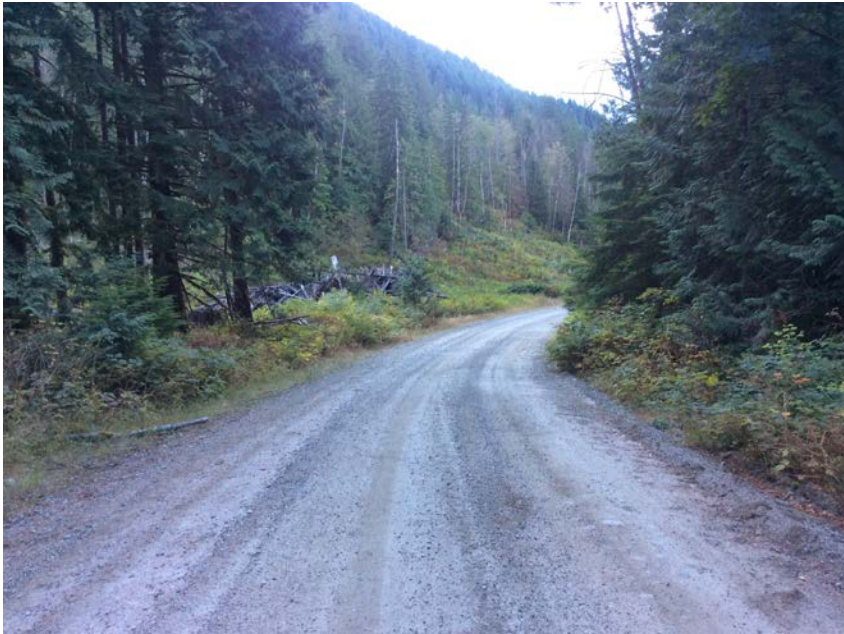
Left approach viewed from bridge

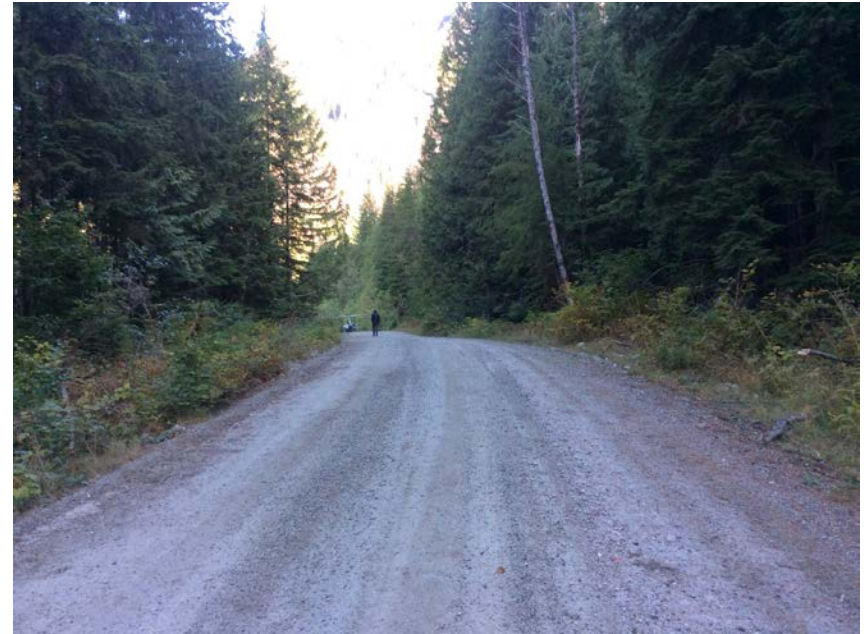
Approach from Left Bank when facing downstream

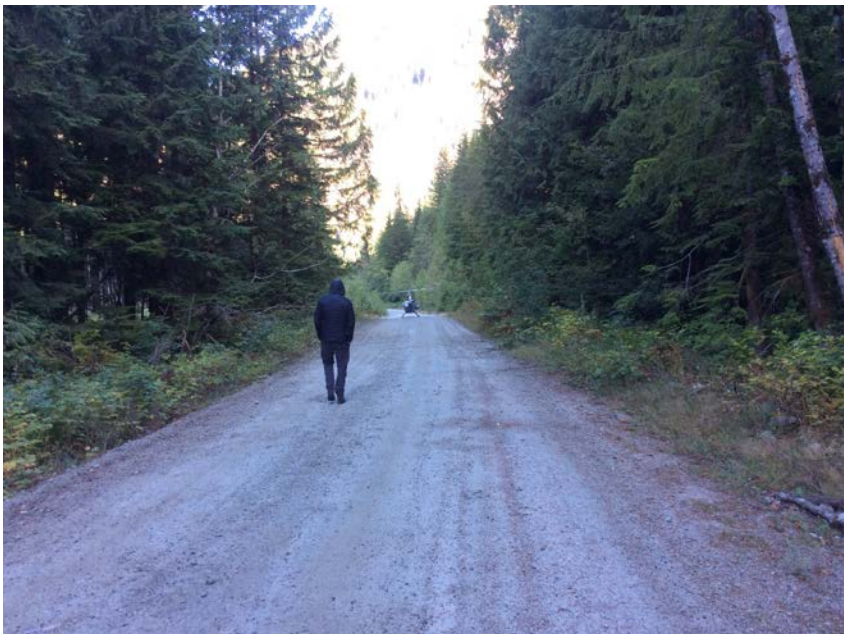
Right approach viewed from bridge
