CK-2356

KOOKIPI NINE 0.5km

2017 Inspection

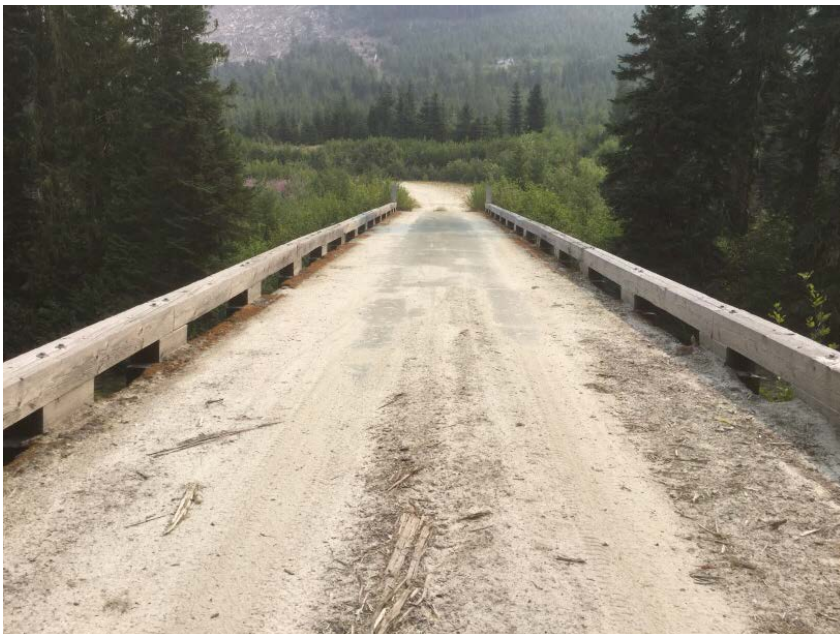
Curb Rail/Blocks/Posts      **Poor**      Rotting

Hardware      **Poor**      Loose rail boltsOverall Deck Condition      **Poor**      Due to rail condition

| Repair Item | Priority | Repair Description |
|---|---|---|
| 3 | Medium | Replace guardrail, risers and blocks |

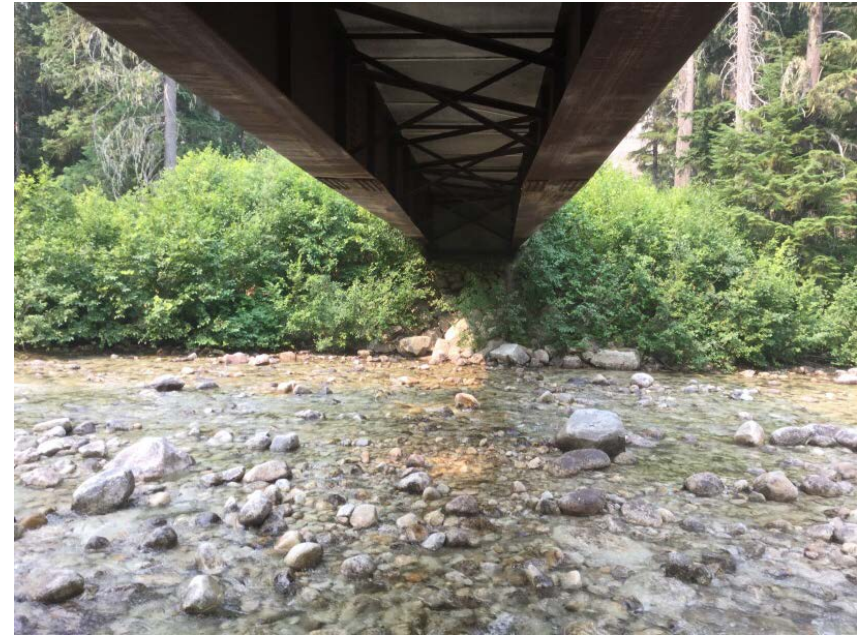
Left Bank Abutment when facing downstream

Pads are buldging left abutment

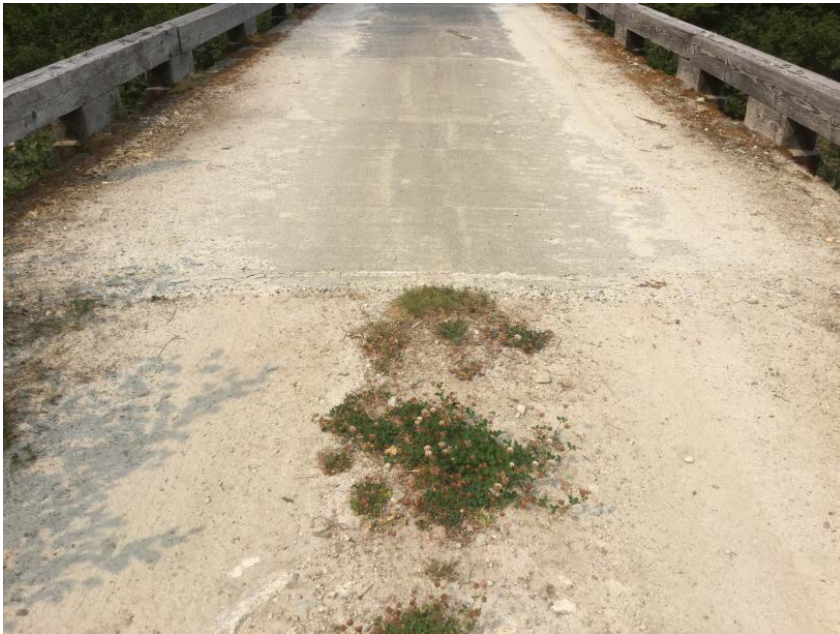
Minor damage to right bank ballast wall on wheel path
