CK-2359

STAVE RIVER 12km

2017 Inspection

| Structure Class | Major Culvert |

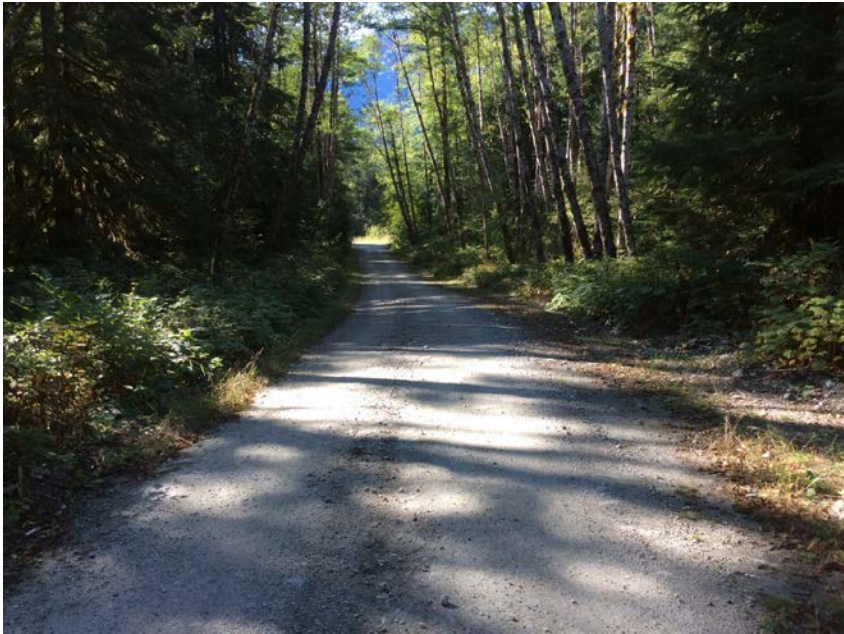
Left approach viewed from bridge

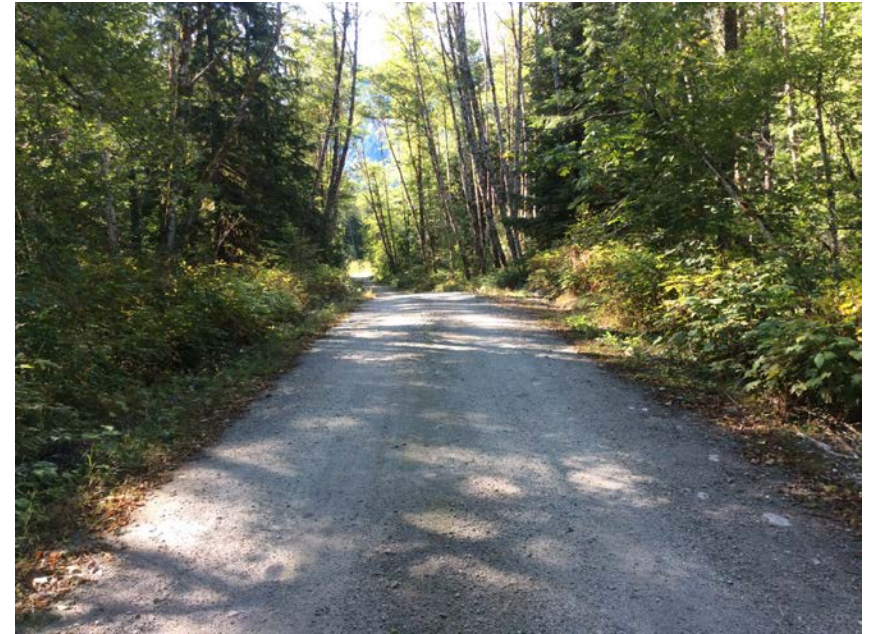
Approach from Right Bank when facing downstream

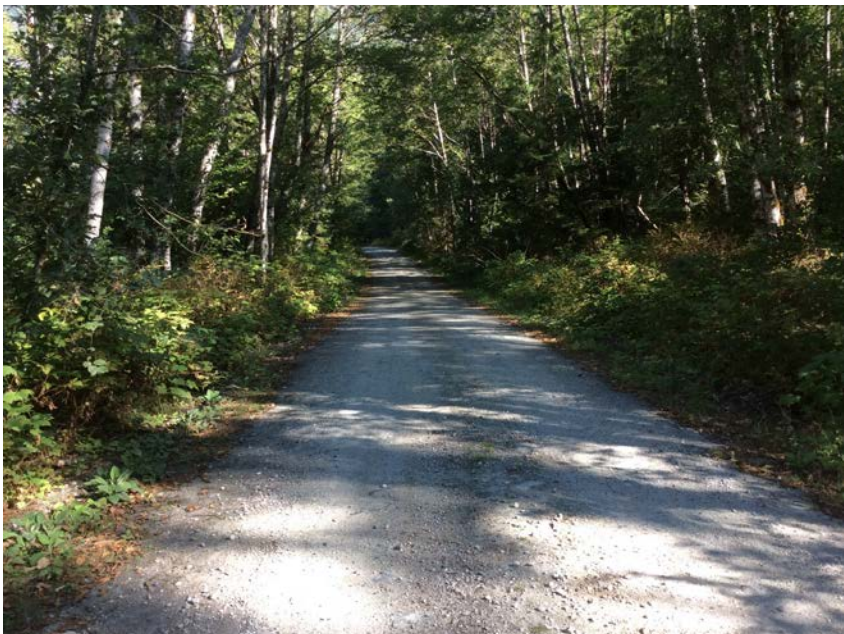
Right approach viewed from bridge

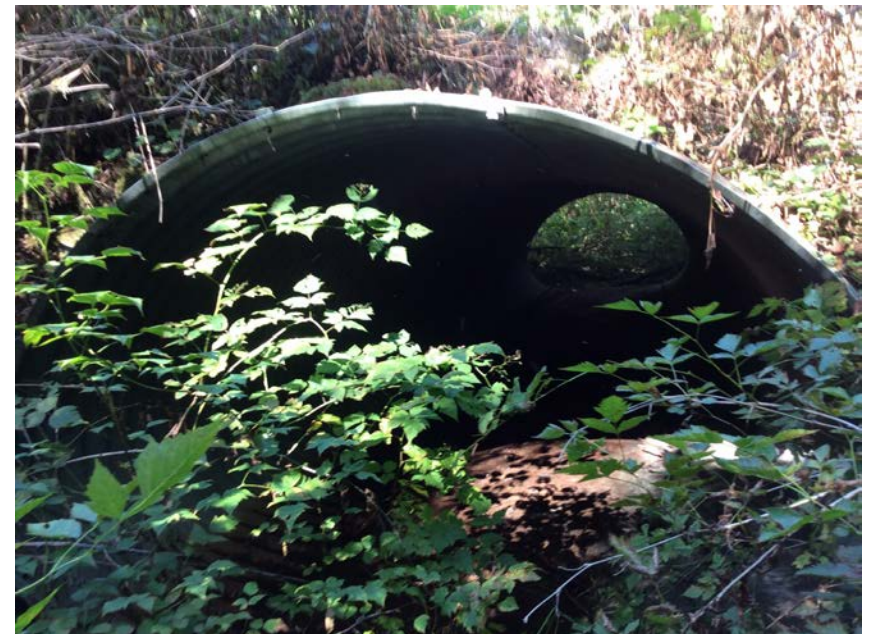
Inlet Good

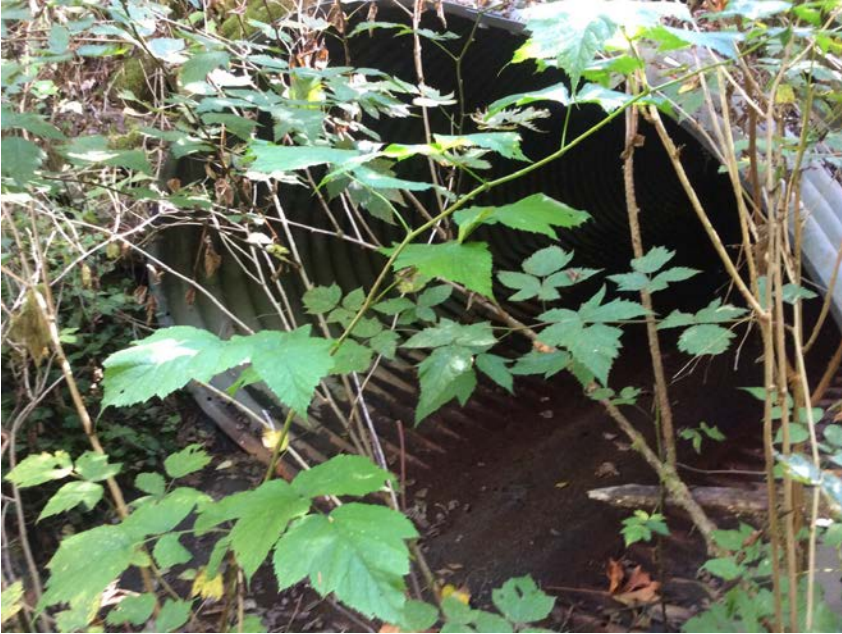
Outlet Good

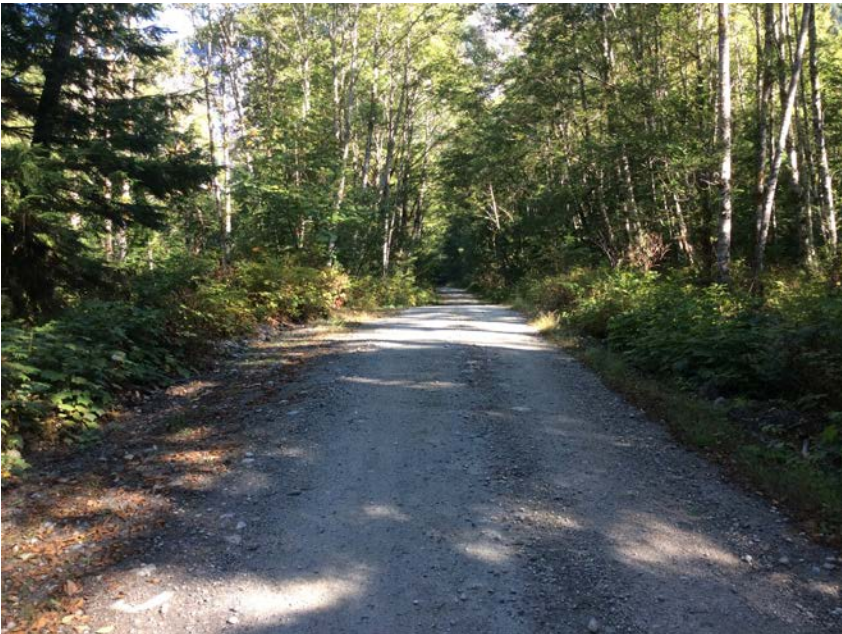
Approach from Left Bank when facing downstream
