CK-2360

KOOKIPI SEVEN 3.8km

2017 Inspection

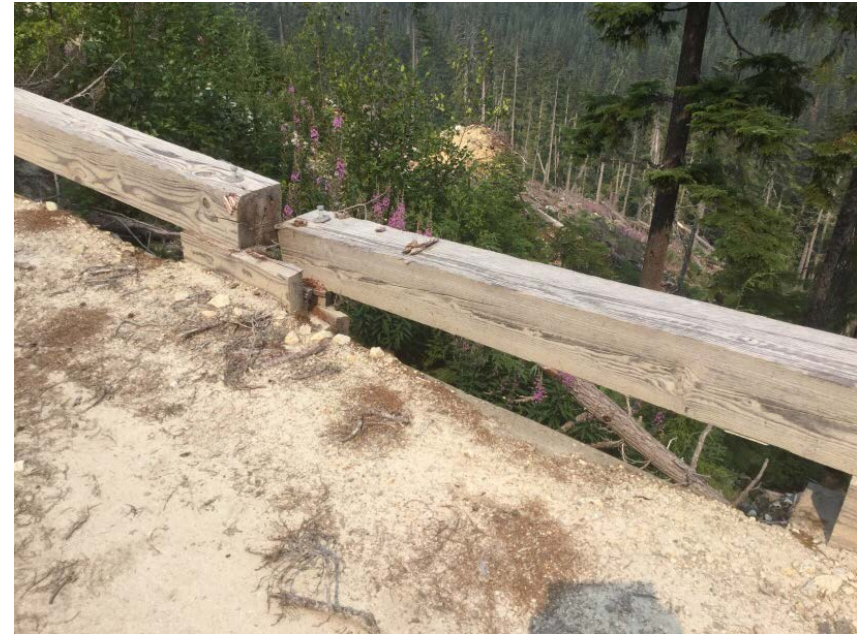
Guard Rail

Curb Rail/Blocks/Posts      Poor      Rotten and broken

Hardware      Poor      Loose rail bolts

Overall Deck Condition      Poor      Due to rail condition

| 1 | Medium | Replace guardrail, risers and blocks |

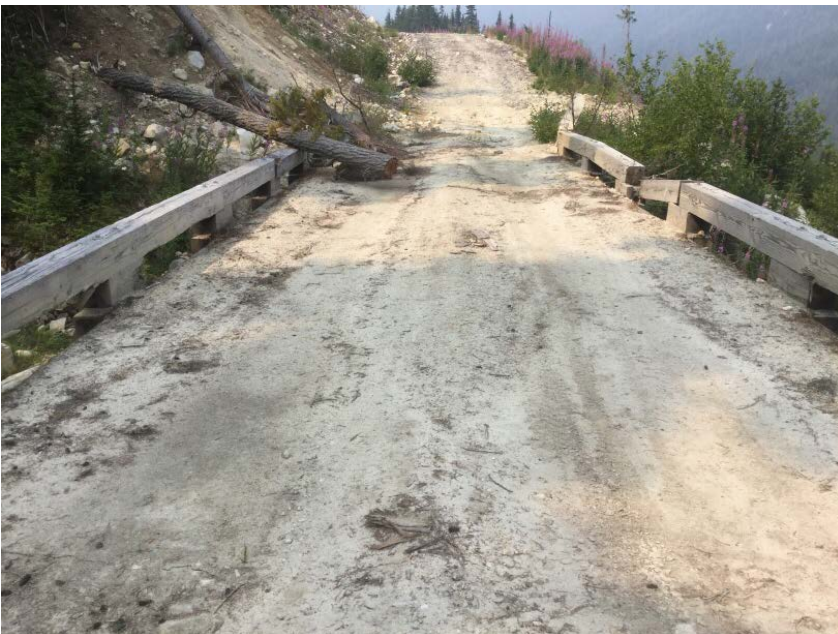
Running Surface      Fair

Concrete Deck      Good

| 3 | Medium | Clean debris and sediment from deck |
